JAMES E. NICHOLS MEMORIAL LIBRARY
35 PLYMOUTH STREET, CENTER HARBOR, NH
EXISTING CONDITIONS REPORT & ASSESSMENT
27 FEBRUARY, 2019

PROLOGUE

4.0 CONDITIONS ASSESSMENT

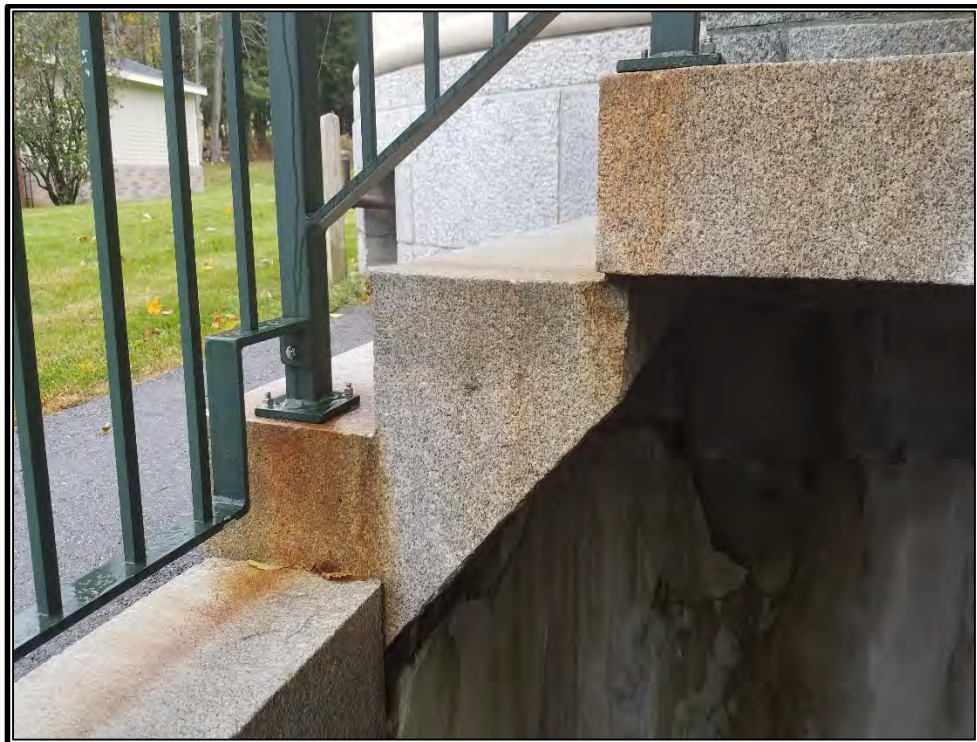
Photo 9: View of granite staining at rear of building.

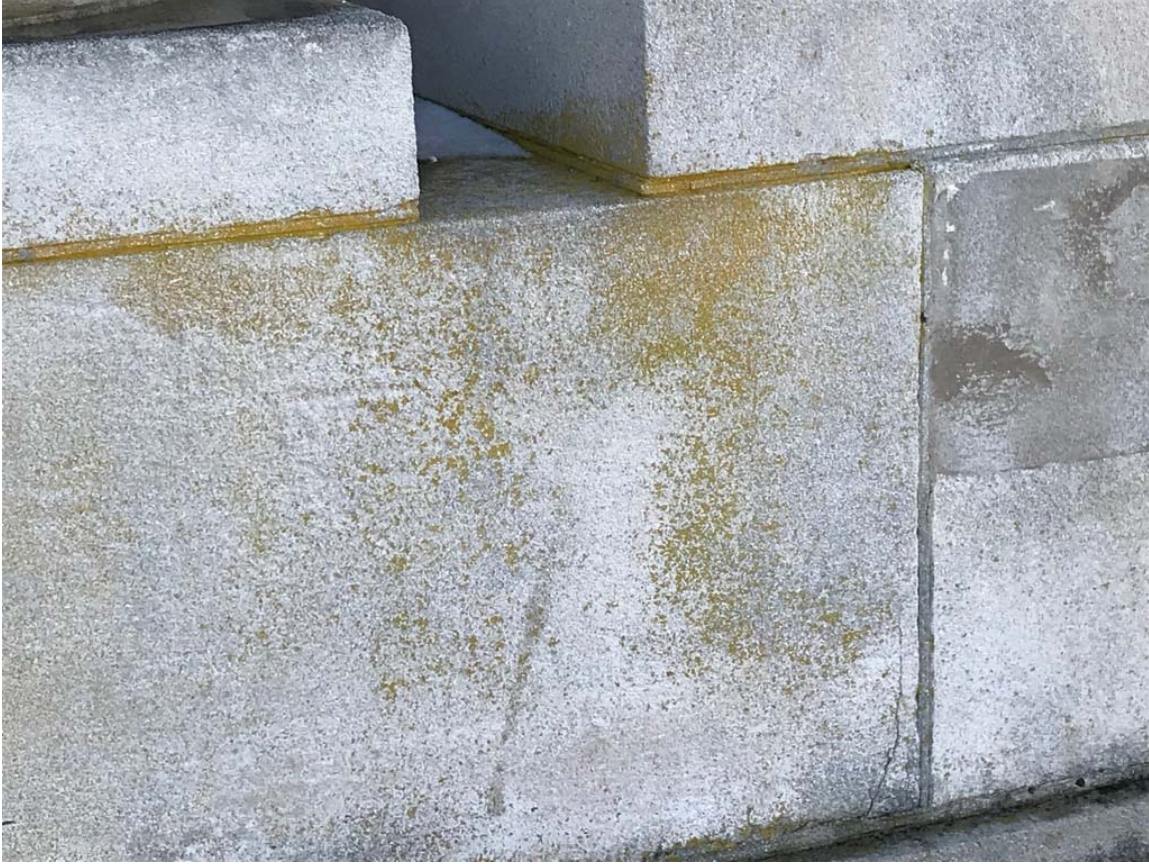
The granite foundation stones require extremely minor re-pointing particularly at the four corners of the building from long-term water-related erosion as well as removal of grime and green biological growth resulting from repeated splash-back of water draining from the roof. [Figure 1](#). They are otherwise in excellent condition and require no further treatment.

Figure 1: Detail of granite foundation stones showing minor accumulations of biological growth due to long-term moisture exposure.

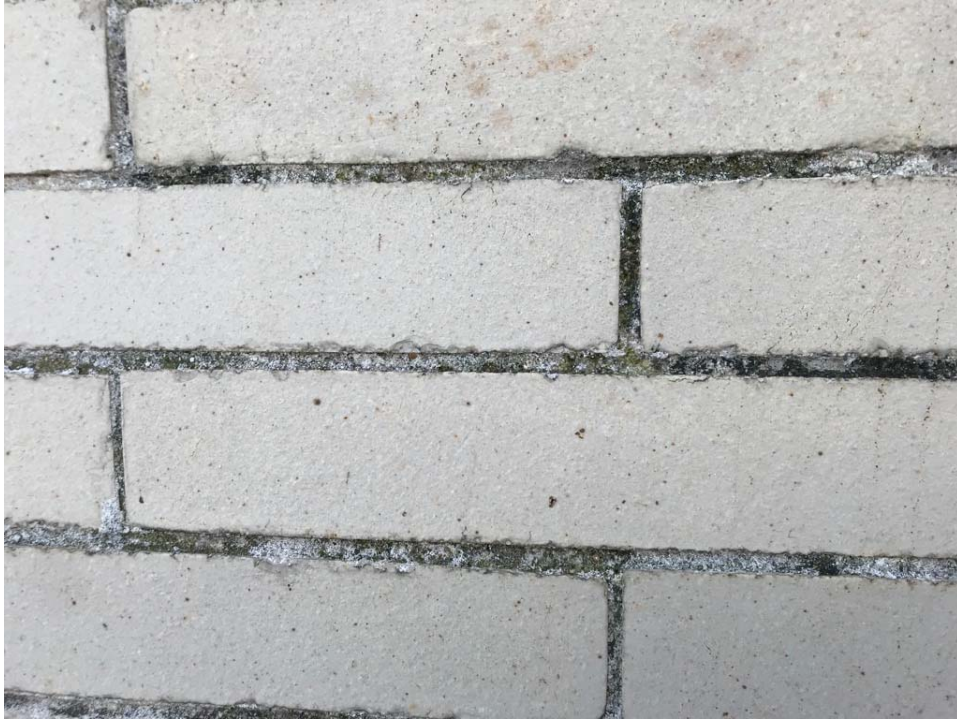
Figure 2: Detail of exterior brick showing typical black mildew growing on the mortar joints.

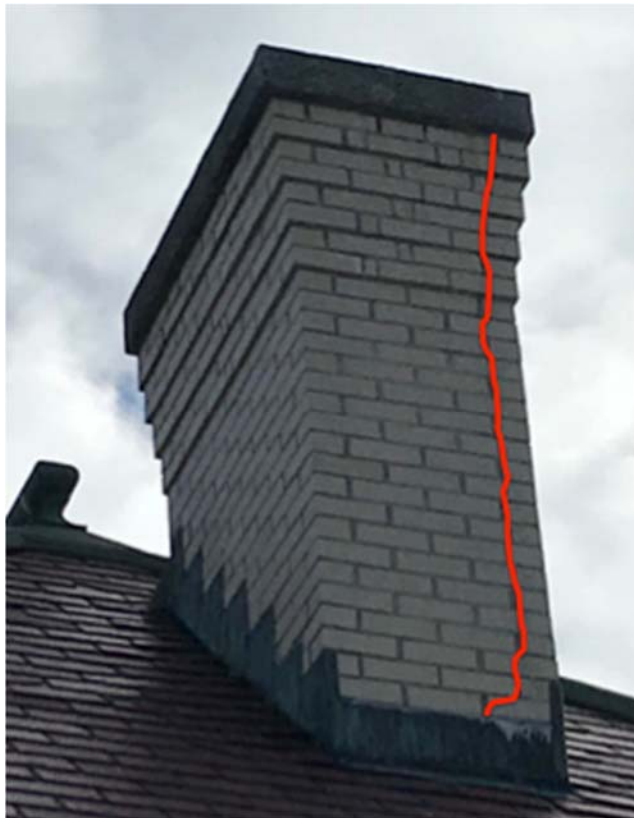
The north-westerly chimney (from the northern reading room) has evidence of a structural crack. See Masonry report in Appendix II for additional detail.

[Figure 2](#) The western chimney exhibits a significant structural crack on its western elevation at the southwest corner [Figure 3](#). The cause of this crack appears to be the result of a combination of several factors: the extreme hardness of the construction materials (the particular bricks and mortar type used); repeated exposure to water infiltration from the top and requisite seasonal freeze-thaw cycles over time, and long-term exposure to wind-driven precipitation, being a highly exposed and ultimately fairly fragile feature at the top of the building.

Figure 3: Detail of the western chimney looking southeast. The red line shows the position of the crack.

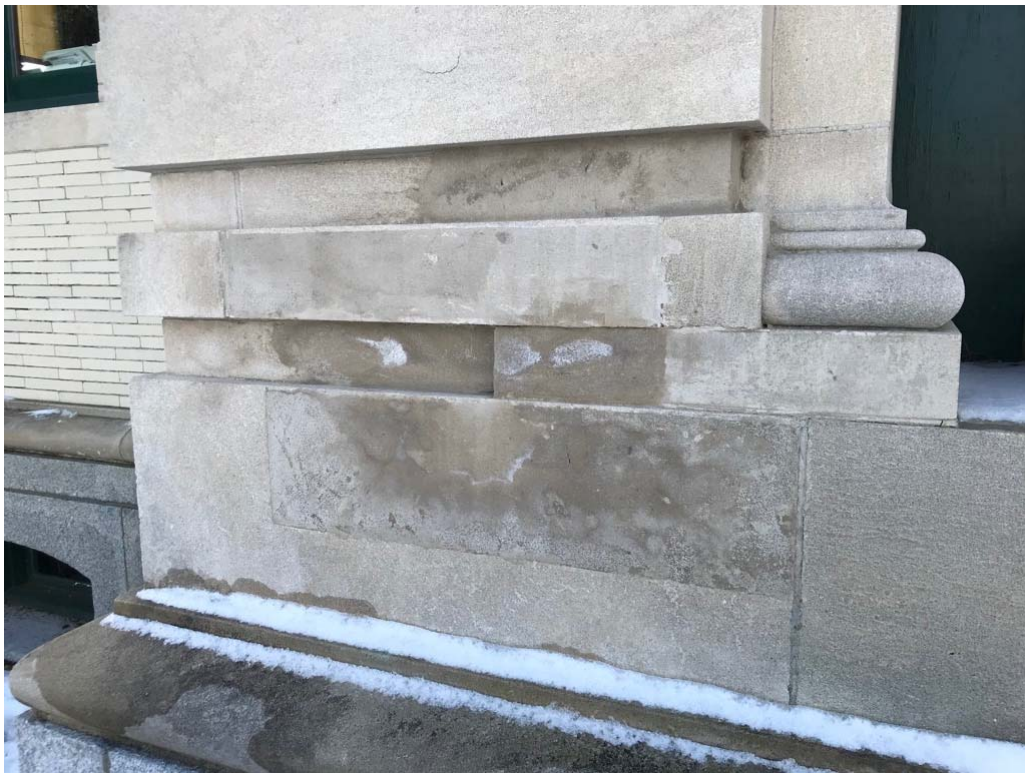
Figure 4: Detail of well-executed Dutchman repairs to areas of sandstone near the front entrance.

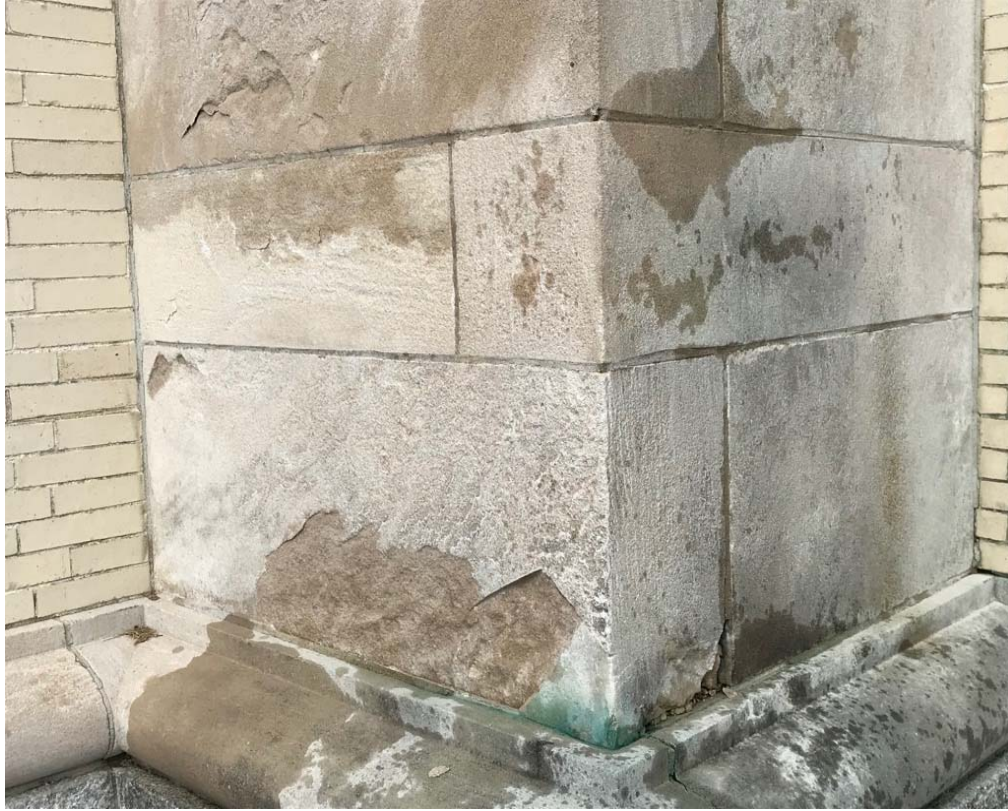
Figure 5: View of spalling, delaminated sandstone at the southeast corner of the building.

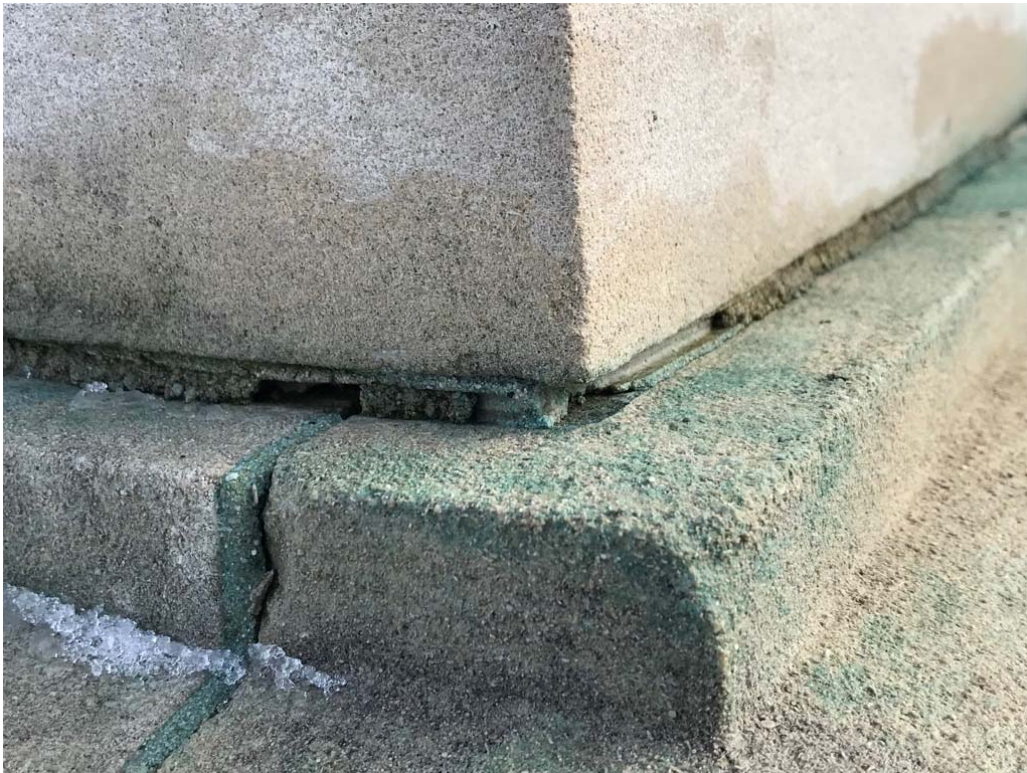
Minor failure of pointing issues was noted in the vertical mortar joints of the sandstone water table, mostly located at the corners of the building. This is due to repeated sheeting action of water cascading down the walls and long-term freeze-thaw conditions. [Figure 6](#) There is green staining on the sandstone in many areas, mostly near copper gutters, drip edges and downspouts, caused by minor leaks in the built-in gutters and downspouts. [Figures 7- 9](#) These stains should be seen as permanent, as they are difficult or impossible to minimize or completely remove with today's technology. Proper maintenance of the gutters and better overall site drainage will help curb ongoing staining.

Figure 6: Detail of sandstone water table mortar joint showing typical, minor loss of pointing mortar.

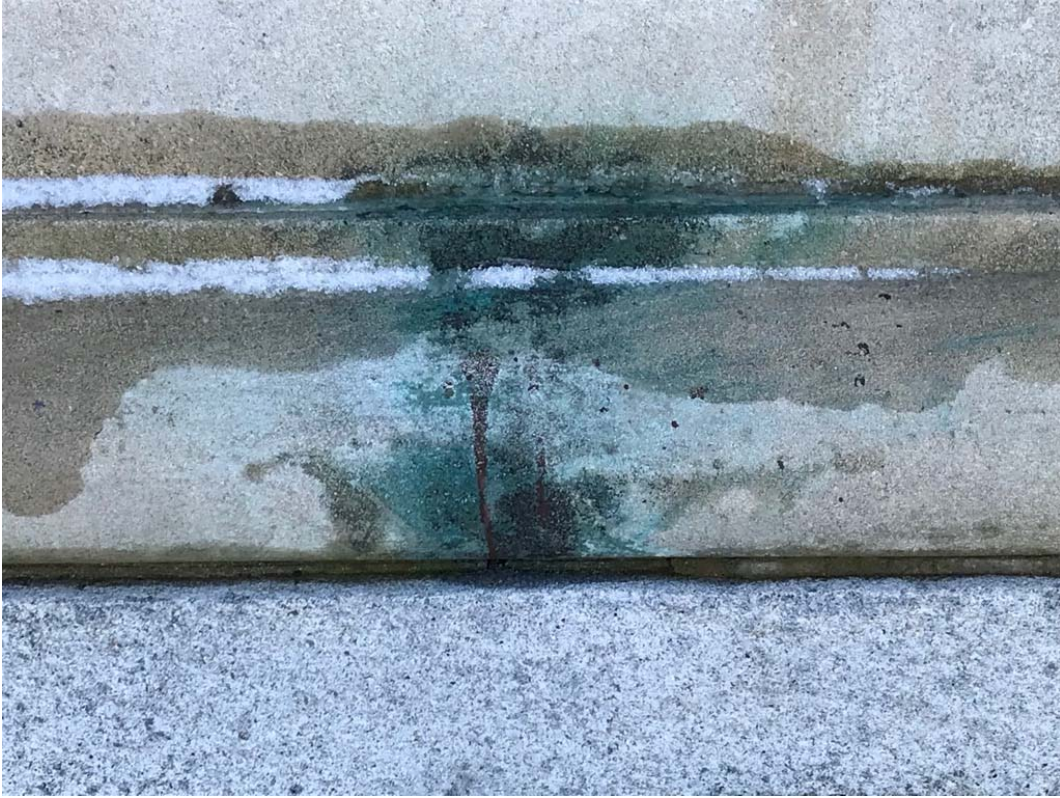
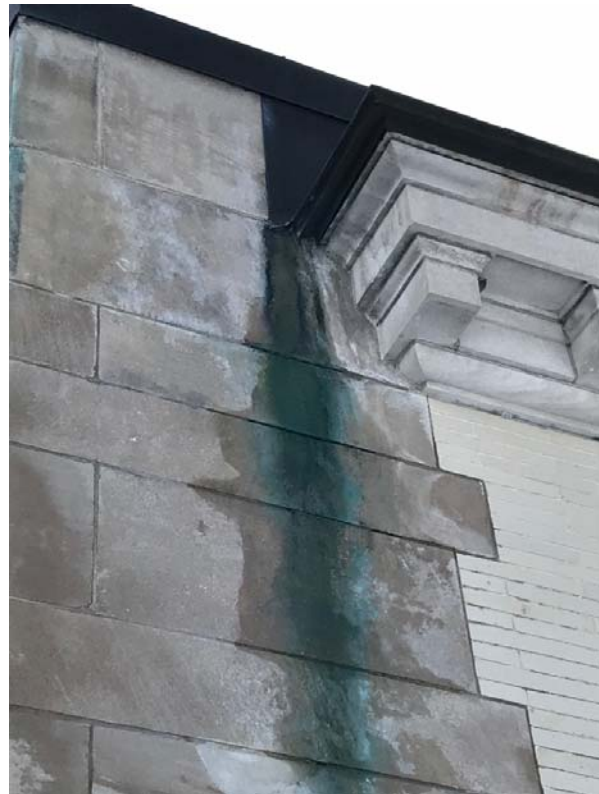
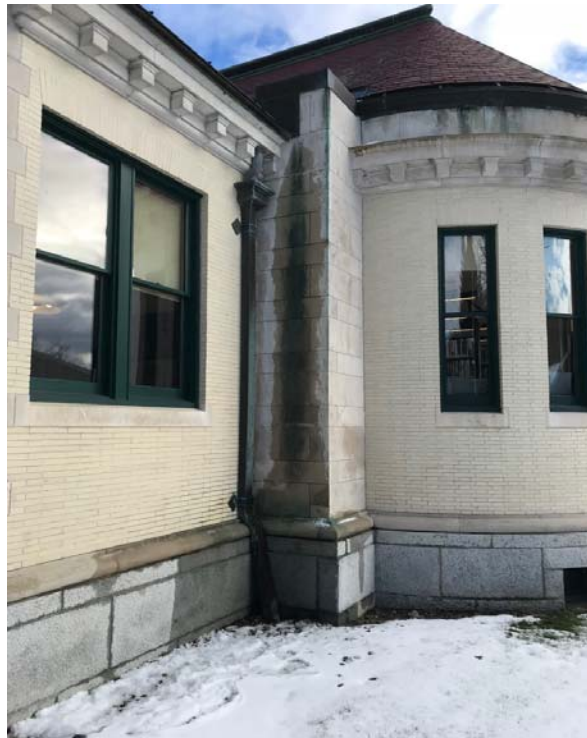
Figure 7: Typical staining resulting from corrosion of copper roofing and gutters.

Figure 8: Typical staining resulting from corrosion of copper roofing and gutters.

Figure 9: Typical staining resulting from corrosion of copper roofing and gutters.

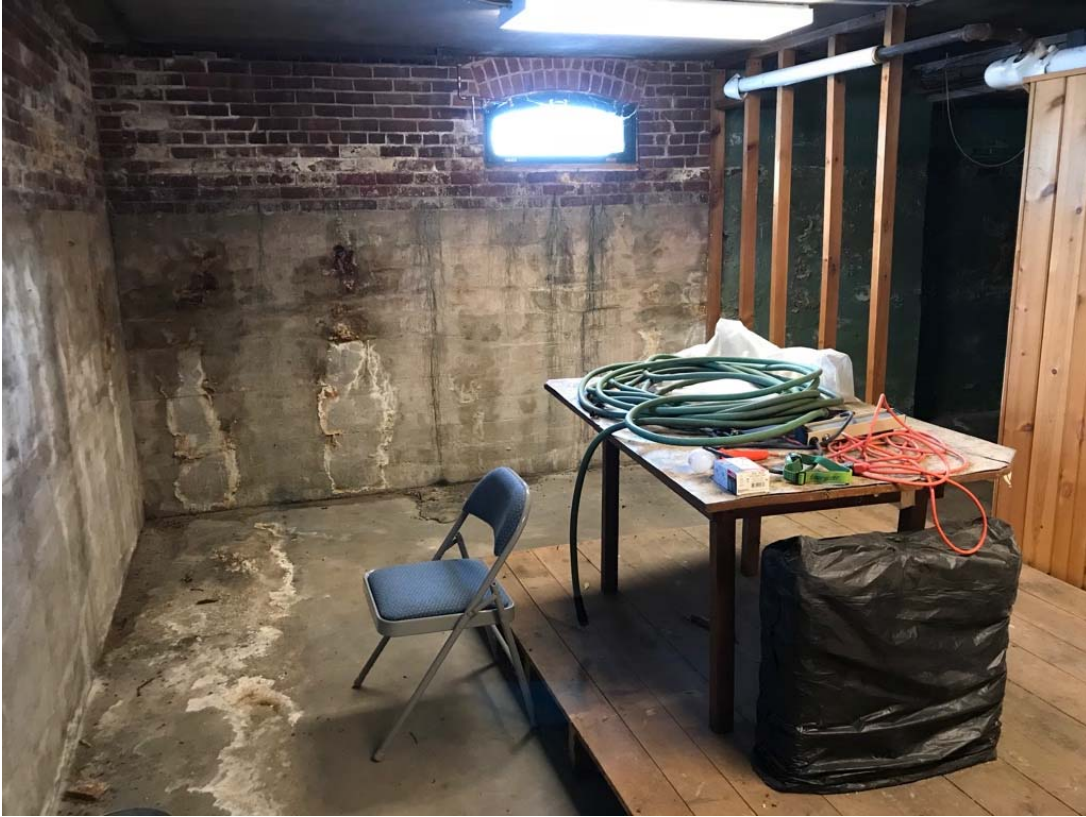
Figure 10: View of typical salt efflorescence accumulating on brick and concrete surfaces on the interior of the foundation. Northwest corner of the basement.

The buildup of efflorescence is a natural phenomenon that occurs when masonry experiences long-term exposure to too-high moisture levels. Water migrating through the masonry whether in liquid or vapor form carries soluble salts within the masonry outward, which crystallize into visible efflorescence. Over a long period of time, and particularly with softer brick associated with buildings much earlier than the Library, this phenomenon will eventually cause brick and some softer types of stone to spall or crumble away. Luckily most of the materials in the Library's construction are much harder and thus the problem has not yet led to structural damage. The only area where extensive and repeated damage was observed was with the wall plaster surfaces associated with the interior basement stairwell.

The existing efflorescence can be easily and inexpensively removed once drainage problems are solved, as discussed below.

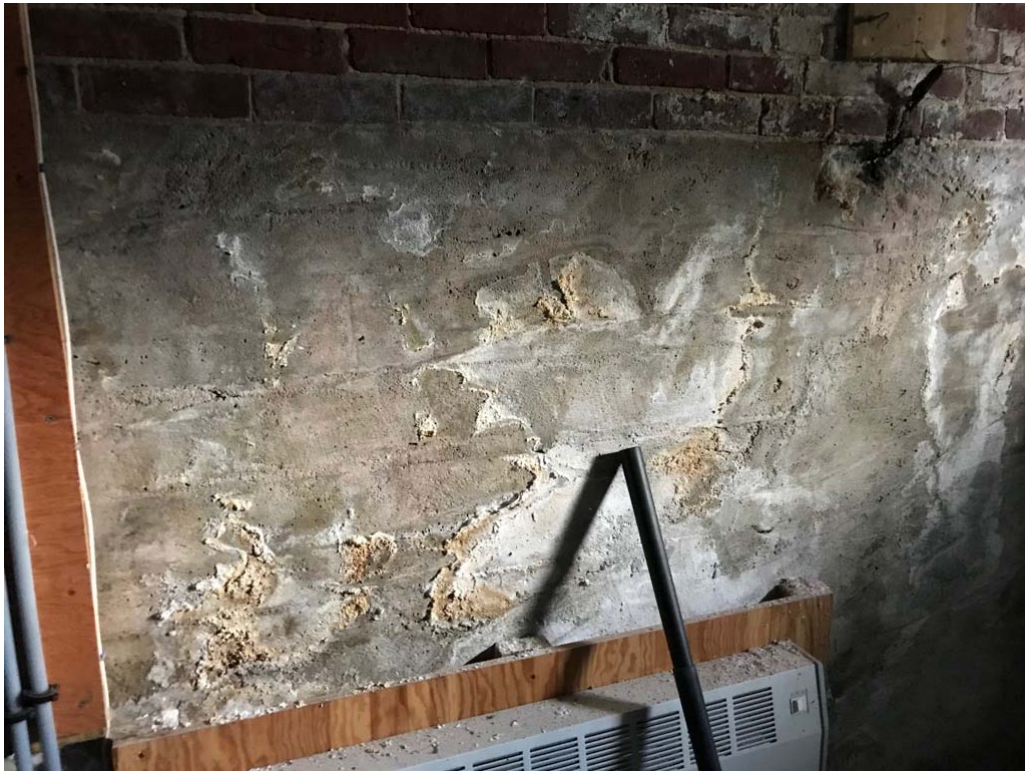
Figure 11: Detail of soluble salts weeping through hairline cracks in the poured concrete foundation.

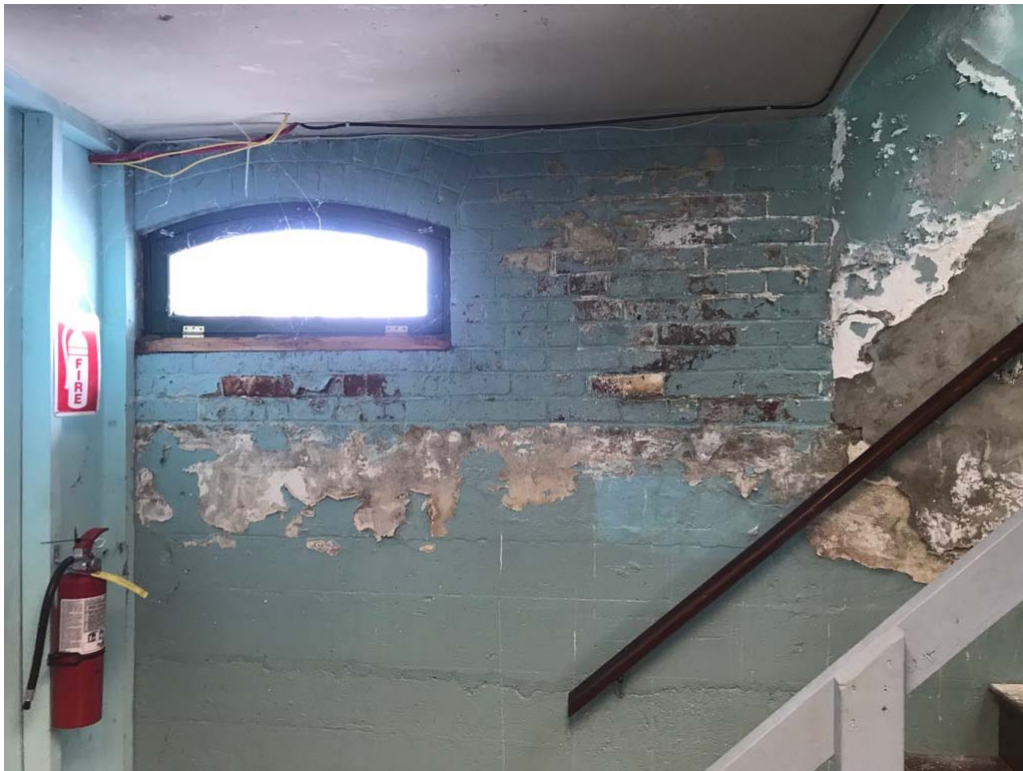
Figure 12: View of southeast wall of the basement showing soluble salts migrating through brick, plaster and paint.

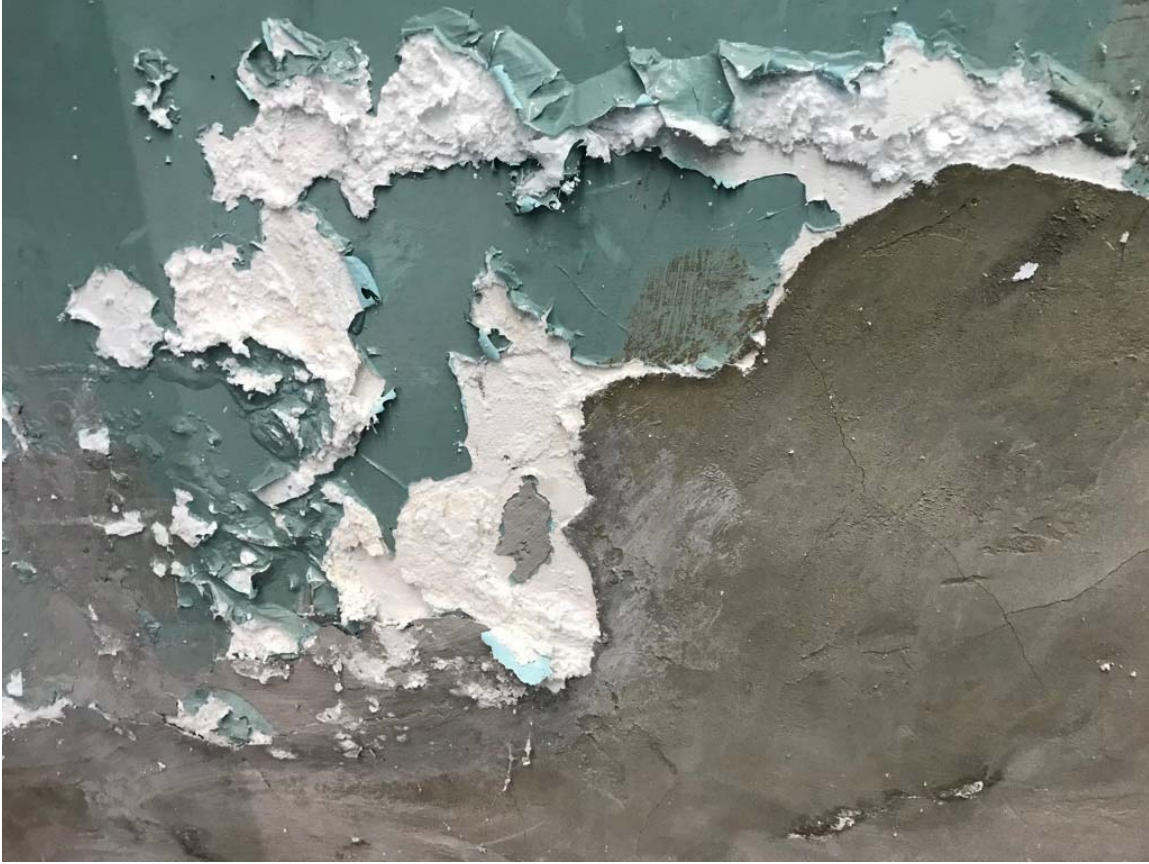
Figure 13 The plaster, which has high gypsum content typical of the early twentieth century, is extremely hard and dense in comparison to earlier all-lime plasters. This material naturally retains moisture rather than allowing it to migrate through and evaporate. This characteristic makes gypsum plaster extremely prone to failure when exposed to long-term high levels of moisture.

Figure 13: Detail of interior basement stairwell plaster showing failure of the finish coat and paint due to long-term moisture infiltration. The white areas are the original finish coat, where crusty soluble salts are forming on the surface and causing the paint to peel. The dark gray area is a later patch consisting of very hard cement plaster.

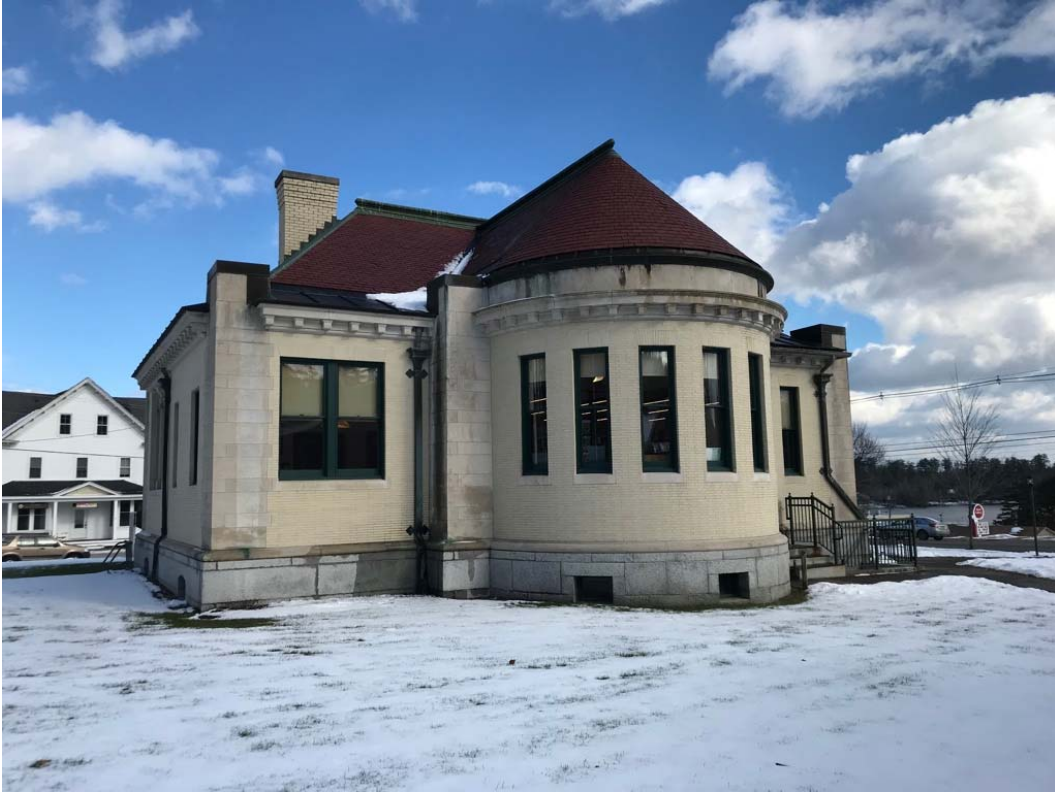
In the case of the Library, the condition of the basement is clearly symptomatic of long-term exterior drainage problems. Though the site is on a hillside sloping to the southeast, the immediate site is extremely flat. [Figure 14](#) The building is fitted with built-in eaves gutters leading to decorative copper downspouts. [Figure 15](#) The foundation features foundation splash stones on all sides. [Figure 16](#) However, the drainage system is currently designed only to concentrate runoff from the roof into isolated gutters that empty out onto the ground only inches from the foundation. While the gutters and downspouts appear to be sized adequately for the water load from the roof, the water does not drain away from the foundation, takes too long to dissipate into the ground, and is constantly being absorbed by the foundation masonry.

Figure 14: overall view of the building from the rear looking northeast, showing very level grade with little opportunity for water to drain away from the building.

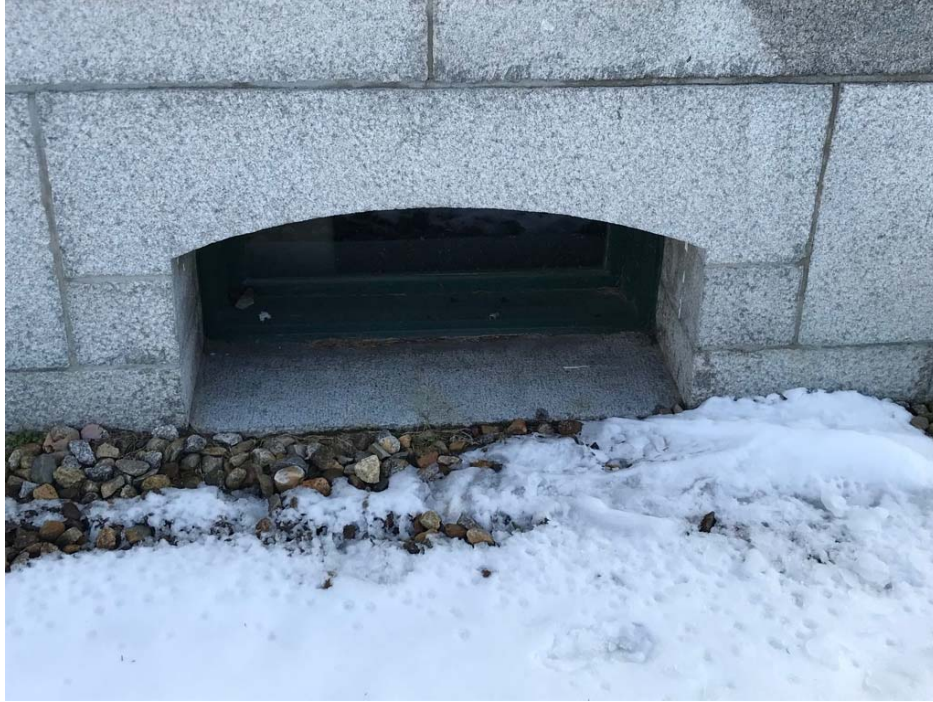
Figure 16: detail of basement window showing perimeter splash stones in place.

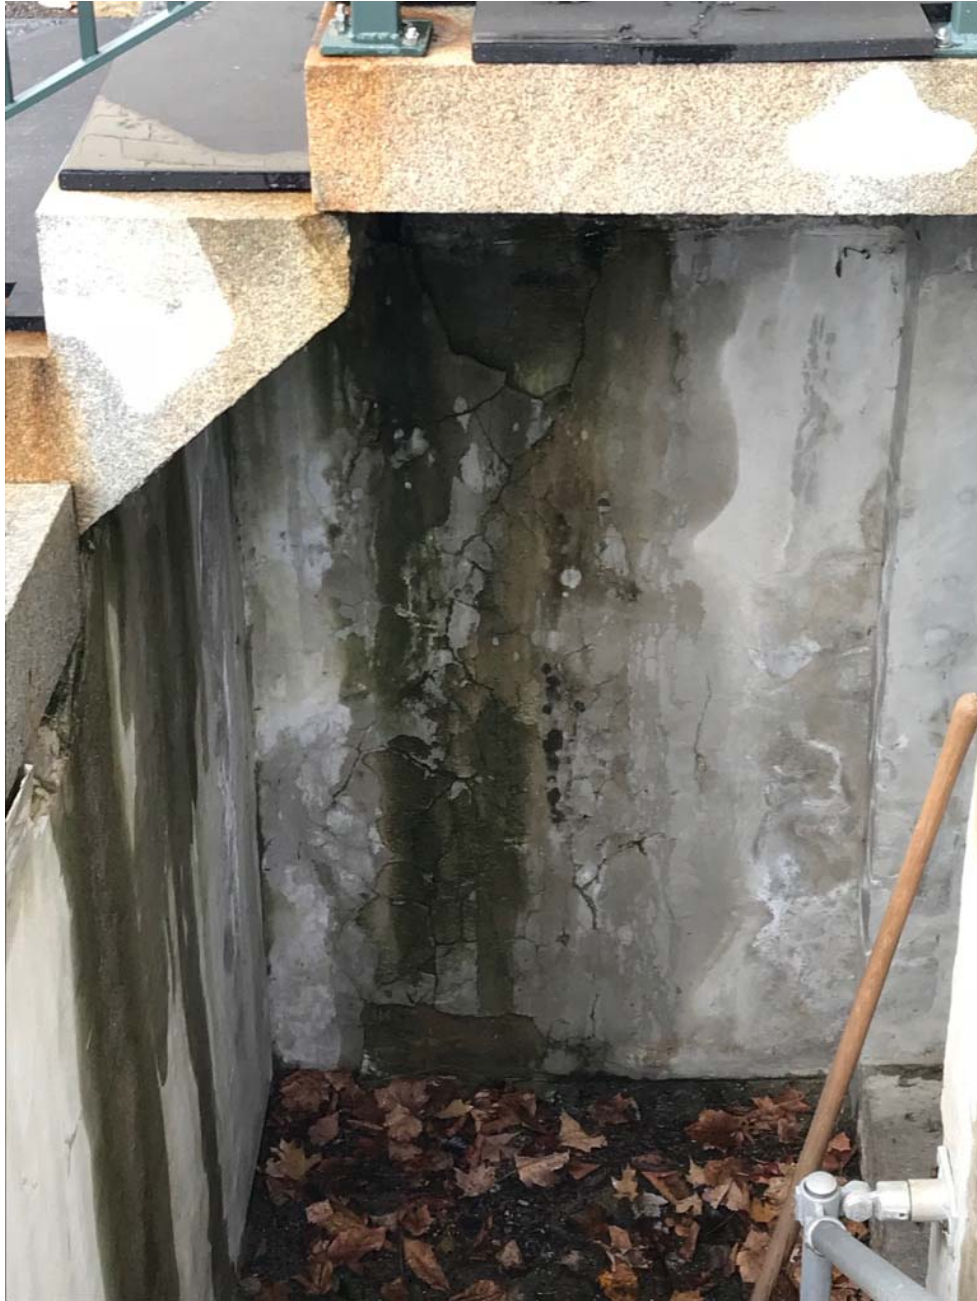
The exterior basement stairwell is of poor initial design given the harsh New England climate, and is a constant trap for rainwater and melting snow that drain into the basement and are absorbed by surrounding foundation materials at even higher levels than the remaining areas of foundation. [Figures 17, 18](#). The cast concrete steps descending to the basement have many cracks resulting from freeze-thaw cycles and will soon become unstable and a safety hazard. The paged masonry covering the open stairwell walls is cracked, deflected, and in a state of near complete failure.

Figure 17: View of the exterior basement stairwell showing failed wall parging, active water infiltration, and standing water at the foot of the stairs.

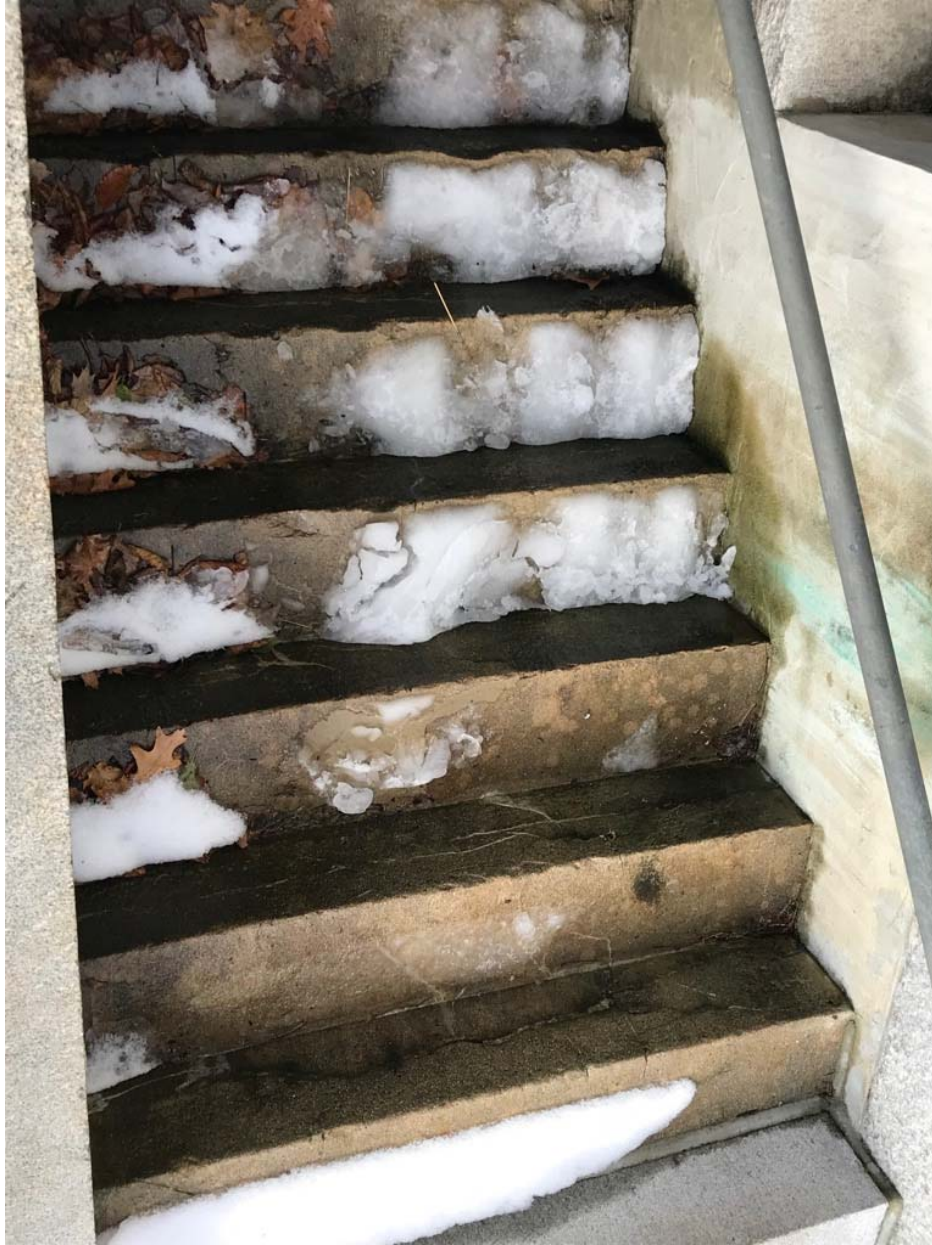
Figure 18: View of exterior cast concrete basement stairs showing active accumulations of snow and ice, leading to freeze-thaw conditions. Many cracks in the steps can also be seen.

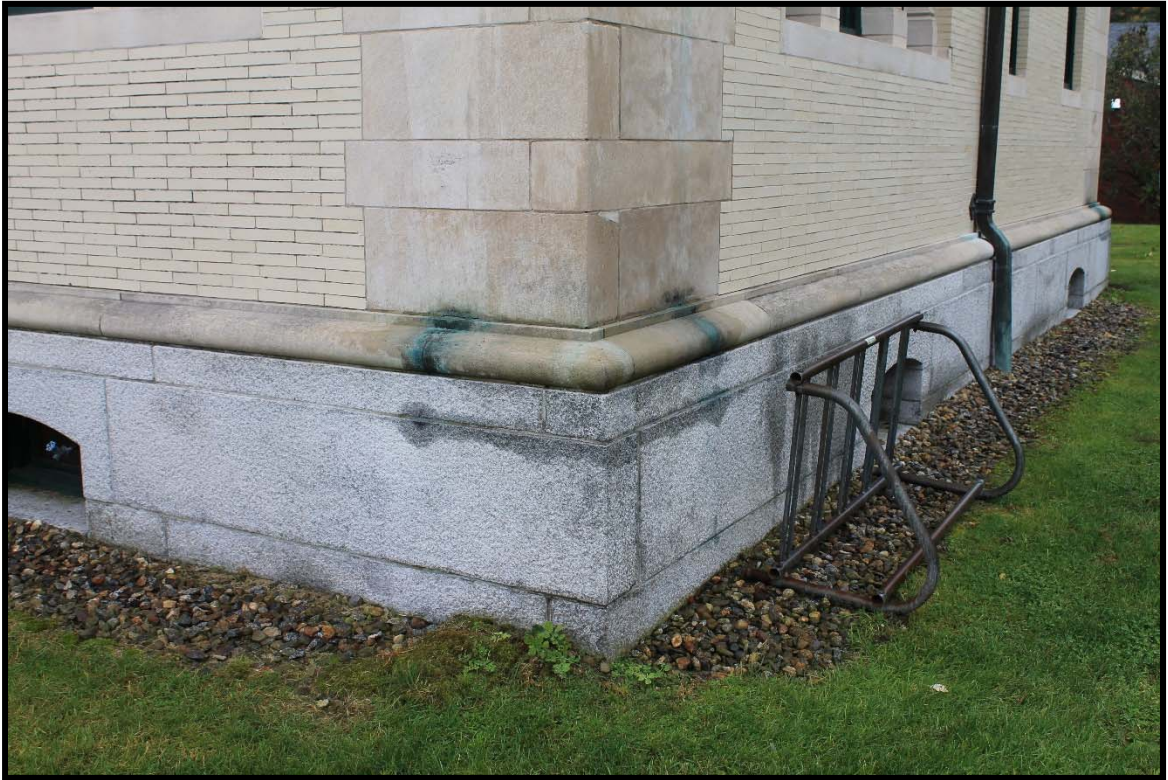
The wall finishes are generally in good condition but do suffer from ineffective roof drainage highlighted by green 'copper' staining at multiple wall locations, and areas of spalling in the sandstone where the water collects (Image Exterior Detail 03 – 04).

Image Exterior Detail 03 – Typical Exterior Corner – Some staining evident to sandstone.

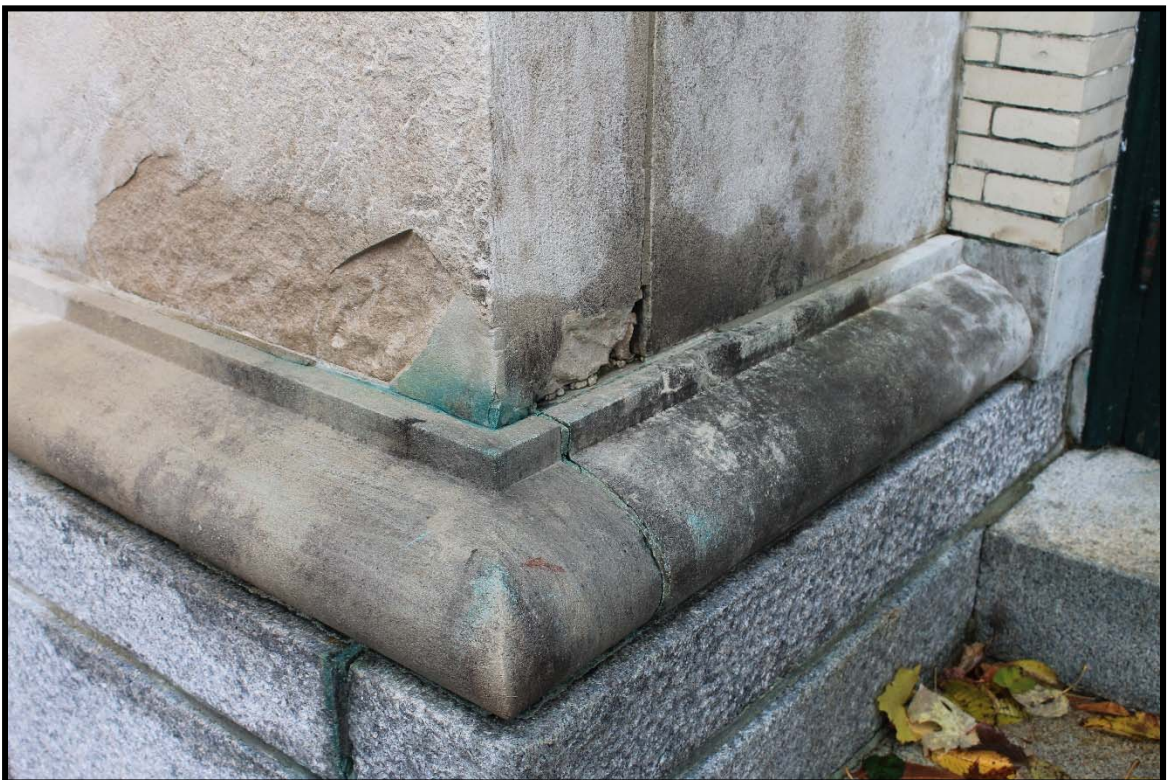
The exterior of the foundation appears to be in good shape with limited signs of moisture damage and minimal spalling of stone and deterioration of mortar. The current roof drainage systems are not completely functioning as intended and are introducing a drip edge condition that is contributing to accelerated deterioration of the exterior (Image Exterior Detail 03 – 04).

Image Exterior Detail 04 – Exterior Corner where spalling evident.

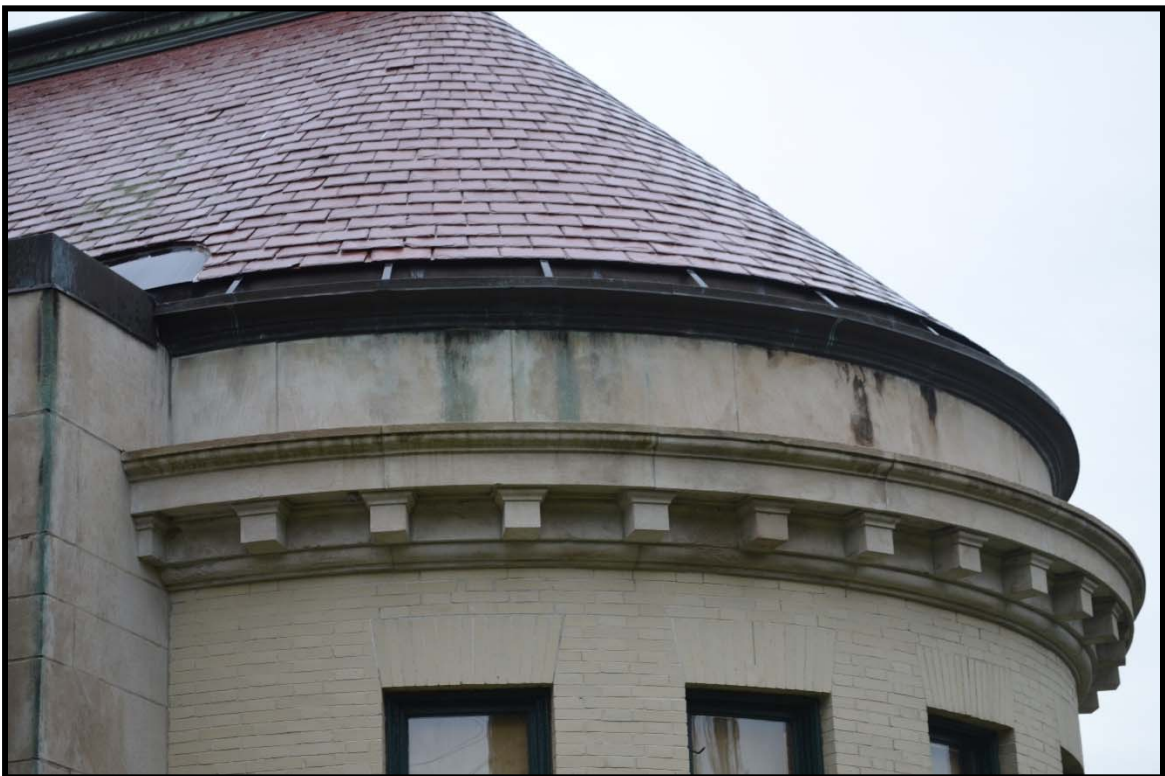
Image Exterior Detail 12 – Rear Roof with evidence of failure of Drainage Channel causing Staining.

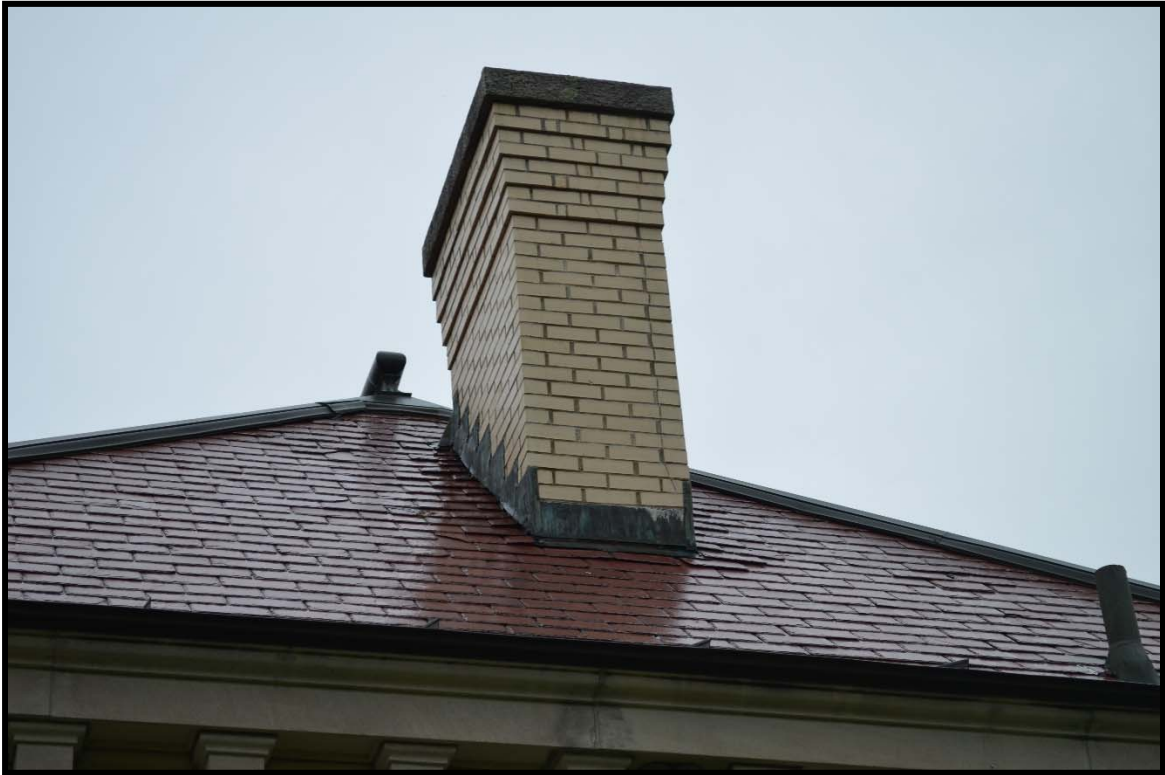
Image Exterior Detail 13 – Typical Brick Chimney with Crack Evident.

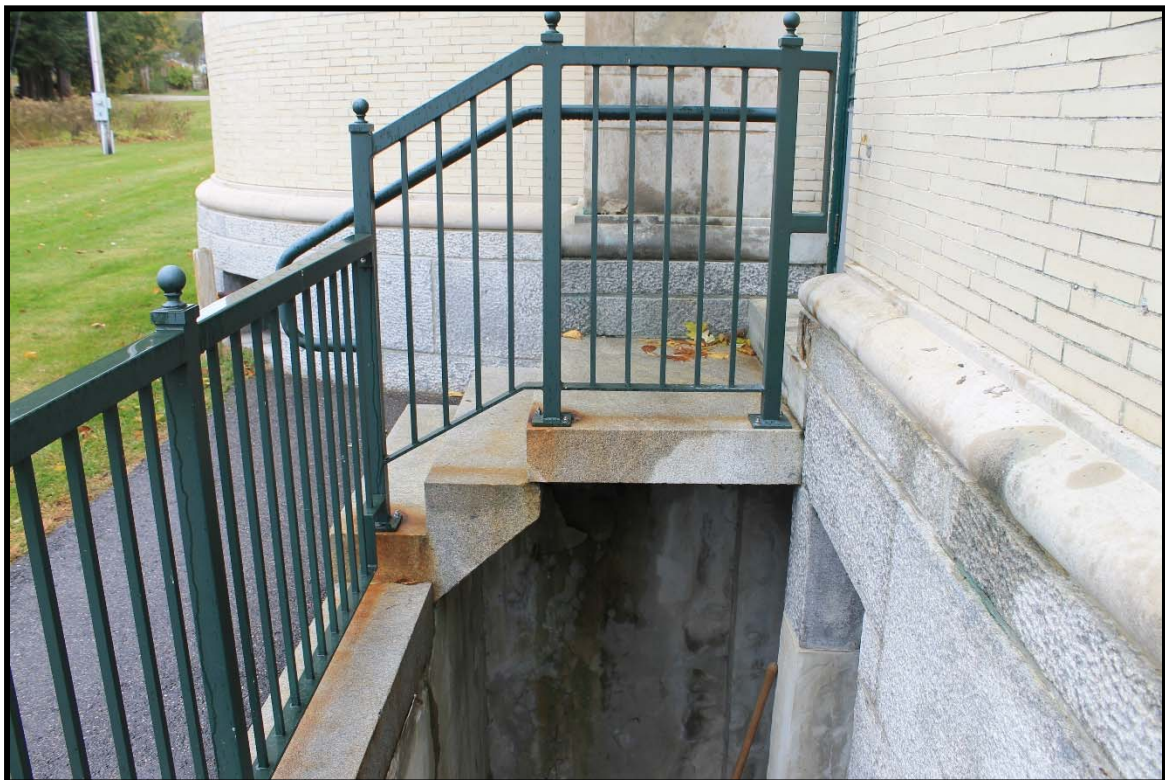
Image Exterior Detail 14 – Rear Entry Steps with Minimal Bearing Condition.

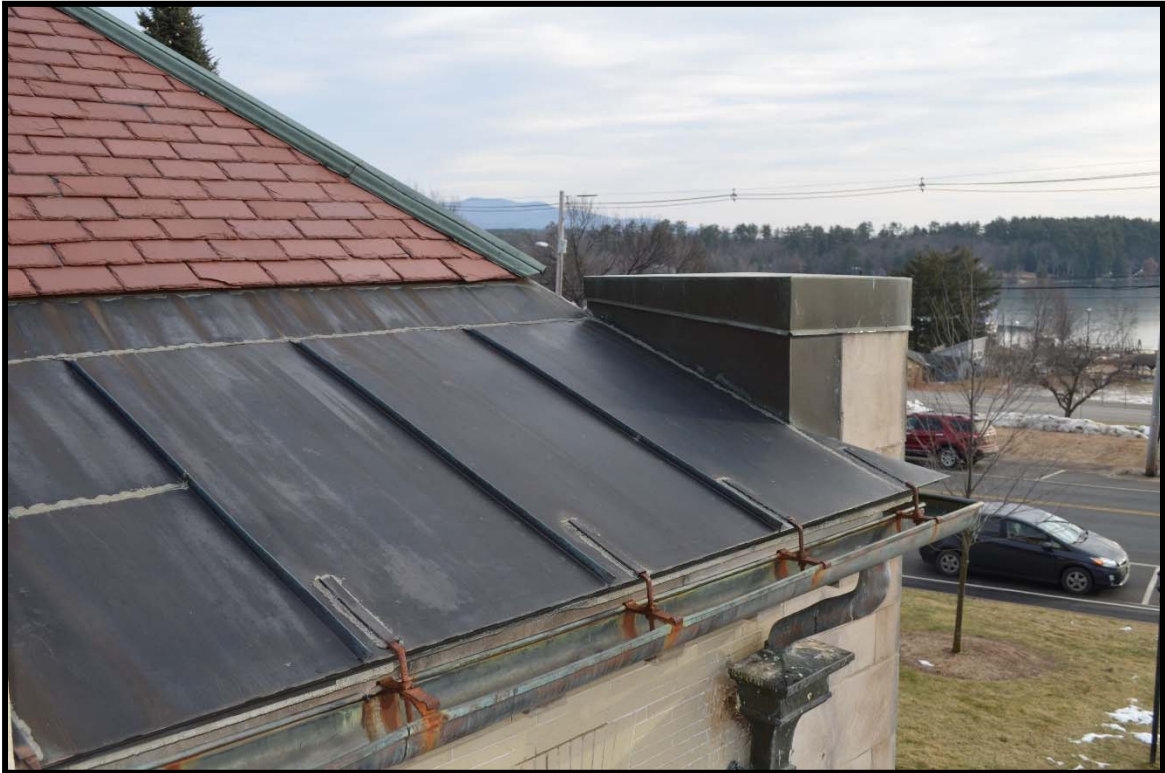
It is understood that the standing seam copper at the eave is covering what was the original drainage channel of integral gutters (Image Exterior Detail 17). The original gutters were towards the inside face of the exterior wall that then penetrated the corbeled overhang. It is assumed that this system was abandoned due to the increased likelihood of any failure in these gutters to have allowed water to migrate to the inside of the building. The covering of the original drainage channel has created a drip edge condition around the majority of the building perimeter, while this is preferable to the previous 'internal' drainage system, it does create increased potential for staining and long-term deterioration of the exterior masonry where the water from the roof now drips.

Image Exterior Detail 17 – Roof Condition where original drainage channel covered.

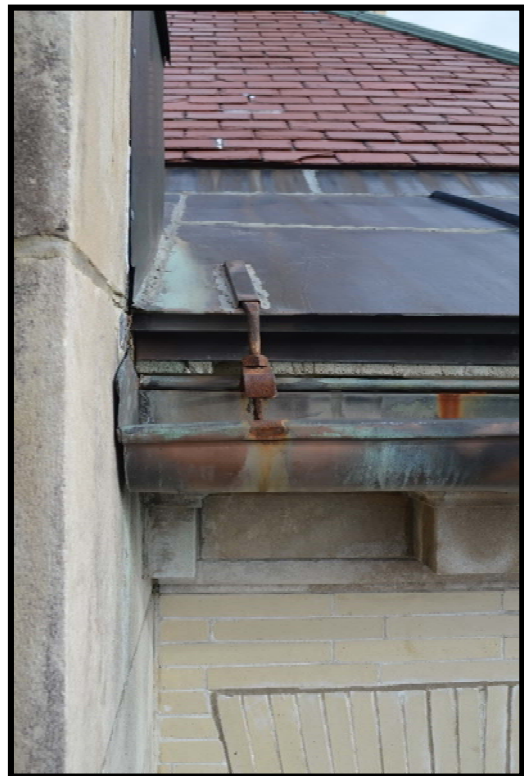
Additionally, the one area with gutter (Image Exterior 06, Image Exterior Detail 10), at the 'back exit' door, is no longer properly supported by the gutter brackets and therefore pitches away from the downspout and drains down the face of the wall, likely penetrating at joints and gaps. The Brackets require to be replaced / repaired and reconnected to the gutter.

Image Exterior Detail 18 – Gutter no longer attached properly and pitching in wrong direction.
