JAMES E. NICHOLS MEMORIAL LIBRARY
35 PLYMOUTH STREET, CENTER HARBOR, NH
EXISTING CONDITIONS REPORT & ASSESSMENT
27 FEBRUARY, 2019

PROLOGUE

4.0 CONDITIONS ASSESSMENT

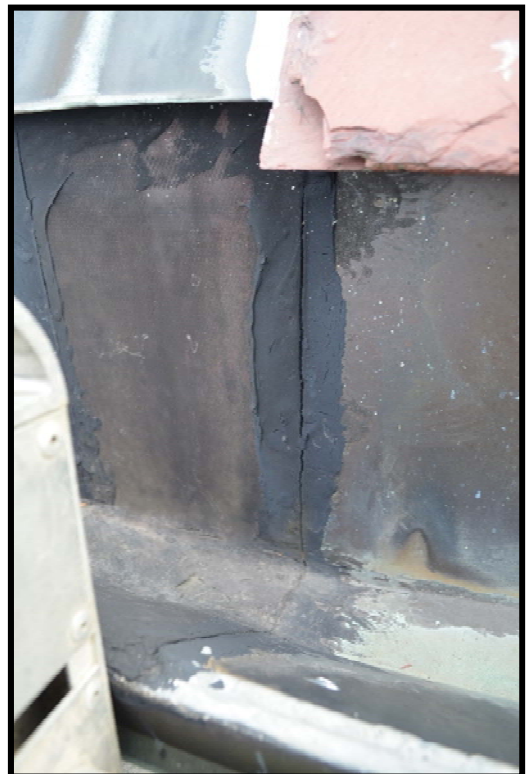
Image Exterior Detail 22 – Patchwork Evident at Gutter.

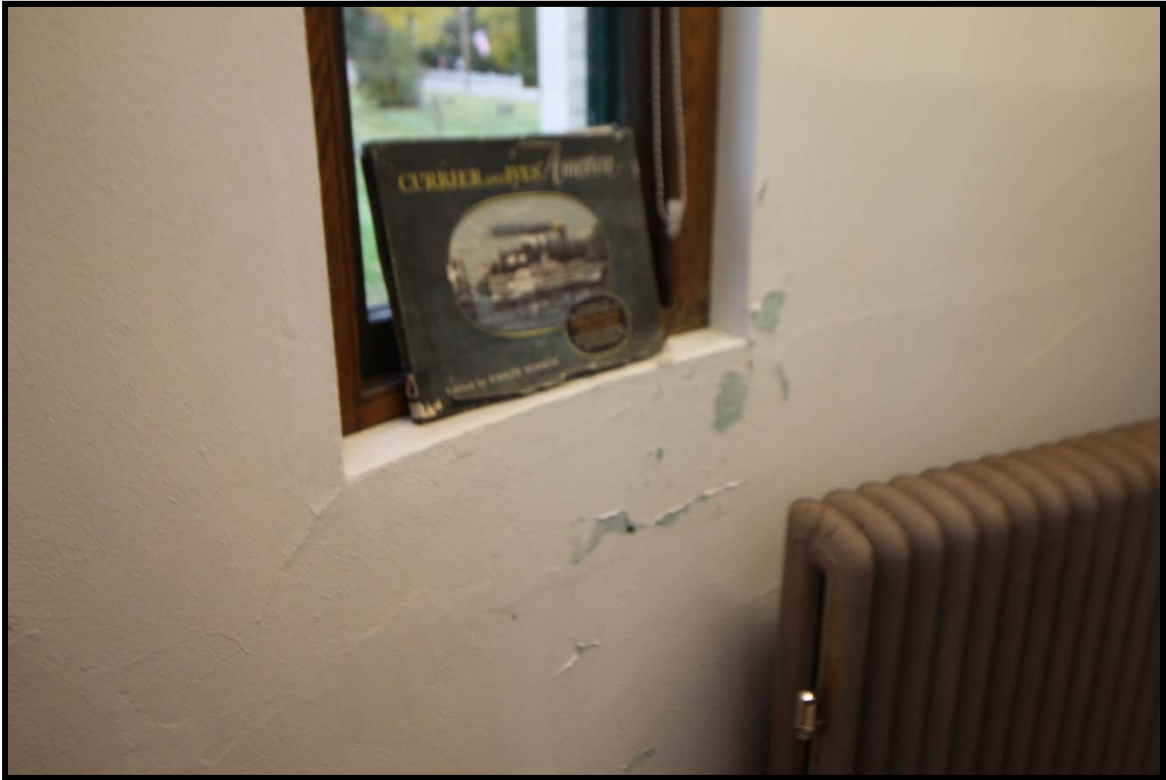
The interior walls are generally in good condition, but do show areas of water damage, with peeling paint, particularly in the book stack area around the curved east wall (Image Interior 11). Some movement / shrinkage cracks can also be seen in this area.

Image Interior 11 – Deterioration of Wall Finish at Semi-Circular Rear.

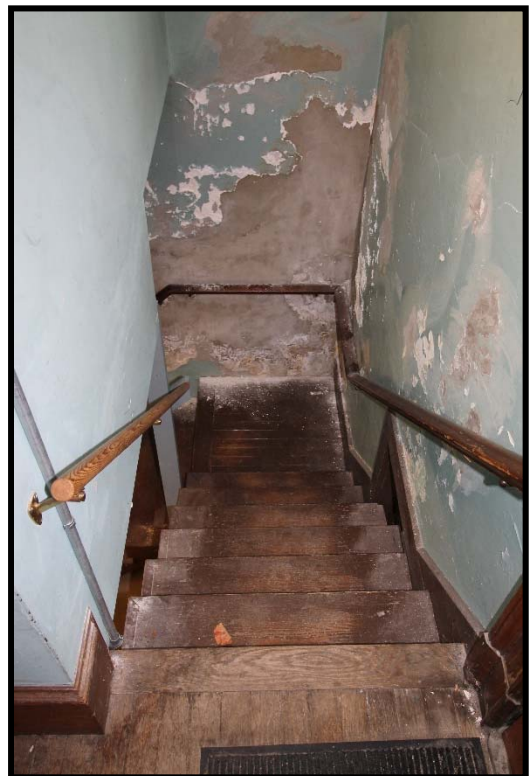
Image Interior 18 – Deterioration of Wall Finishes at Basement Stair.

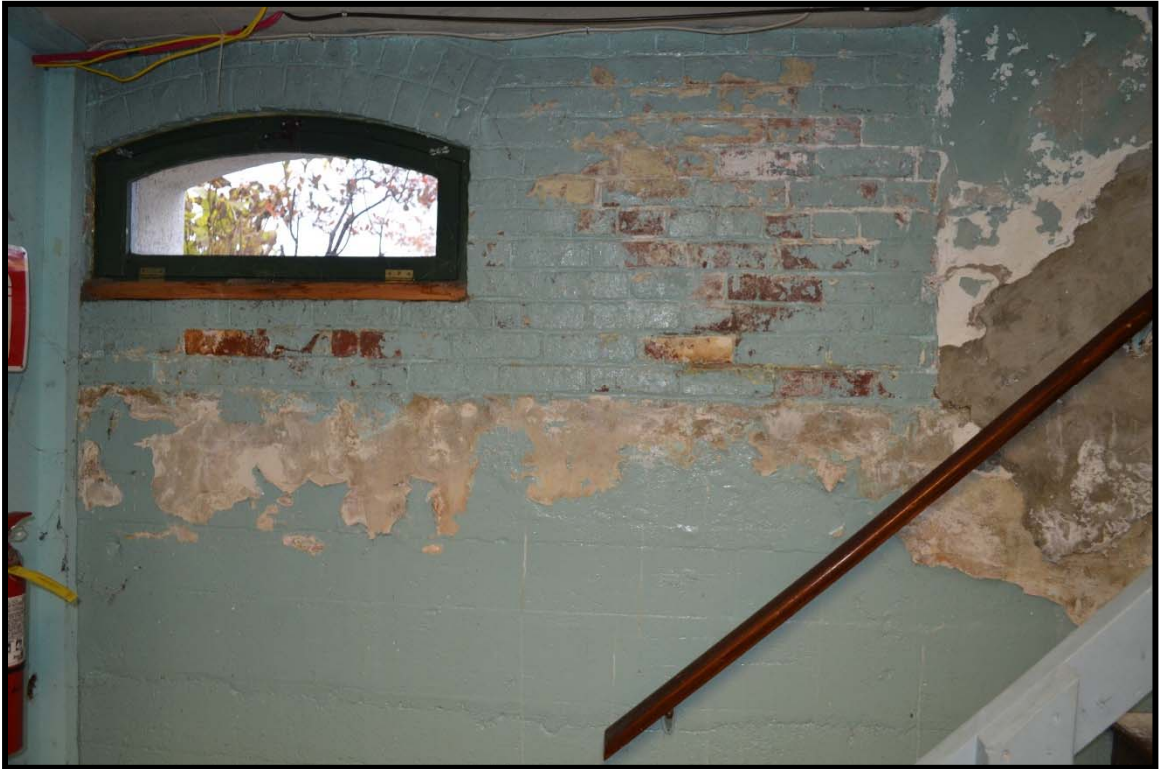
Interior foundation walls and basement floor show signs of water ingress, confirmed by reports of water on both basement walls and floor. Efflorescence is evident on almost all masonry surfaces (Image Interior 19 – 25). See Masonry report in Appendix II for additional detail.

Image Interior 19 – Deterioration of Wall Finishes at Basement Stair.

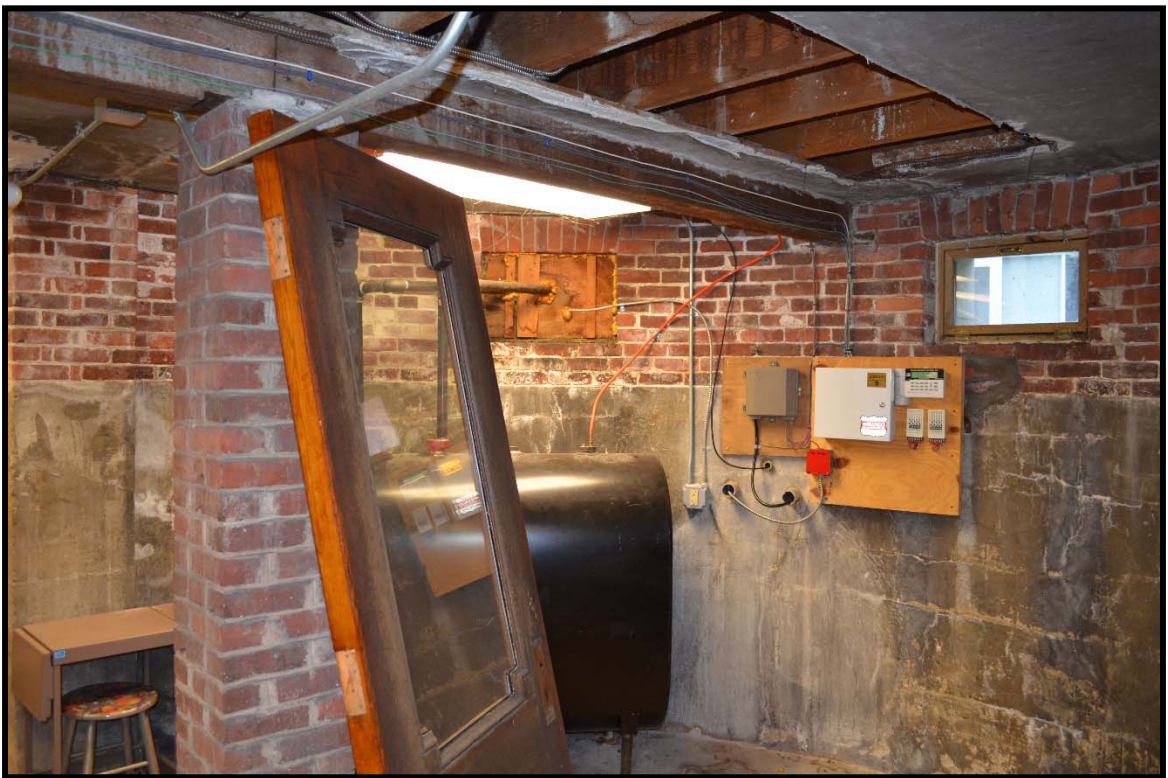
The basement ceilings are in varying degrees of disrepair, with numerous holes cut for access and deteriorating finish (Image Interior 20 – 22). Although the basement is not open to the public, consideration

Image Interior 22 – Basement below Semi-Circular Rear.
