CHRISTOPHER P. WILLIAMS ARCHITECTS, PLLC
PO Box 703 · Meredith, New Hampshire 03253 · 603-279-6513

Historic Building Assessment and Feasibility Study

Center Harbor Town House

March 31, 2016
Revised - May 18, 2016

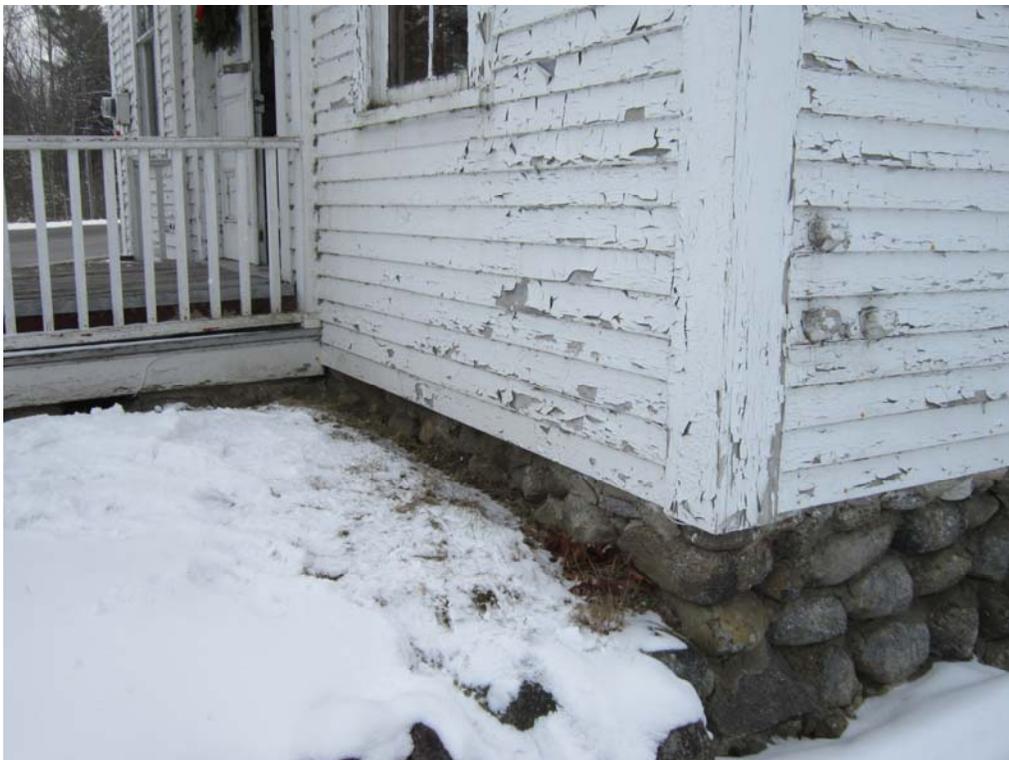
The paint finish on the exterior is in poor to extremely poor condition, with paint failure a primary concern on the north, east, and south elevations of the main block and woodshed addition. The west façade is in better condition with fewer complete paint failures. At large areas of the clapboard siding and trim, paint is heavily peeling with substantial areas of bare wood visible. Paint is peeling off in large flakes and falling on the soils around the building, a concern because all paint applied prior to the mid-1970s is likely to contain lead, a known hazardous material with special state and federal handling requirements.

North east corner of main block showing extreme paint degradation and stone foundation

It is preferable to retain existing siding material and remove damaged paint finishes than to replace the siding wherever possible. On all areas of the north, east, and south elevations of the building where paint is peeling to bare wood, remove all remaining existing paint by hand and apply a quality latex primer and two coats of finish paint. On the west side, where the existing paint condition is better, painting preparation should be as appropriate for localized conditions. Painting in fair to good condition should be lightly sanded to assure that new paint binds adequately to the

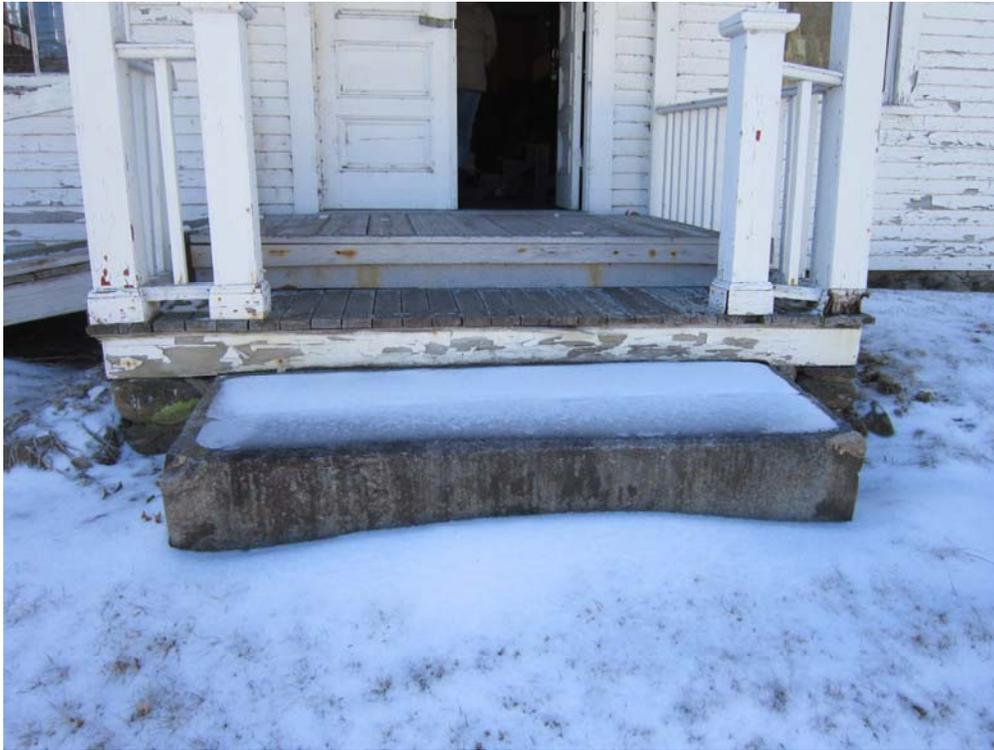
The floor of the entry porch and the bottoms of the decorative posts that support it the porch roof are suffering from structural deterioration as well as finish failures. The shallow porch frame is even closer to the soils beneath than is the floor of the main block to the crawlspace dirt and is therefore exposed to even higher levels of continuous moisture. Compounding that, the porch floor is laid to allow water through the porch floor deck, but the space below the porch is closed in at the porch perimeter with stonework. The addition of the ad-hoc handicapped accessible ramp over the top of the porch floor all conspire to allow moisture into the cavity beneath the porch and then trap it there without adequate ventilation of the space to allow for drying. The porch floor is deteriorating and crushing where it bears on the corner stones and elsewhere. The column bases and lower portions of the railings are suffering from rot as well as paint failures.

Porch floor is in very poor condition related to trapped moisture in the current assembly

It appears that the entry porch floor and the porch's corner columns require rebuilding because of water damage. The existing molded railings, balusters, and post trim should be carefully removed and set aside. The porch roof assembly is in good condition and should be supported in place while the existing ramp, the water damaged porch floor, and the porch frame are replaced. Use pressure treated pine with painted pine trim for the the porch floor and vertical grain douglas fir with a clear finish for the flooring. Coordinate foundation work described elsewhere in this report to be done in conjunction with the porch repair. Damage to the corner posts may be limited to the decorative base moldings only or may include damage to the structural post as well. To the highest degree possible, retain or reinstall original post materials. Once the posts are secure, fabricate additional materials to rebuild the railings to match the original intent. Regrade across the front of the building to provide good access to the reset stone step at the front of the porch.

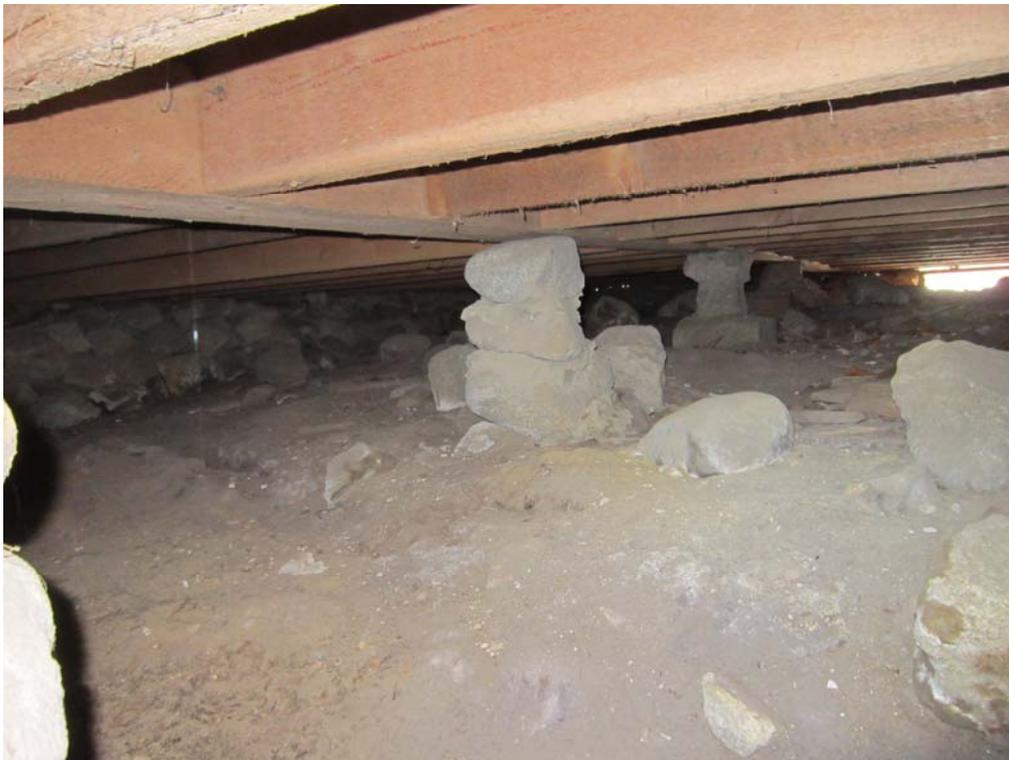
The piers at the interior of the crawlspace were also inaccessible, but observation from the locations of the limited vent spaces in the perimeter foundations reveal that these are the weakest components in the foundation system. These piers serve to support the beam floor beams that span north to south across the crawlspace and are typically composed of two or three stones stacked together. Because there are no footings for these piers below grade, they are the most subject

to movement under frost conditions. Some are raising the floor beams higher than necessary and introducing curvature to the floor above, and others fail to even support the beams at all, leaving air gaps under their intended bearing points. Four vents into the crawlspace are provided with fixed louvers, removal of which does not allow an adult to enter the crawlspace. No standing water was observed in the crawl space, though the proximity of soils to the building floor frame is a concern. Grades around the building appear to pitch more than the minimum of 3" in six feet that would be desirable.

Existing crawl space with stone supports under beam - note proximity of floor framing to soil and complete lack of insulation in floor system above.

At the foundation level, there are significant additional challenges with the building structure that need to be addressed: moisture in the crawl space and frost action under the building's central piers. The following recommendations should greatly improve the building's current moisture problems. In the crawl spaces, all soil within 18" of the wood frame should be removed by hand (8" +/-). A vapor barrier should be installed over the dirt floor of the crawlspace, taking care to allow for a wide overlap and taping of all vapor barrier components under all structural work. Once the ground is covered, vents in the foundation should be rebuilt to allow them to be opened in the late spring and early fall and closed in the remaining seasons.

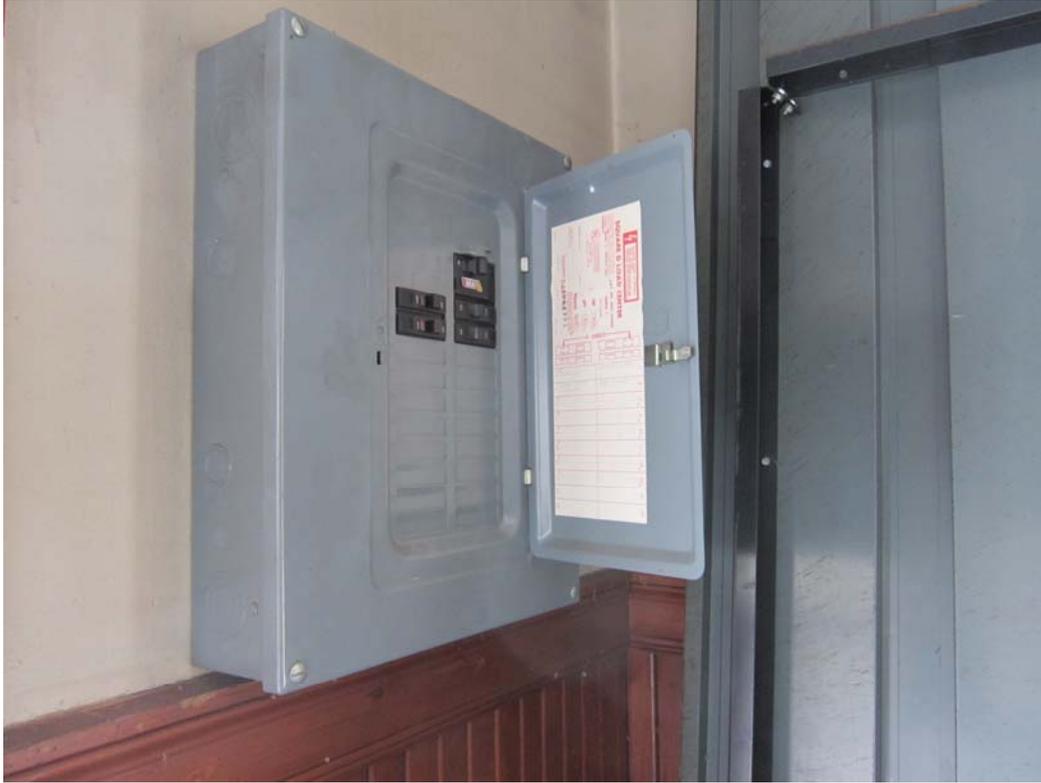
Electrical service in the building is of mixed quality. Electrical systems have been updated to provide grounded service at the limited locations convenience outlets are located, but much of the older wiring remains within the ceilings and likely the walls. Out of service wiring should be removed and the service panel on the wall should be opened and the wiring inspected to confirm that any dangerous wiring is out of service. The service entrance wiring outside the building to the meter is cloth jacketed and the jacketing is failing. This wiring should be replaced immediately, as it poses a fire risk to the building.

Circuit breaker panel. Most electrical work appears to have been updated in the 1980s, and other new wiring installed ad-hoc.

The existing electrical service to the building should be replaced to remove this fire hazard. The service panel should be inspected and made safe by an electrician, who can remove and replace any deteriorated wiring or remaining ungrounded circuits. Unused wiring from previous repairs should be pulled and removed from the building. New LED lighting in warm color should be installed to augment lighting levels without changing the lighting patterns. The Center Harbor Energy Committee has expressed an interest in providing assistance with energy related issues with the Town House.

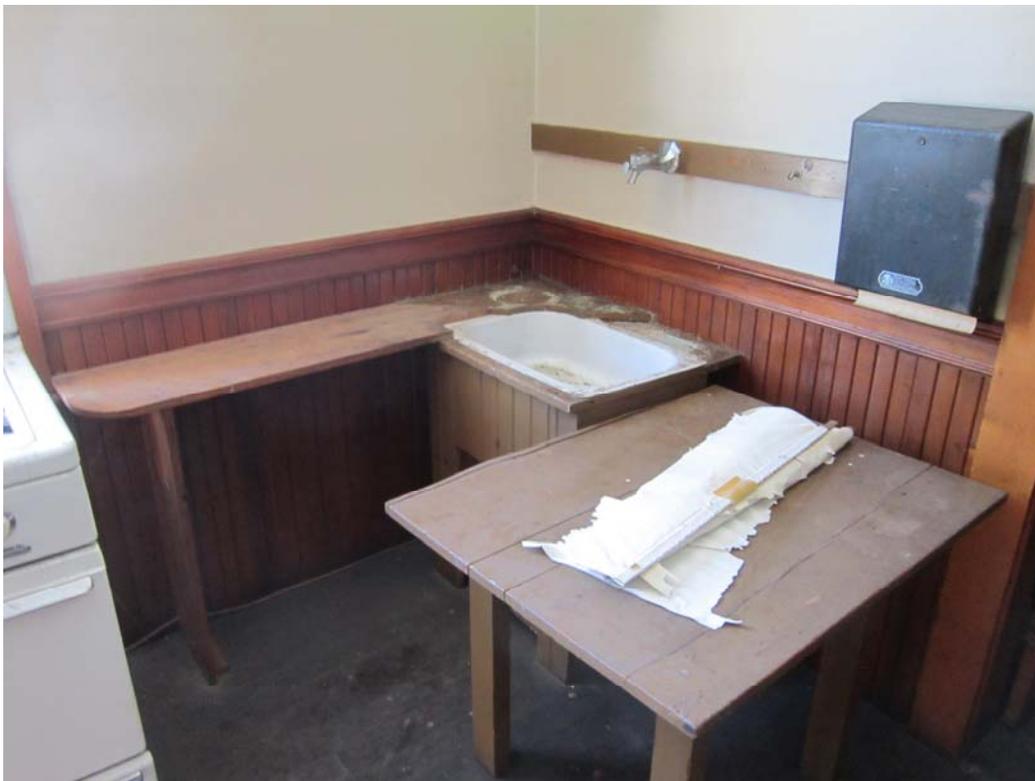
Makeshift kitchenette in southwest corner of stage area has no running water

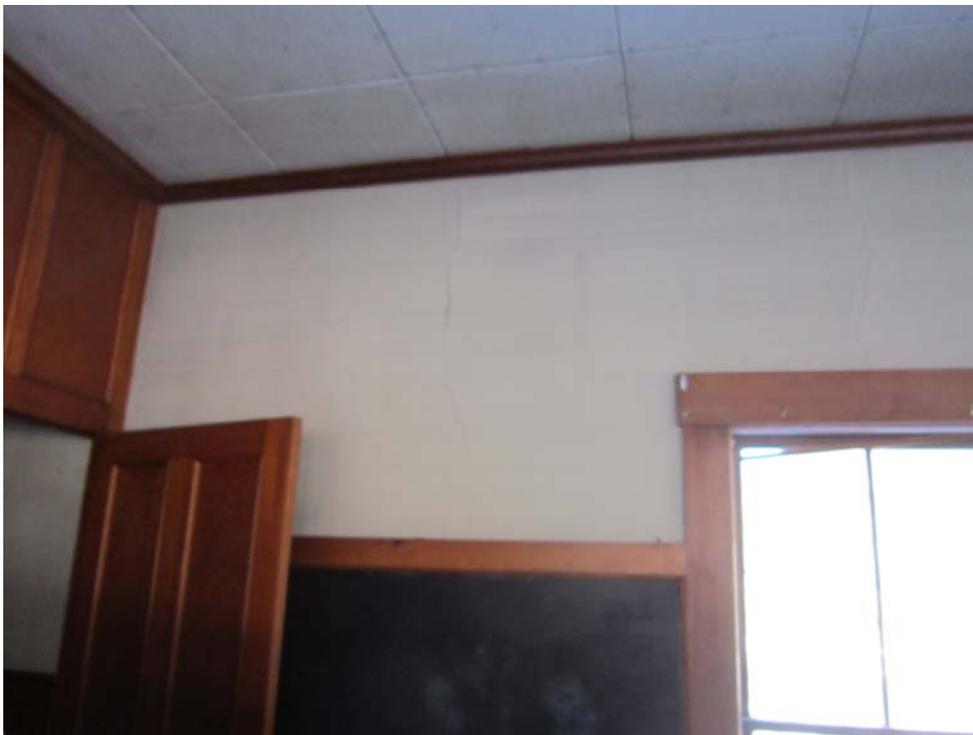
Minor cracking of plaster typical of foundation movement under frost action.

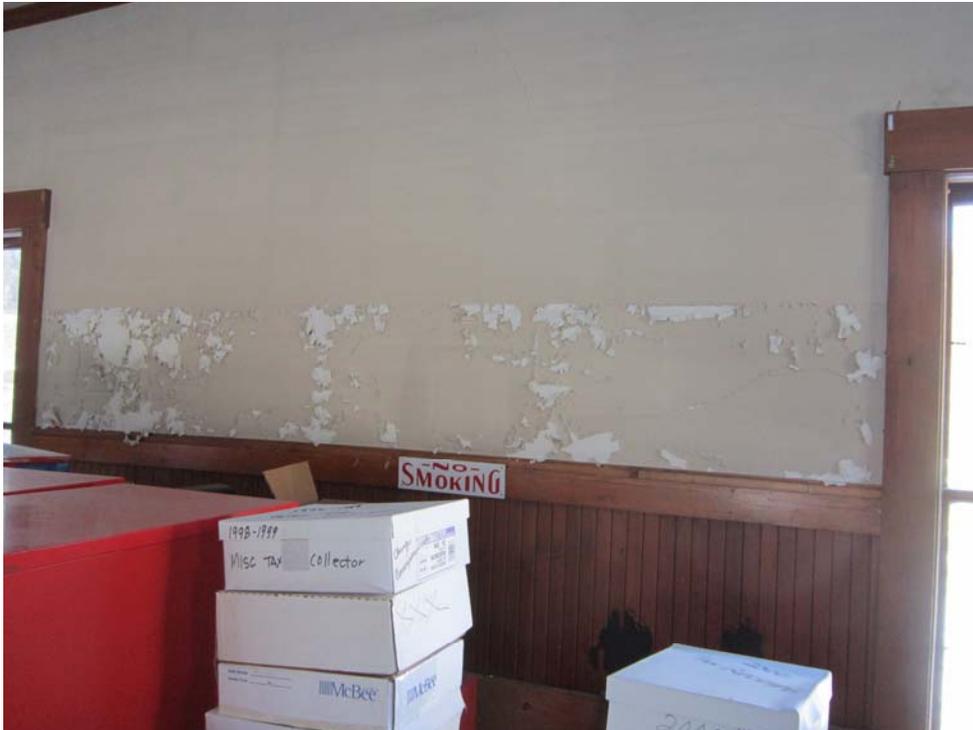
black board installed on the north wall adjacent to the stage door. There is an incidence of dramatic paint failure on the plaster at the north wall between the windows and above the wainscot. Previous replacement of the wainscot cap on this wall and bonding cement on the wainscot indicate that this portion of the wall was once covered with a blackboard or bulletin board, now removed.

Localized area of paint failure behind where chalkboard or bulletin board was previously removed

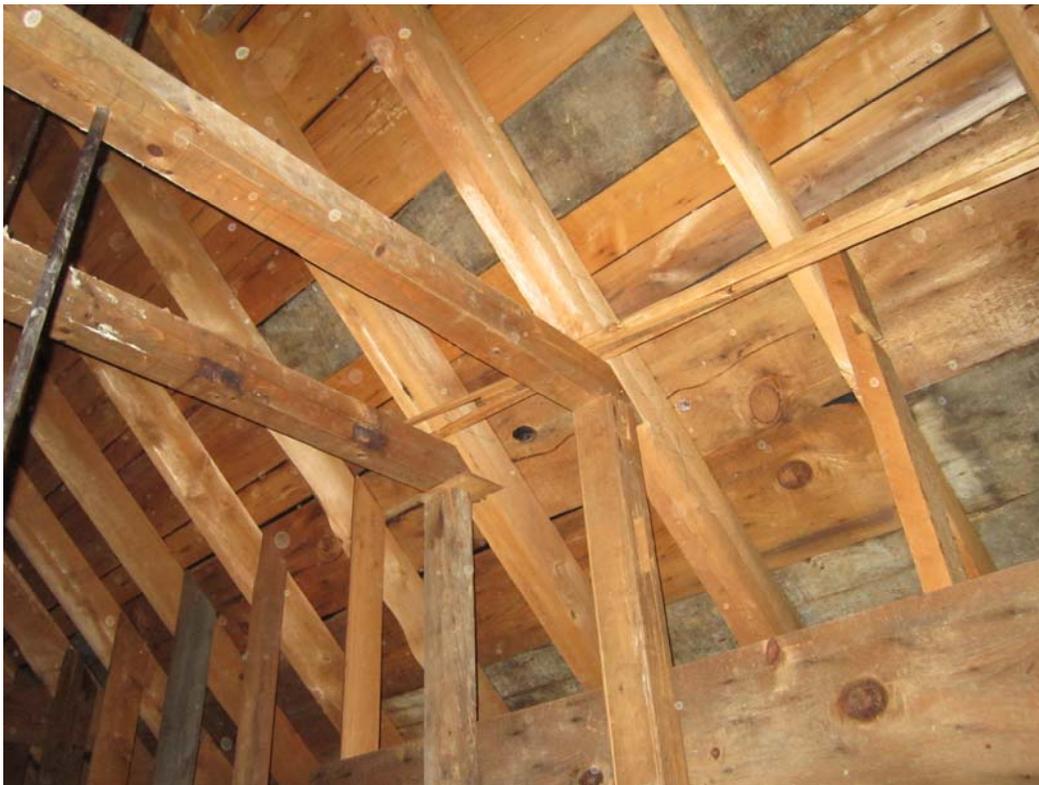
Attic with sawn common rafters. Additional framing to left was apparently added for lateral support of recently removed hanging chimney at center of meeting hall.

Wall framing and roof framing in place is generally in good condition. The structural engineer has determined that the roof framing would generally be capable of carrying code required snow loads with the addition of collar ties and gusset plates in the main block. 2x6 collar ties should be installed across rafter pairs in the attic connecting to the rafters just above the vertical ties supporting the ceiling. Plywood gusset plates should be cut to match the roof profile and face nailed to the rafters where they meet at the ridge. In the wood shed addition, new 2x8 attic joists should be installed at the tops of walls to prevent roof spreading.

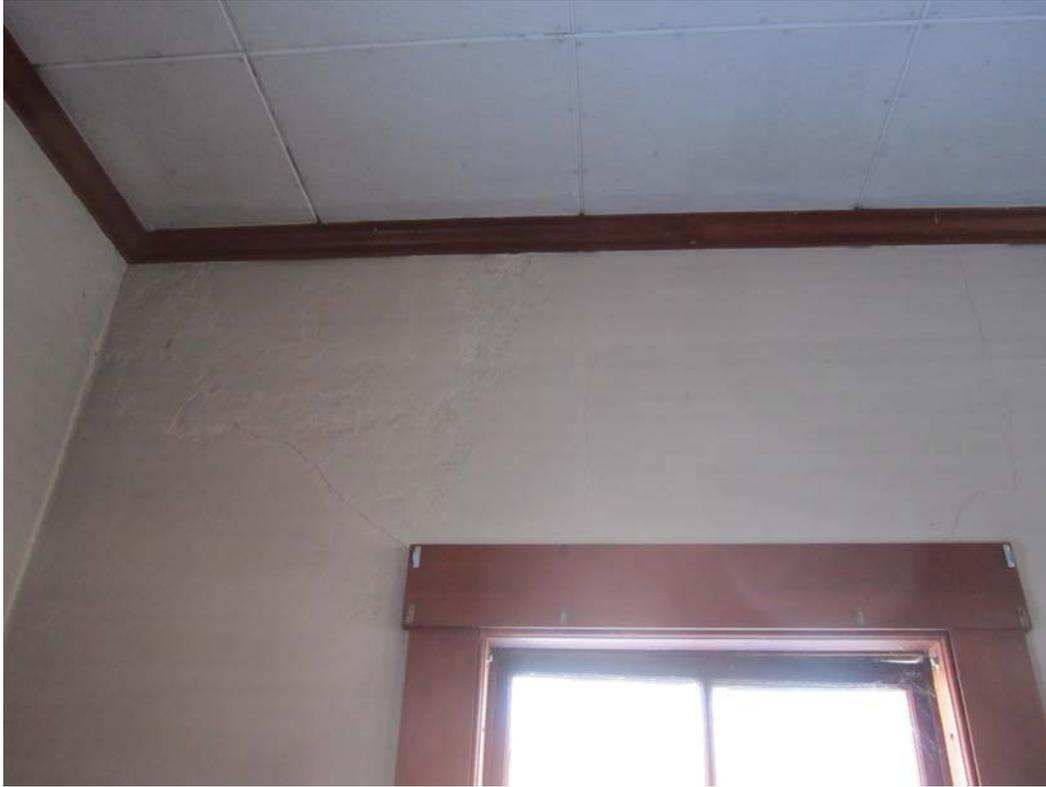
Stress cracks in plaster work have been previously repaired at northeast corner of meeting hall

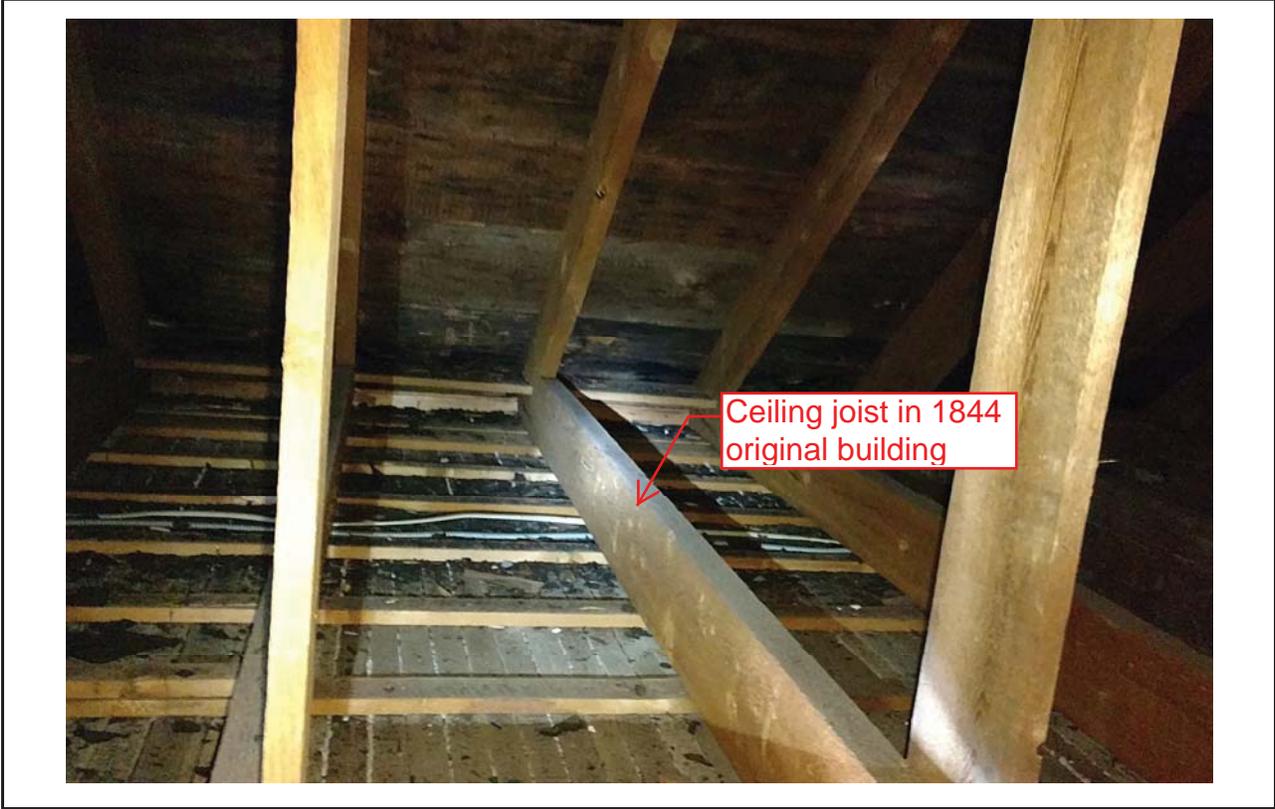
Ceiling joist in 1844 original building

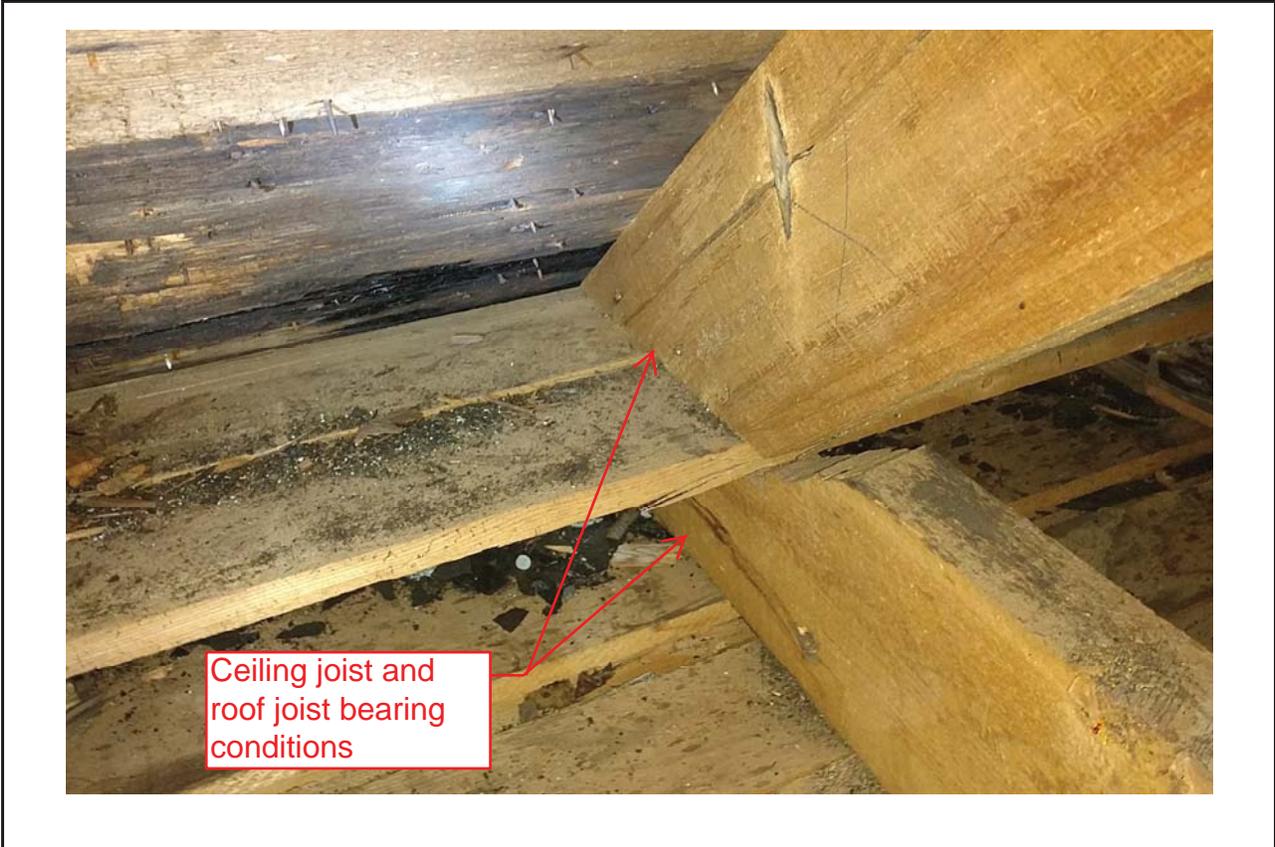
Ceiling joist and roof joist bearing conditions
