### **Report of Site Inspection**

#### **Centre Harbor Historical Society**

**94 Dane Road, Center Harbor, NH 03226**

**Date of Inspection: October 21, 2022**

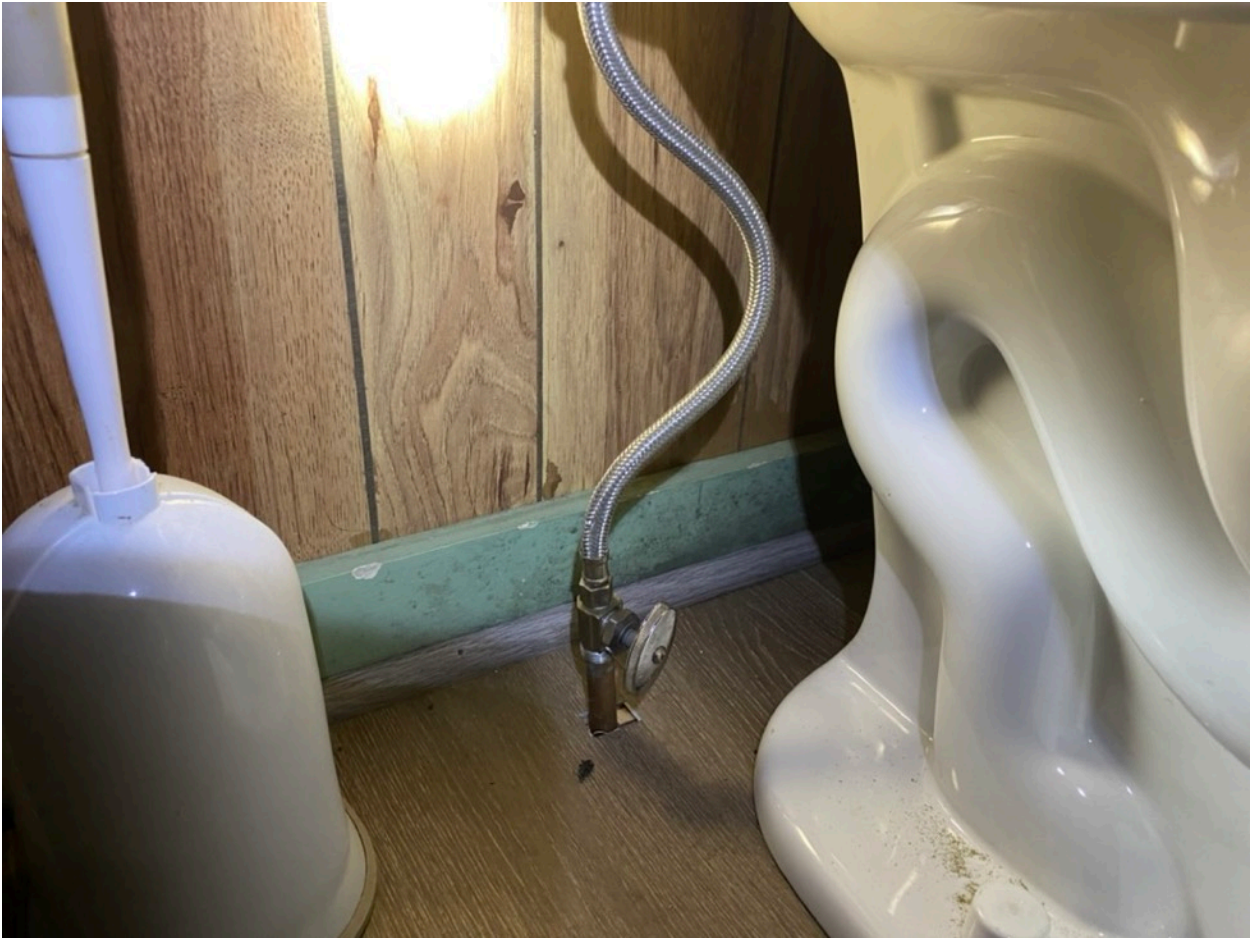
Fig. 1

Due to the prior report of water and mold in the bathroom, this was the first area inspected. It was noted that the water tank had been insulated, but pipes remained bare. As the weather was cool and dry, there was no condensation noted on the pipes. The floors had been recently replaced and the walls recently painted per Mr. Garland. Upon close inspection, it was noted that there was a small amount of mold on the trim boards, especially behind the toilet (Fig. 1). There was no evidence of significant mold growth.

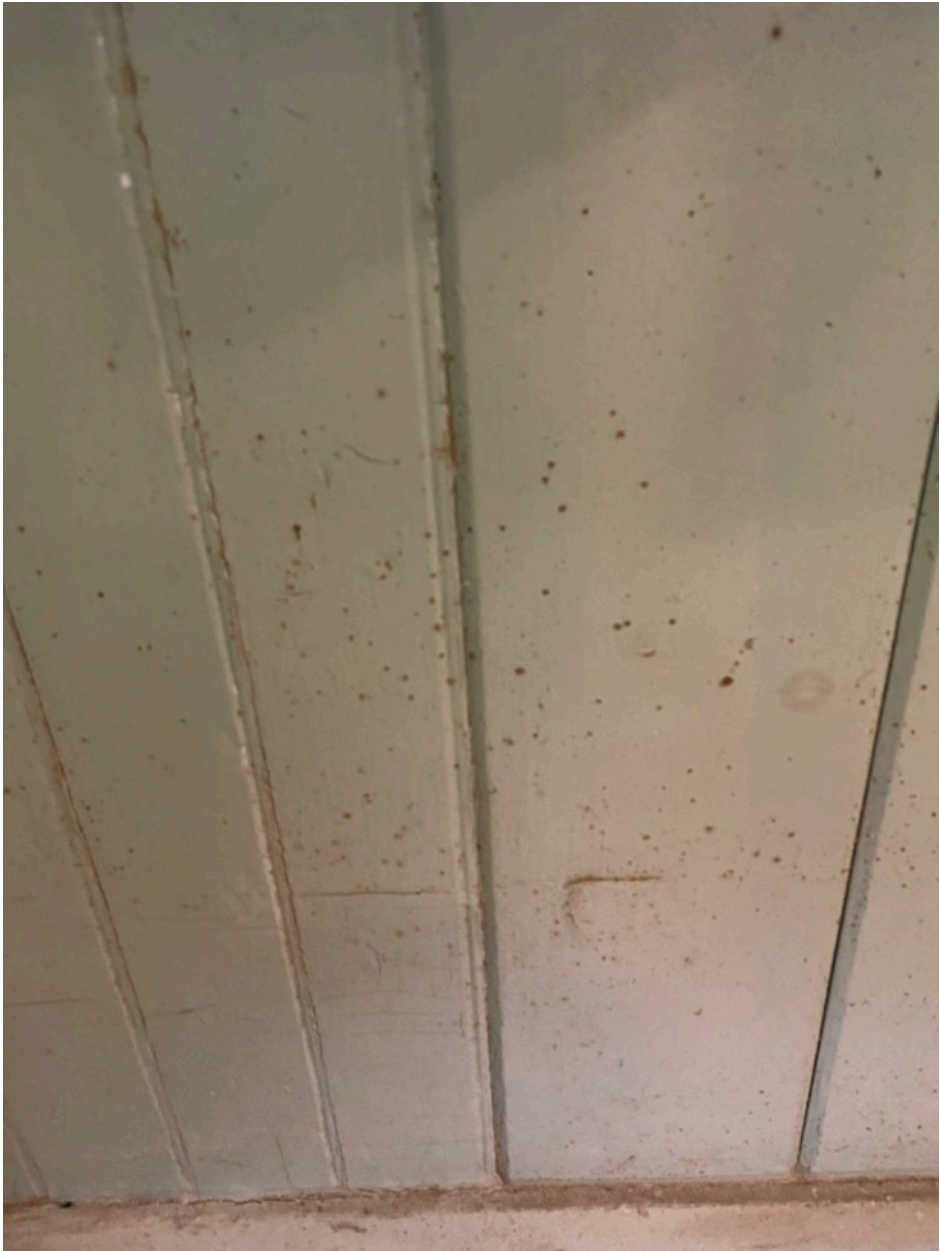
Fig. 2

The main area was again inspected. Small areas of mold were noted on painted walls and some trim (Fig. 2). There was no obvious mold growth on any artifacts in this room. An additional front room used to store documents was inspected which showed some dust collection, but no areas of mold growth to include on documents and photo albums stored in this room.

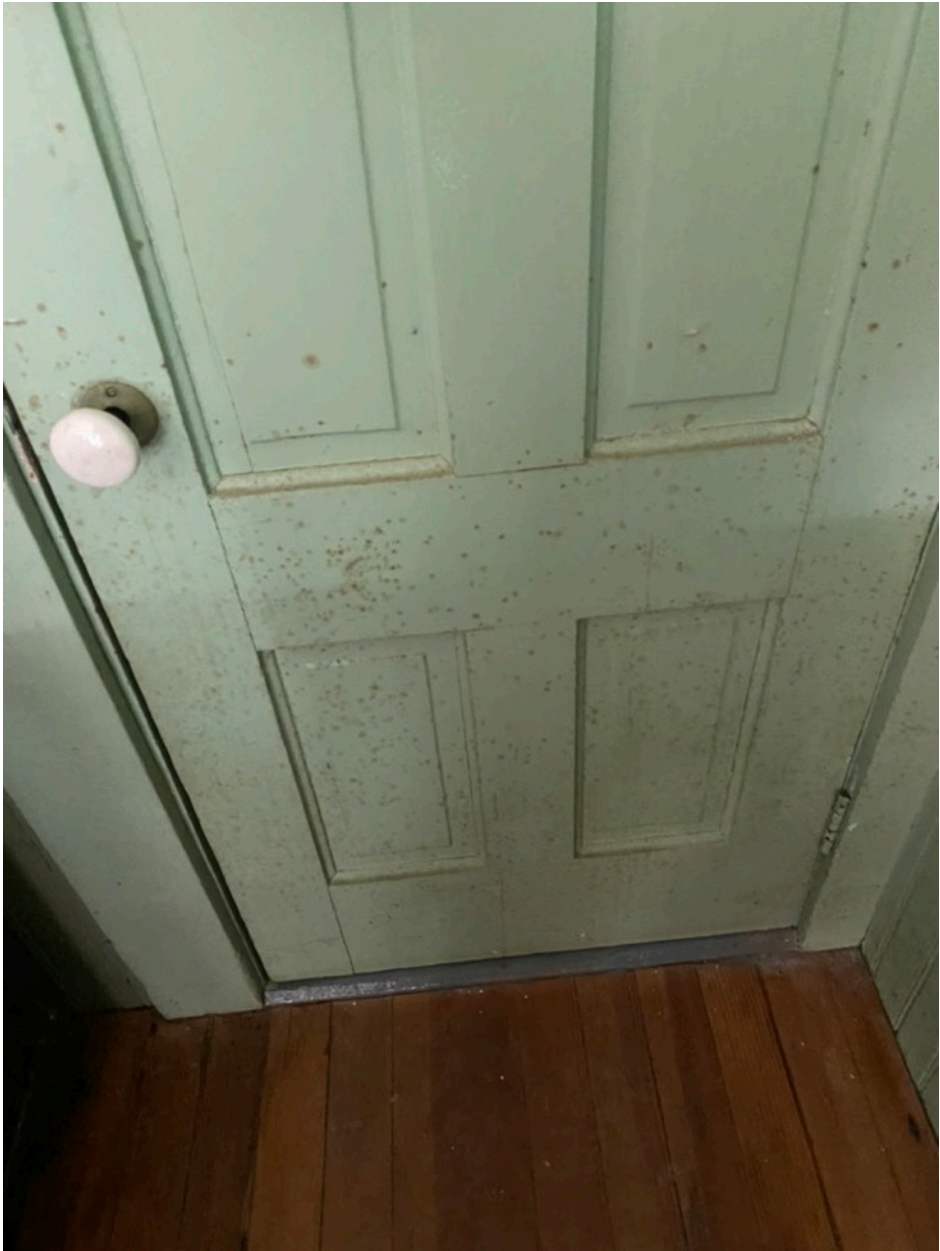
Fig. 3

Attention was then turned to the “new” classroom on the west end of the building. Mild to moderate mold growth was noted on painted surfaces to include the door to the kitchen (Fig. 3), wall surfaces (Fig. 4), and chalk trays and boards (Fig. 5). Mold growth was noted on artifacts in this room to include eyeglasses and spectacle cases within a glass display case (Fig. 6) and a rifle stock.

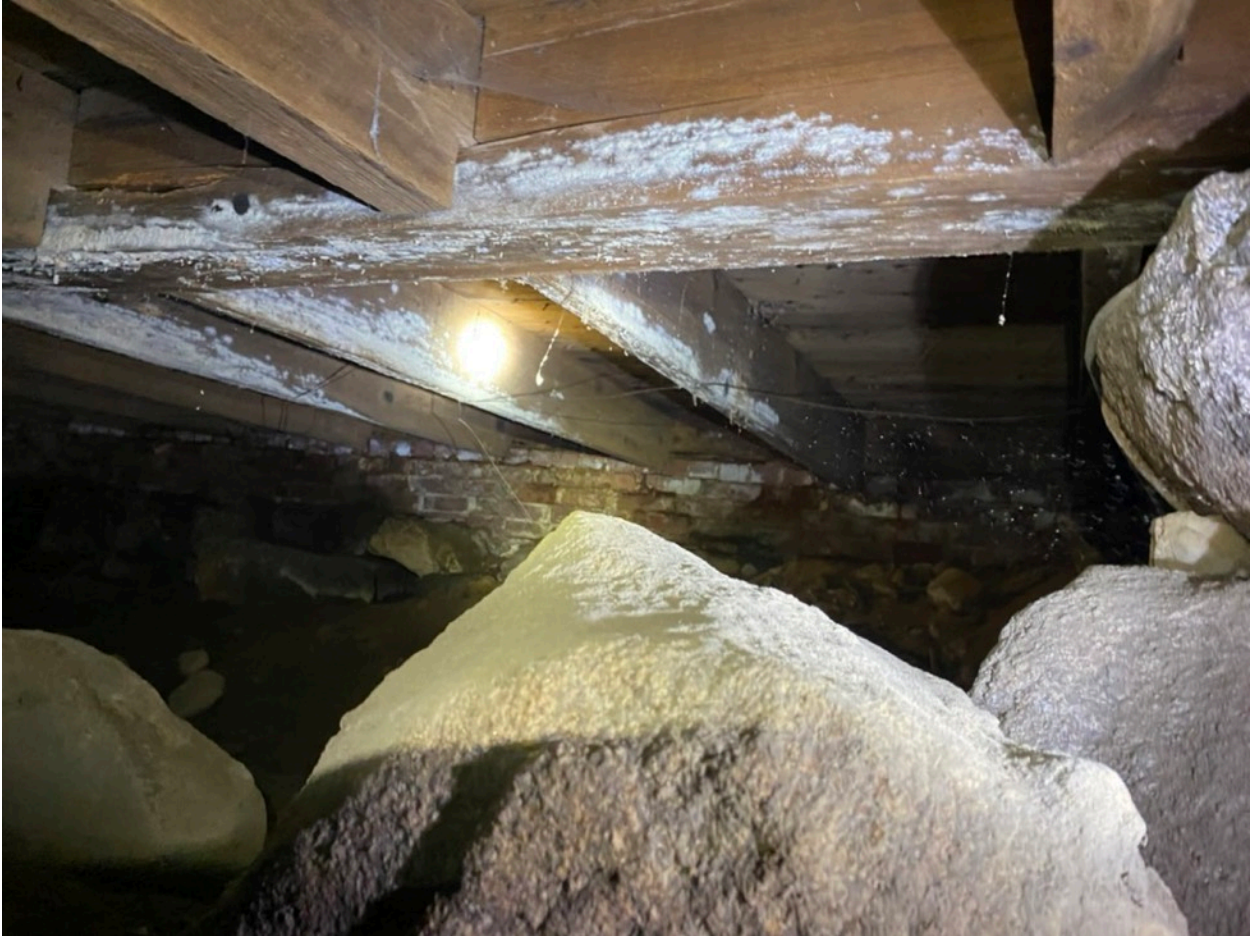
Fig. 7

The underside of the building was then reviewed. The crawlspace in the rear of the building under the old kitchen area was accessed through a small panel in the workshop area. The floor was noted to be dirt without an obvious moisture barrier. There was minimal ventilation in this area. There was minimal water rot noted to the bottom of a wooden pipe chase, but no evidence of mold growth. No significant moisture was noted in this area. The crawlspace in the front of the building under the main classroom was accessed through a floor hatch in the main classroom area. The floor was also noted to be dirt without an obvious moisture barrier. A drain pipe was noted running through this area which appears to be the pipe mentioned in the conditions report that had been prepared. No obvious leakage was noted, but the water had been turned off in the building for approximately one month. Most of the floor was noted to be dry, but moisture was noted in the dirt at the front of the building. In this area, there was a moderate to significant amount of mold growth noted on the floor joists (Fig. 7). There was no evidence of standing water in this space. There was passive ventilation in this area in the form of vents.

Second, the asphalt driveway creates poor drainage and appears to be making the dirt floor of the basement damp, particularly in the front of the building. This area appears to be the focus of most of the potentially structurally-damaging mold growth on the floor joists under the building.

In order to reduce growth of mold, the presence of conditions which favor mold growth should be reduced, if not eliminated. This includes limiting heat and humidity in and under the building and increasing ventilation. We recommend that dehumidifiers or air conditioners be used when the building is closed, both during summer and winter. It may also be reasonable to consider addition of additional ventilation in the occupied portion of the building and in the crawlspace, potentially including powered ventilation.
