**CENTER HARBOR VILLAGE SCHOOLHOUSE**

**94 DANE ROAD, CENTER HARBOR, NH**

**EXISTING CONDITIONS REPORT & ASSESSMENT**

**8 JANUARY, 2018**

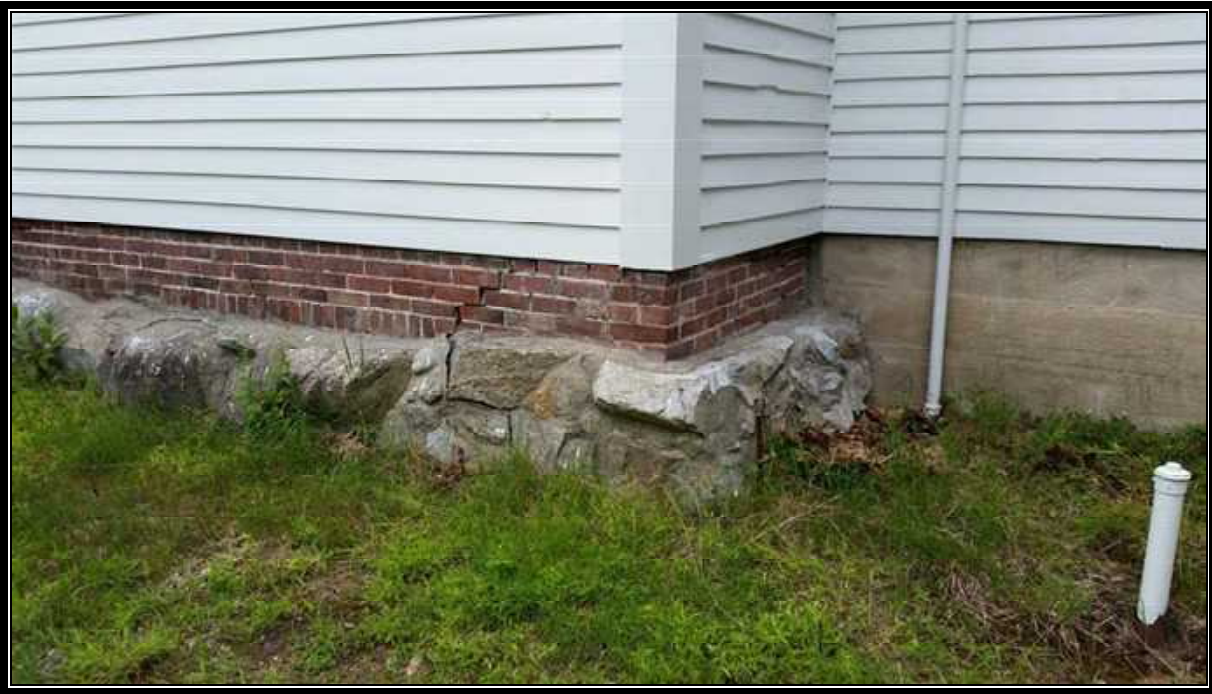
The combination stone / brick foundation walls show signs of settling and / or movement through the seasons. The north-east corner of the foundation should exhibit signs of deterioration.

Photo 3: Settling crack at corner of foundation.

| ▪ Structural - Repair north-east corner foundation of 1886-original block. Consider introduction of insulation under grade to exterior of corner and insulation to inside of corner to minimize future freeze-thaw induced movement. | \$3,840 |

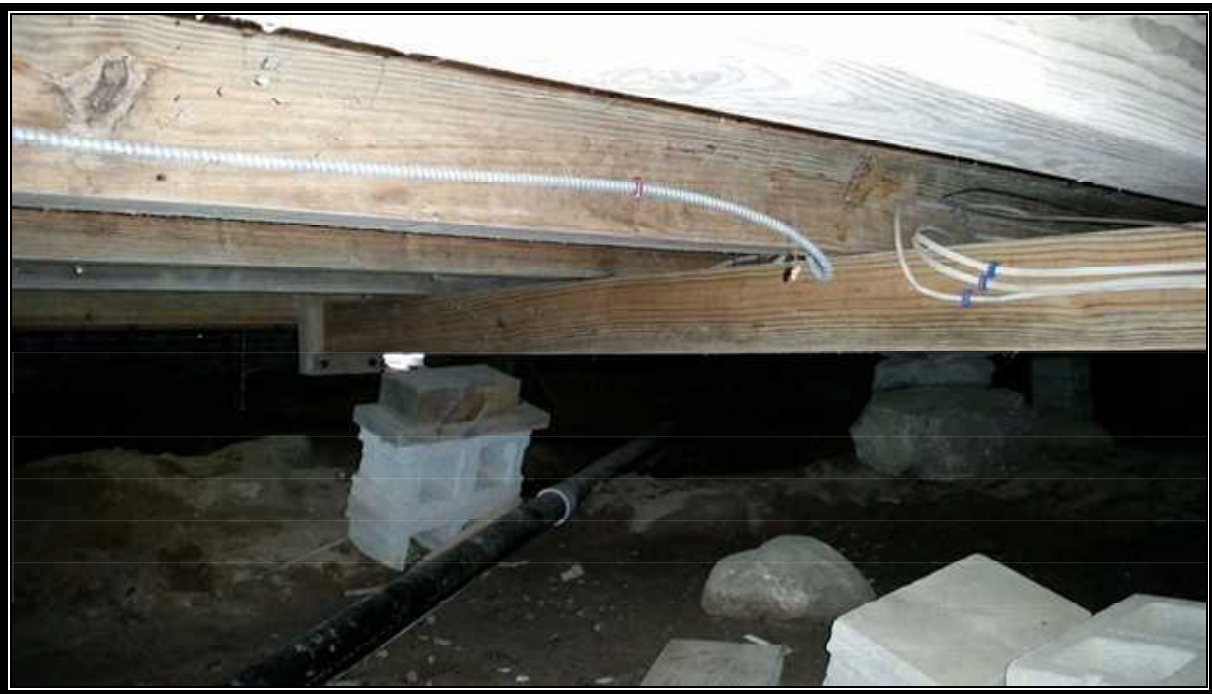
Photo 4: CMU pier not supporting beam.

| ▪ Structural - replace piled stone / block piers within crawl space of 1886-original block supporting the floor structure with suitable foundations and insulate to prevent cold weather heaving (concrete footings with pressure treated 6x6 stub columns anchored to footing and framing above). | \$7,680 |

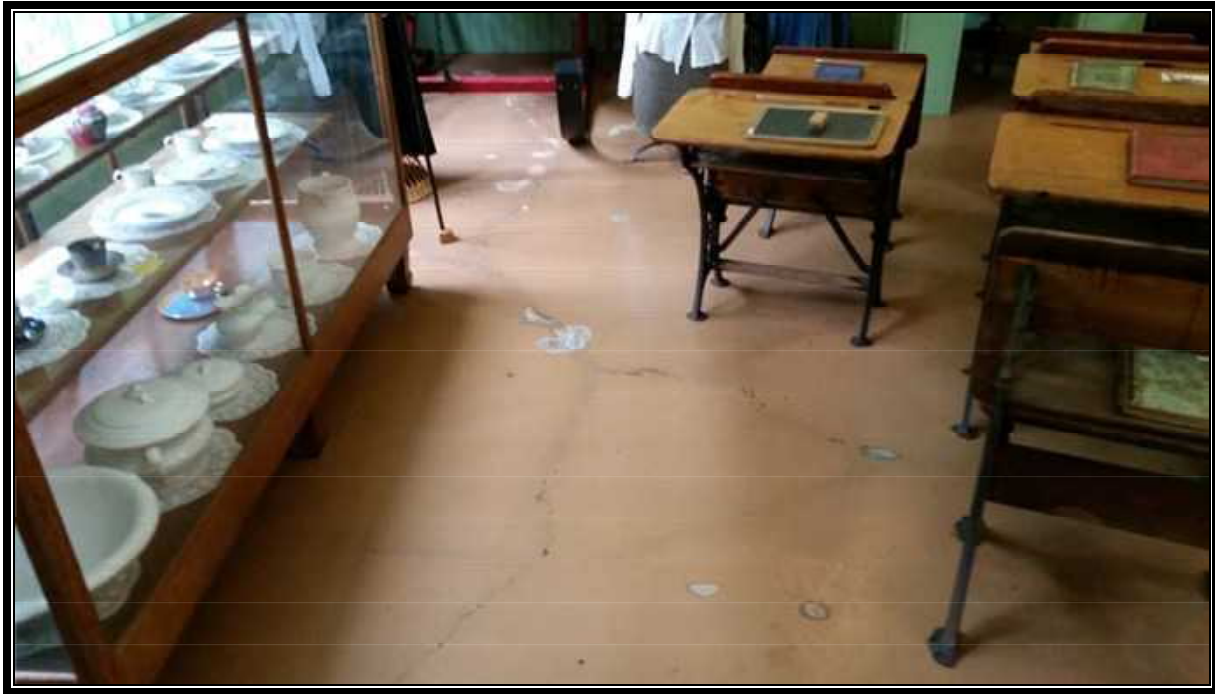
Approximately 8' of the floor is the same wood strip flooring on wood frame with the remaining 27' a painted concrete slab on grade. The floor slab does have numerous cracks showing some signs of settling, but appears not to be recent. Filling cracks and continued observation to insure no further movement is apparent is sufficient at this time.

Photo 5: Cracks in floor slab.

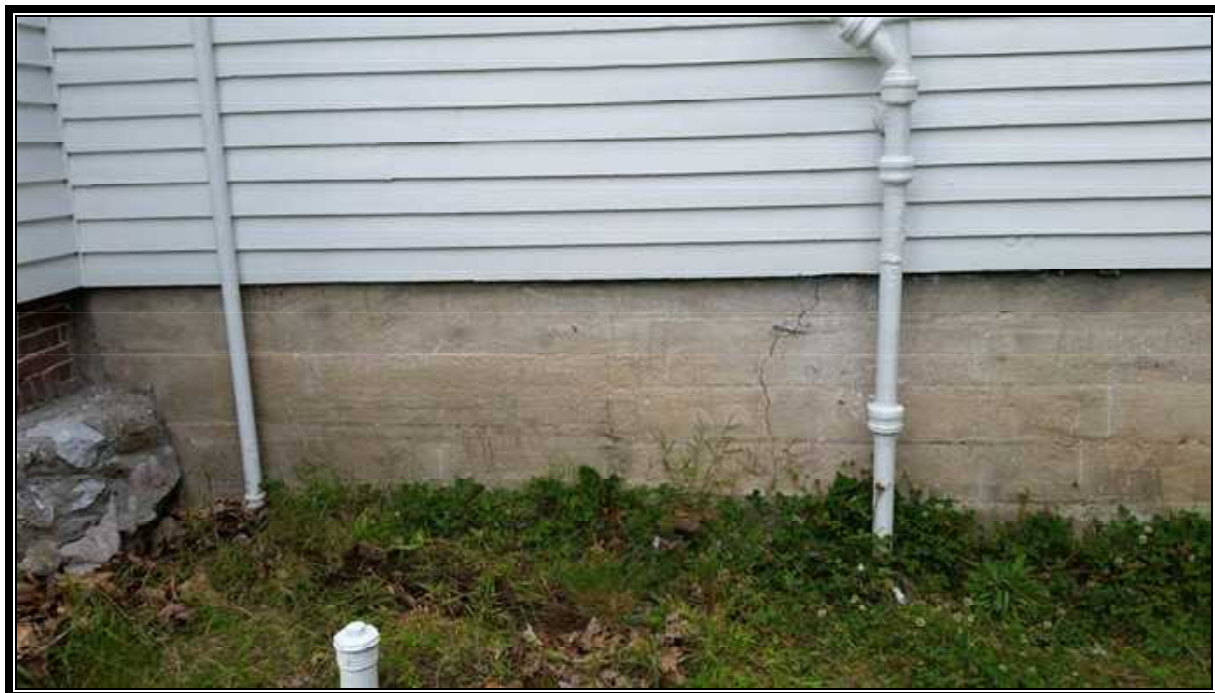
The foundation of these two blocks appears to be concrete block and some stone rubble foundation. There is also a section of concrete wall with board-formwork lines. There is some cracking in this wall which should be pointed / sealed and regularly observed for further movement / cracking.

Photo 6: Minor crack in concrete wall.

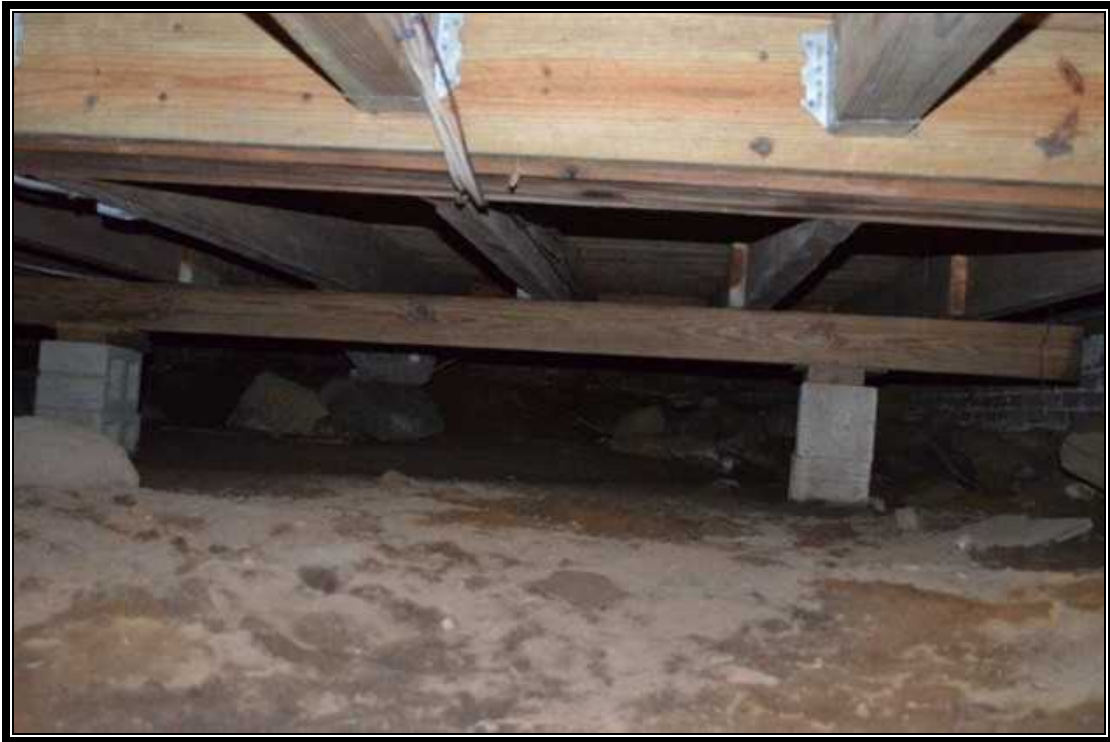
Photo 7: Repaired floor framing.

| ▪ Structural - Repair structural upgrades within crawl space of 1886-original block supporting floor structure, north corner (reconnect structural members, fasten with through-bolts and/or galv connectors) | \$6,400 |

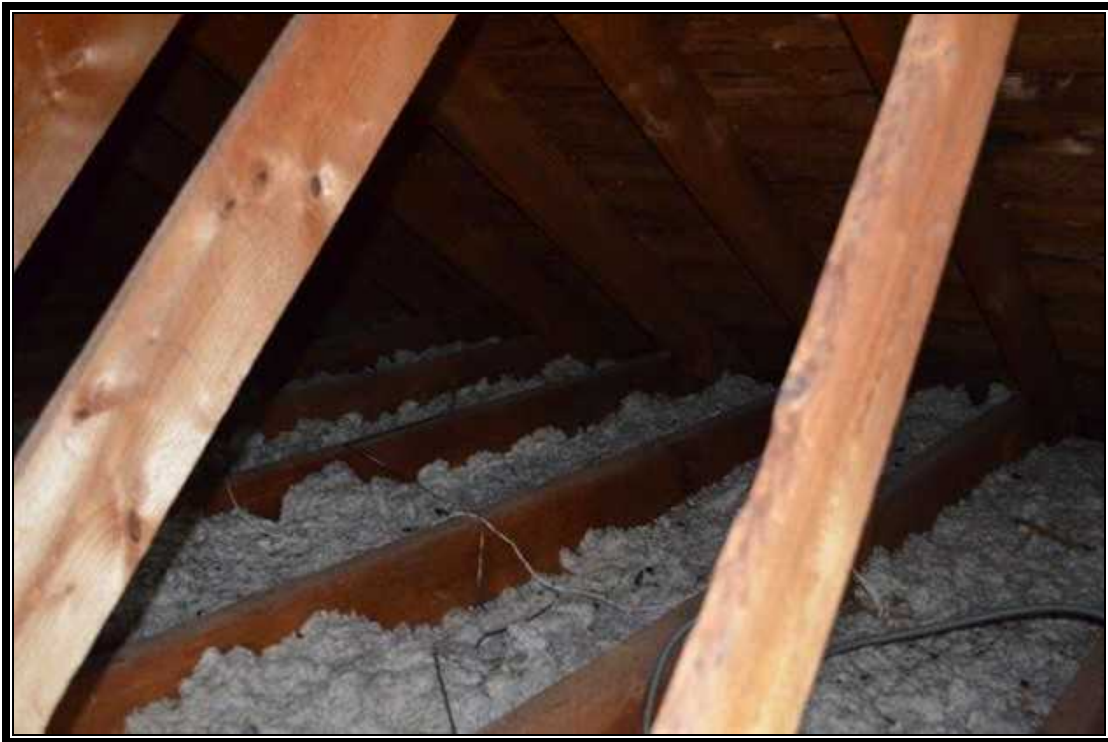
Photo 8: Roof truss.

| RECOMMENDATIONS | SECONDARY PRIORITY |
|---|---|
| ▪ Structural - Repair cut bottom chord of 1886-original block roof truss | \$600 |

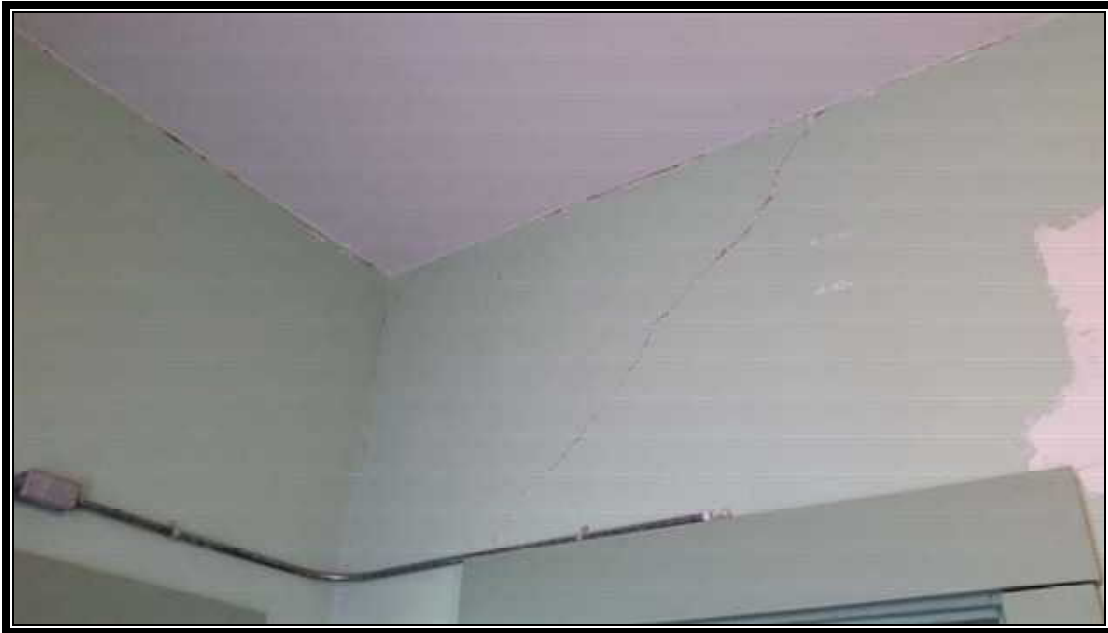
Photo 9: Cracks in the plaster on the inside of the front walls.

| RECOMMENDATIONS | TERTIARY PRIORITY |
|---|---|
| ▪ Finish – Repair cracking in plaster / sheetrock walls were evident. Monitor areas for additional cracking which would indicate further movement in structure. | \$2,560 |

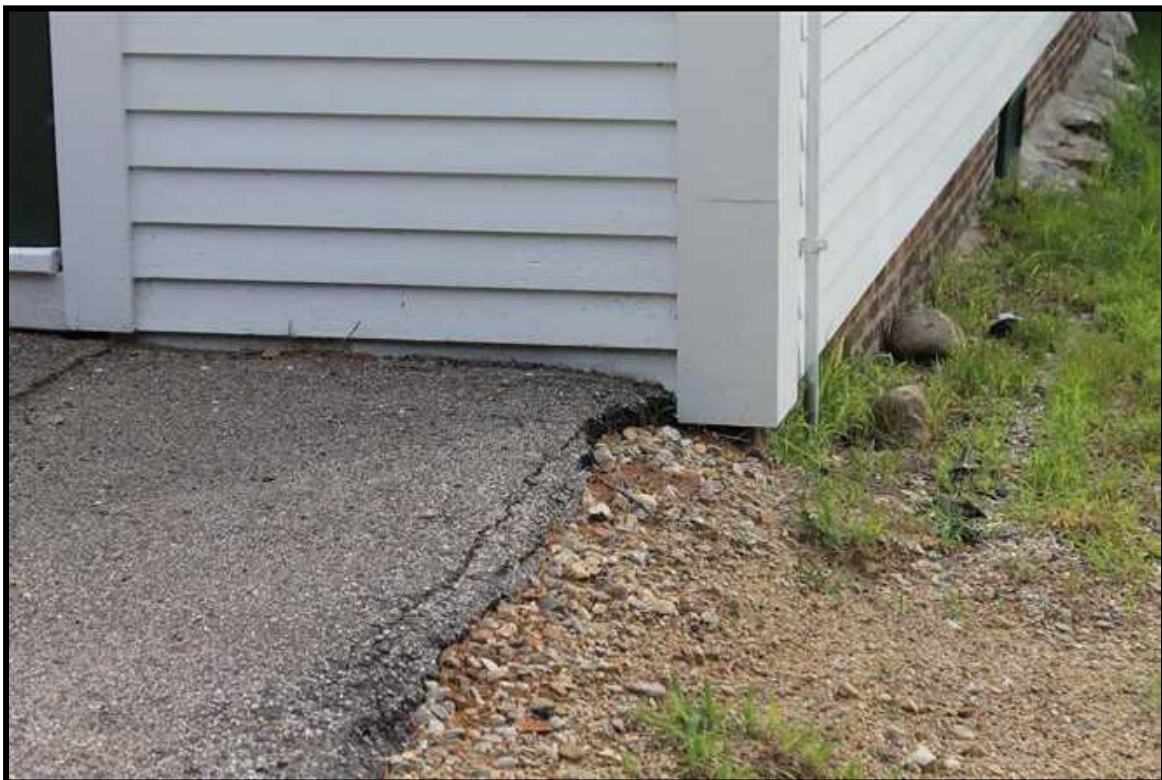
Image Exterior Detail 002 – Typical Grade Condition at 1886 Schoolhouse

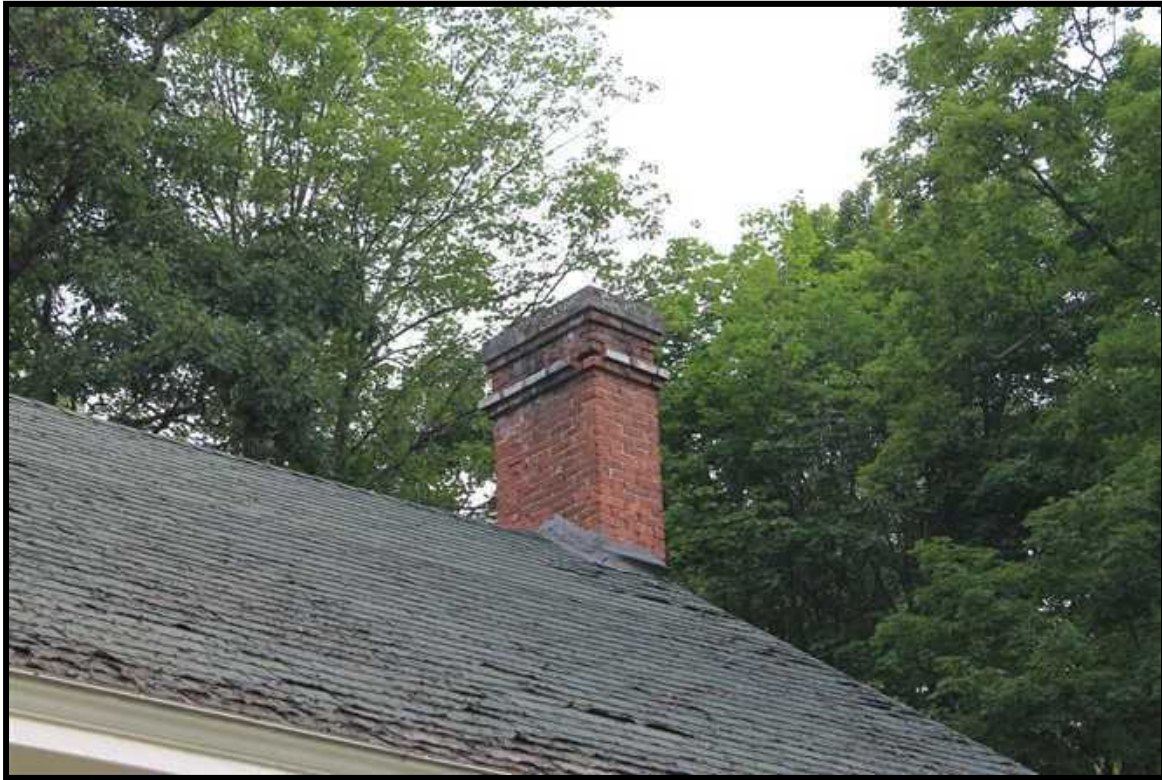
The brick chimney appears to be in stable condition. However, some loose brick has been observed, as well as at least one occurrence of dislodged brick, and further detailed inspection is recommended.

Image Exterior Detail 009 – Chimney at rear of 1886 Schoolhouse

| RECOMMENDATIONS | PRIMARY PRIORITY |
|---|---|
| ▪ Masonry chimney – Repair / repoint all exterior brickwork to chimney, seal with suitable application. <i>Note: age and make-up of existing mortar should be confirmed with specialist consultant to insure appropriate material usage.</i> | \$5,000<br><i>+ consultant</i> |

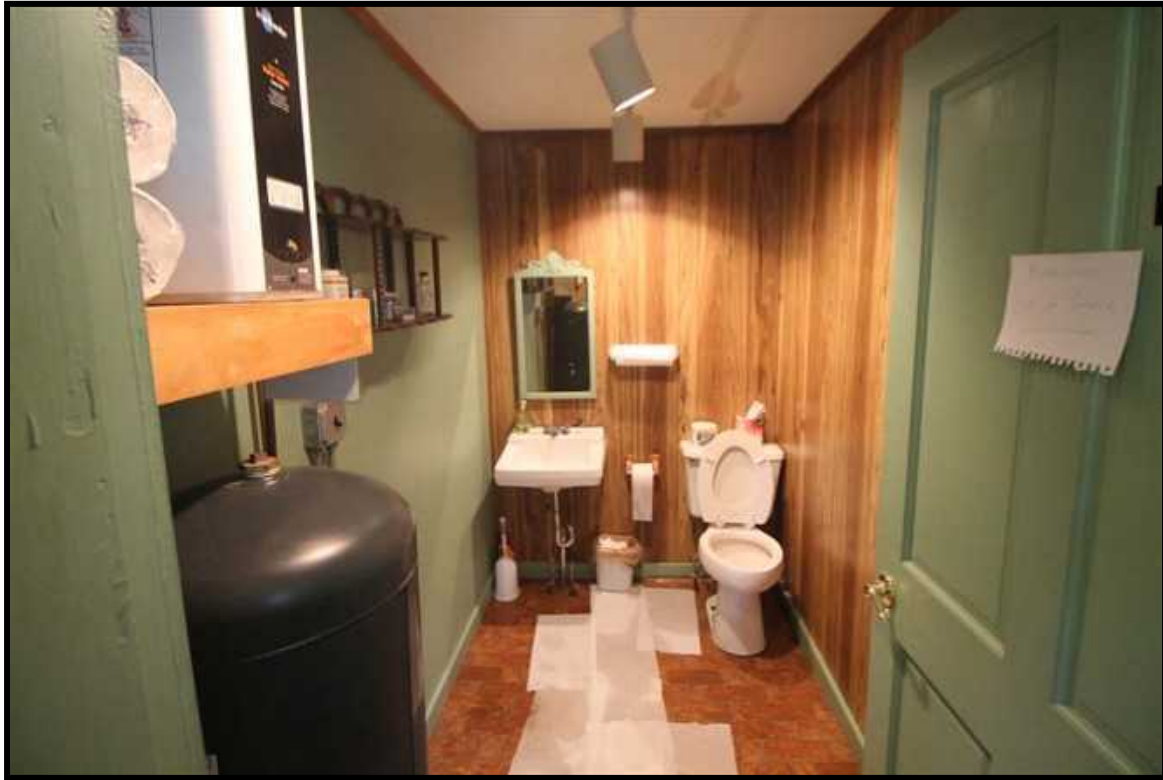
Image Interior 009 – Bathroom Interior

| ▪ Finishes / Substrate - Replace curled / delaminating floor finish in bathroom. Confirm condition of substrate prior to new install, and address accordingly (Note: black mold on floor near toilet). | \$2,400 |

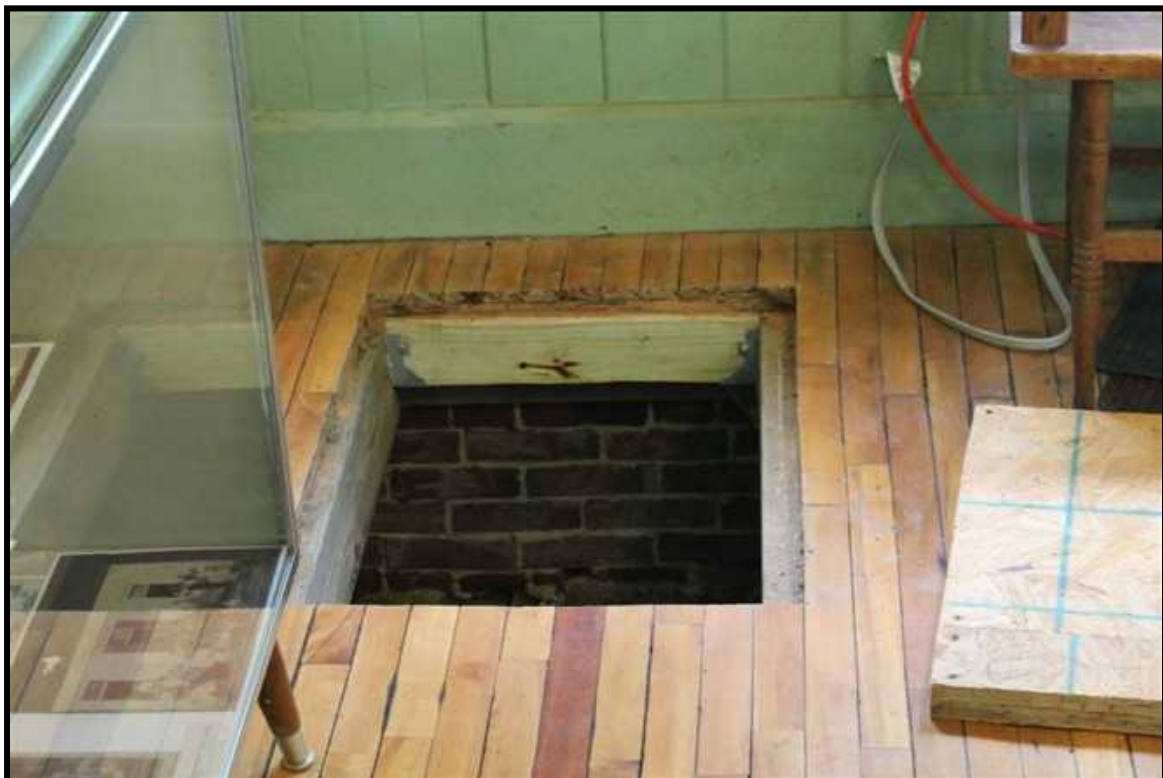
The original block is a wood framed floor with 2-1/2" - 3" strip wood flooring. The flooring and finish are in fair condition. There is concern with the north-west corner where an access hatch to the crawl space has been cut. Structural upgrades, some of which was undertaken in June 2016, appears to be comprised of new bearing points, sistering of floor joists, and mechanical fasteners. These upgrades to the floor system were effective with the exception of the stone / block piers, which have settled and/or collapsed and no longer support the framework. Significant bounce is noticeable in the floor and at that time it was not possible to close the hatch due to movement in the floor.

Image Interior Detail 004 – Crawl Space Access Hatch at 1886 Schoolhouse
