INDIVIDUAL INVENTORY FORM

NHDHR INVENTORY # CEN0010

1. Historic name Center Harbor Village School
2. District or area _____
3. Street and number 94 Dane Road (25B)
4. City or town Center Harbor
5. County Belknap
6. Current owner Town of Center Harbor

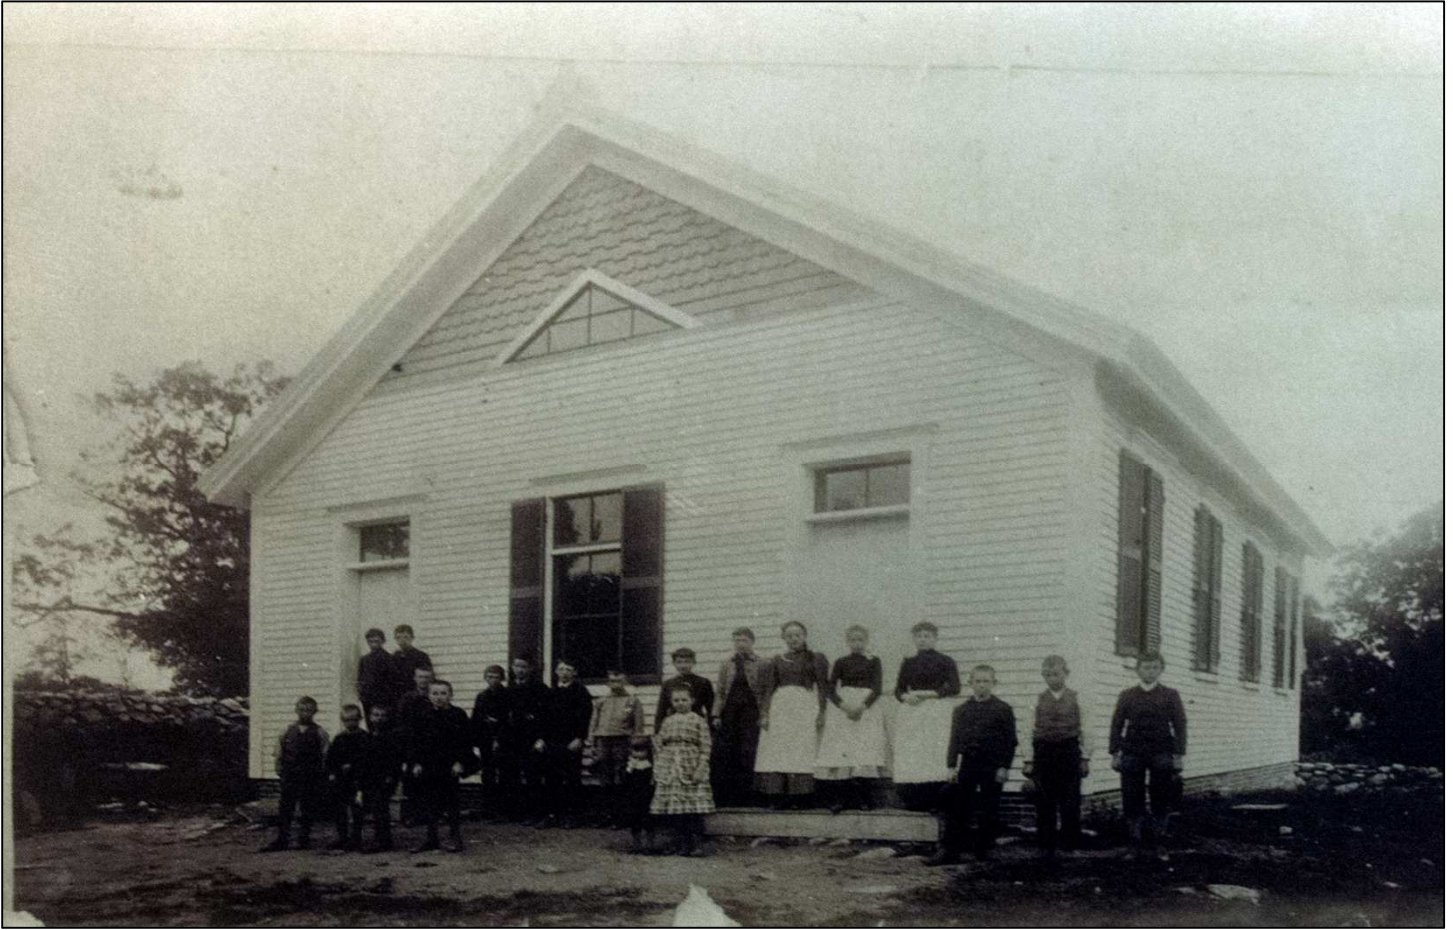
Figure 3: Center Harbor Village School, c. 1900

When it was constructed in 1886, there was a center window at the primary façade, between the doors. (**Figure 3**) This window was removed in c. 1929. Early photographs of the building show a single wooden step beneath each door, dark window shutters, and a contrasting paint color in the gable-end. By 1902 the steps were rebuilt, creating a wide set of four steps between the two doors and the flagpole was added. (**Figure 4**) By the 1940s, these steps had been replaced by a large open porch. (**Figure 6**)

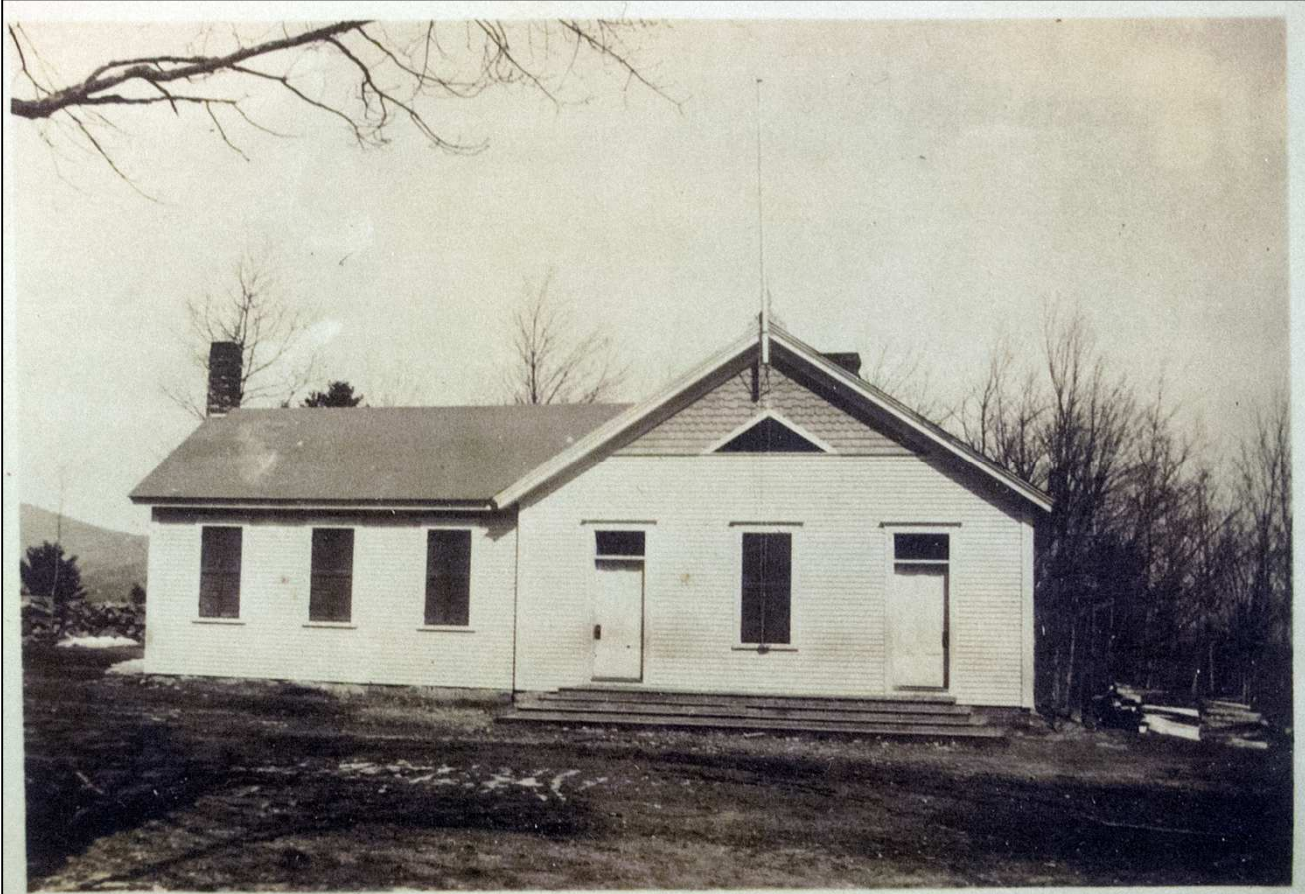
Figure 4: Center Harbor Village School, c. 1902

The first major alteration to A. L. Davis' design came in 1902, when a secondary classroom was added off of the northwest side of the original structure. (**Figure 4**) This classroom allowed for the single room to be separated into a Primary Department (with 20 students) and a Grammar Grade (with 19 students), creating a more age-specific learning environment.²² This first addition was three bays long and had a chimney at the north end of the gable roof. Lumber for the addition was supplied by James P. Leighton²³ and the addition was constructed by Fred. E. Webster, who was paid \$300 for his labor and \$72 for desks.²⁴

The southern section of this ell was added in 1902 as a three-bay addition. (**Figures 4 & 5**) This addition had a chimney at the north end and was used as a second classroom. In 1929, the addition was extended to its present size. The windows were replaced and the chimney was removed. In c. 2015 a protective overhang was removed from over the exterior door by the Historical Society in an effort to mitigate rot issues.

Center Harbor Village School shortly after 3-bay addition to the north.

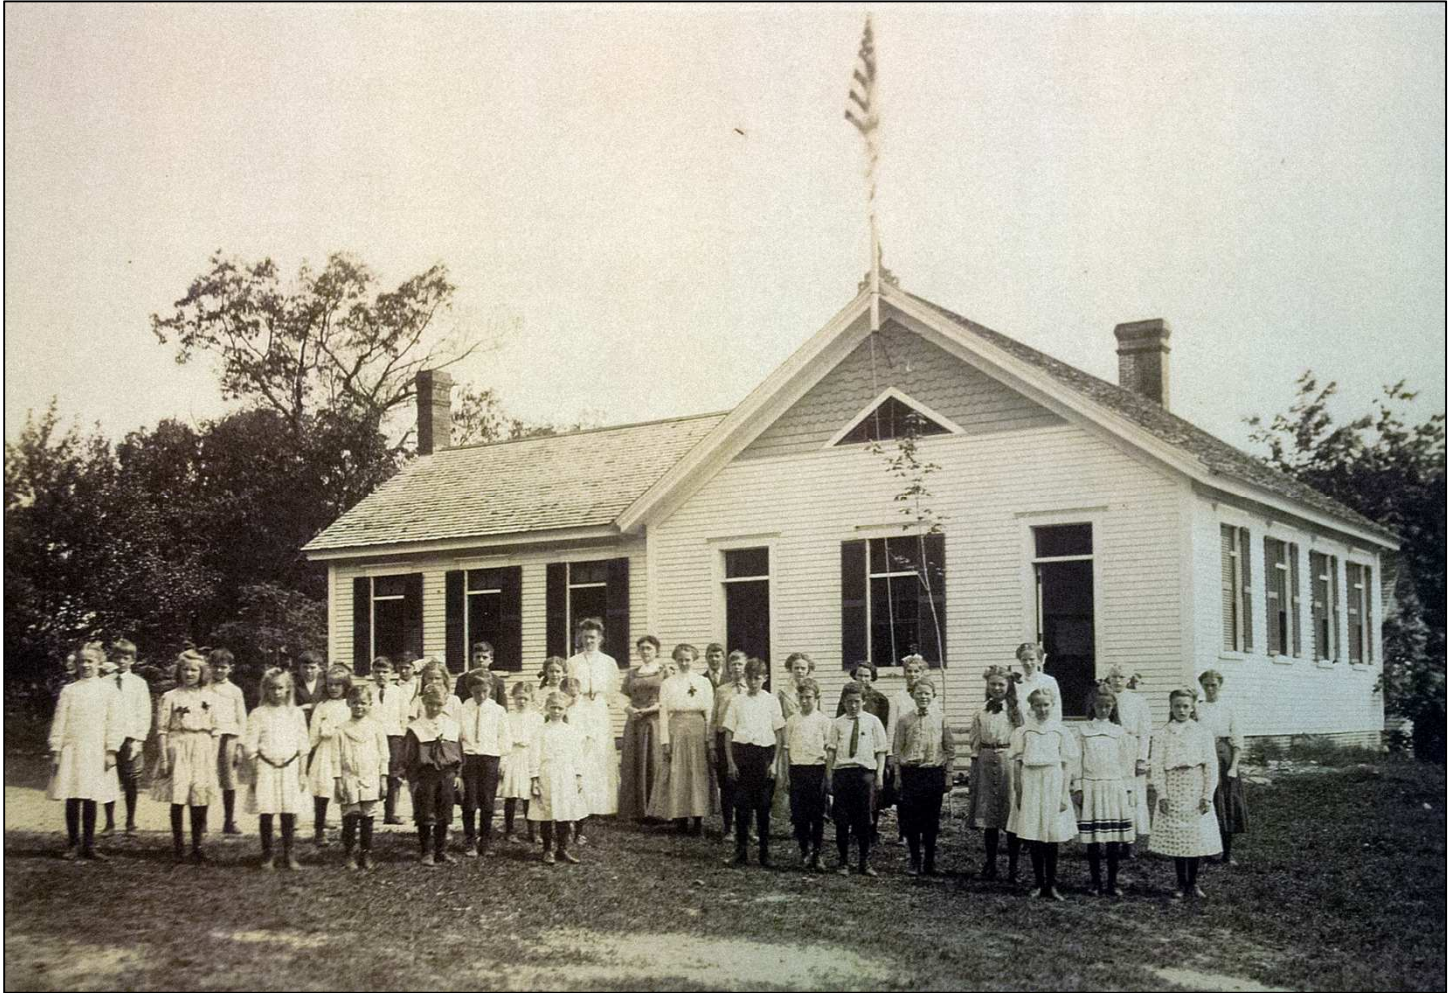
Figure 5: Center Harbor Village School, c. 1920

In 1919, the Moultonborough District No. 18 school combined with the Center Harbor Village School. (**Figure 5**) The Village School now accommodated children from Moultonborough, Center Harbor Neck, Center Harbor Village and Garnet Hill. While it shared the second classroom, Moultonborough paid the salary of a second teacher. The teacher of the Grammar Room received \$6/week and the teacher of the Primary Room \$5/week.²⁵

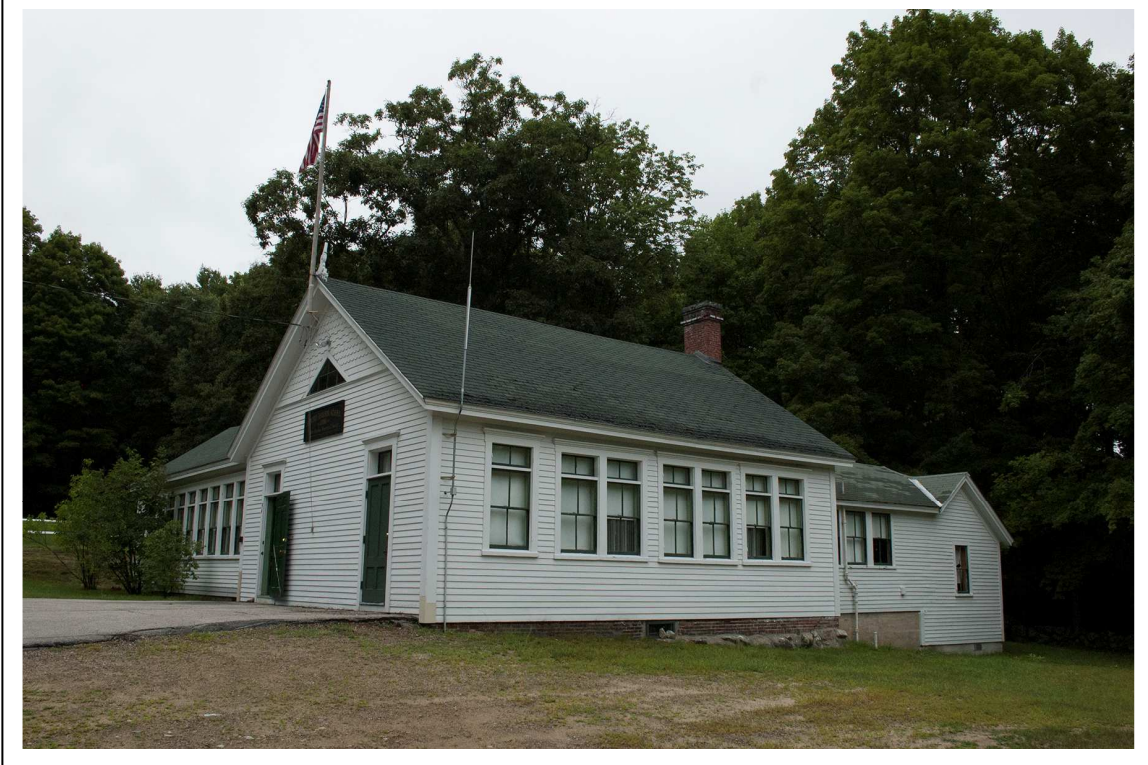
The 1886 main block is Queen Anne in style. (Photo 1 & 2) It is one story with symmetrical gable-end facing the street. The roof is covered in asphalt shingles. A rustic flag pole is located at the gable-end and constructed of a small tree-trunk. Slightly behind it, is a decorative wooden finial. A brick chimney with decorative cap is located at the rear end of the gable. The roof has a modern overhang with open rake and enclosed rafters. The narrow fascia is flat and decorated by a shingle molding.

There is a long addition off of the southwest corner of the main block. (Photo 2, 3, & 4) Like the main block, this addition has an asphalt shingle roof and clapboard siding. The foundation of the addition is concrete. Here, the window units have been set in a contiguous band of nine windows across the southwest side. There are three two-lite louvered windows at the northeast elevation, just below the roof. A doorway is located at the northeast corner of the ell. The historic door has been replaced with a modern single-panel door.

Photo # 2 Description: Left to right: classroom addition, 1886 school, kitchen, and "workroom."
Reference (file name or frame#): DSC_0055.NEF Direction: North

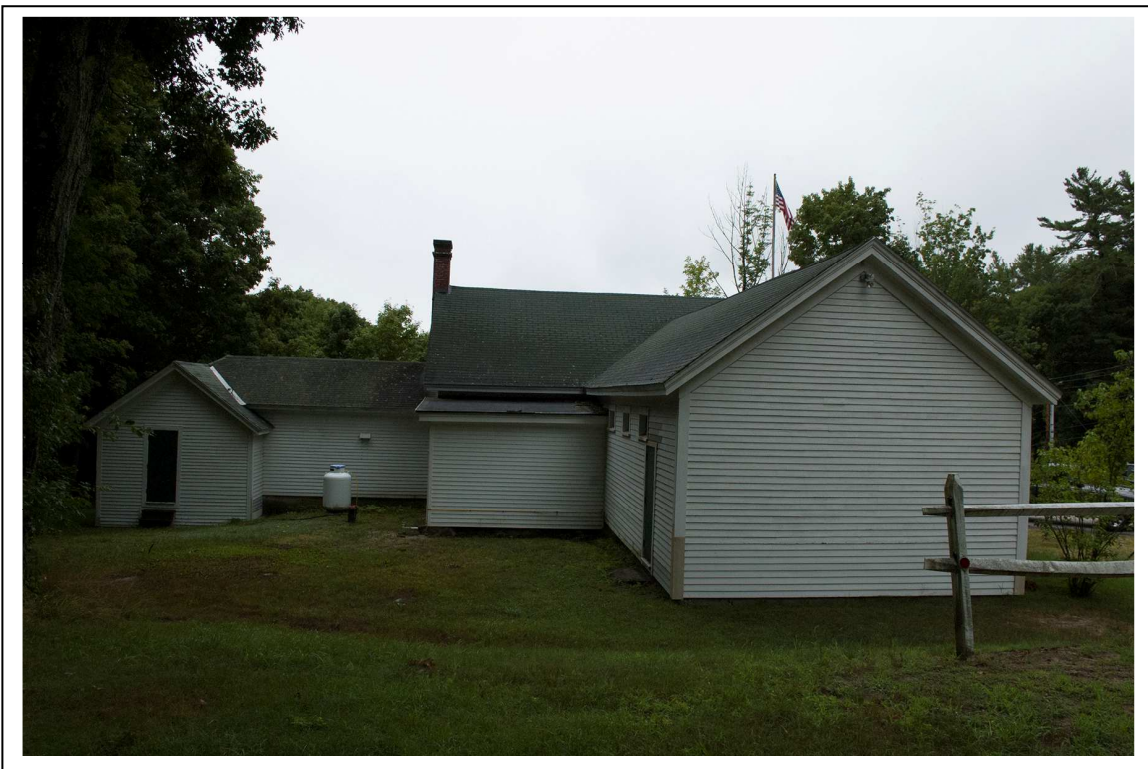
There is a 1921 shed addition off of the east side of the ell. (Photo 3 & 4) When it was built in 1886, the original Schoolhouse had a privy and woodshed, but the location of this detached structure(s) is unknown. The shed has no

windows and was sheathed in aluminum siding c. 2010.⁴⁰ The foundation is mixed, with concrete against the classroom addition, and mortared field-stone at the northeast side, above two ventilator windows. The presence of the windows suggest that this shed may have once housed a privy.

A wing addition is located off of the northeast end of the 1886 building. (Photos 3, 4, & 5) This was added in 1929 for use as a kitchen. Like the classroom addition, the kitchen sits atop a concrete foundation. There are three 2/2 windows on the south side, and no windows to the north.

Photo # 3 Description: Left to Right: "workroom", kitchen, shed (1886 school behind), classroom addition.
Reference (file name or frame#): DSC_0046.NEF Direction: Southeast

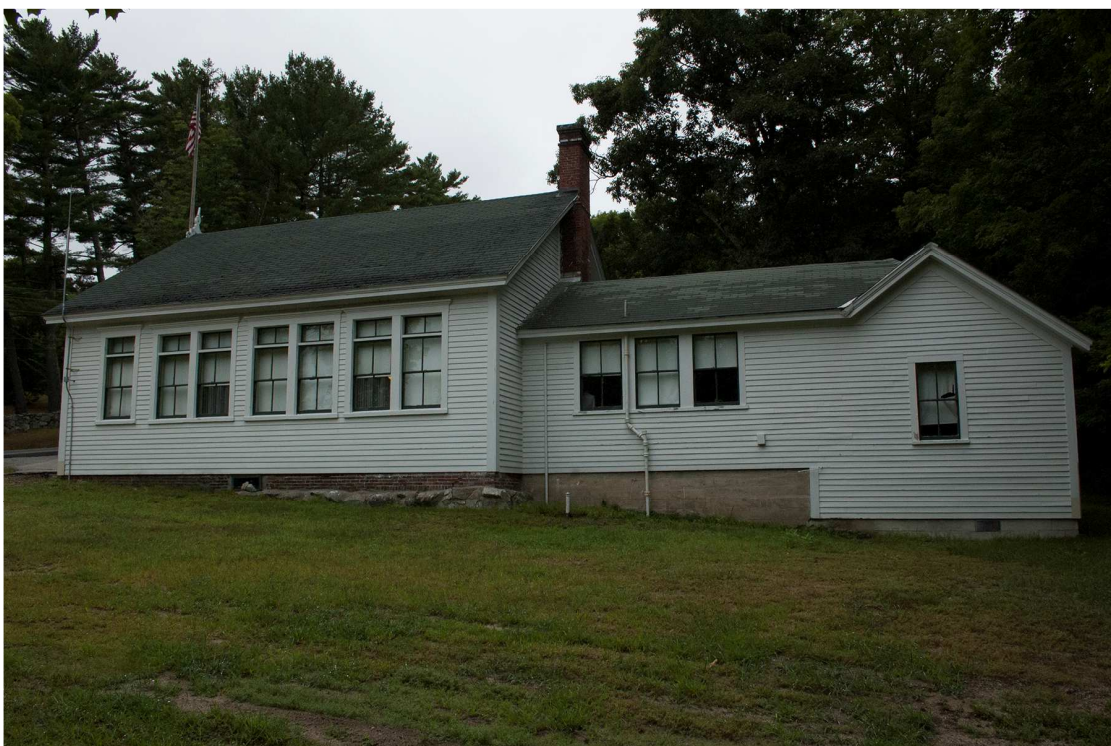
The final section of the Center Harbor Village School is an off of the northeast end of the kitchen. (Photo 5) This is commonly referred to as the "Workroom" and was originally used as a woodshed. The workroom has a concrete block foundation, and clapboard sheathing. The structure has four lite single-sash windows. The date of the workroom is unknown and may have been constructed in 1902, when the first addition was made to the School. It does not appear in early images of the building, but is shown in a photograph that was taken c. 1920. **(Figure 5)** Most-likely this building originally served as either a privy, or, more-likely, as a woodshed.

Photo # 5 Description: 1886 School at left, kitchen at middle, "workroom" at right.
Reference (file name or frame#): DSC_0053.NEF Direction: Northwest

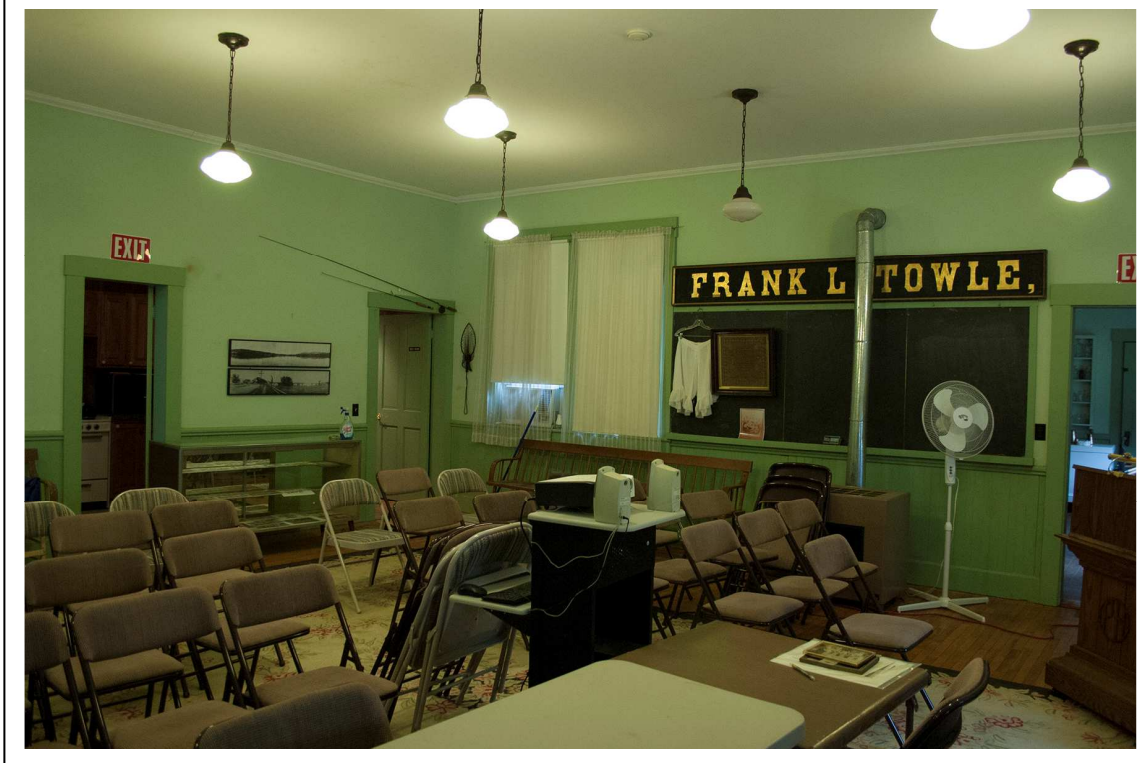
The 1886 classroom has vertical bead-board wainscot, picture rail, and plain flat trim around doors and windows. (Photo 6) There are chalk boards along the northeast and southwest walls, with built-in chalk ledges. (Photo 7) The room is lit by c. 1925 ceiling fixtures and there is a modern gas-fired heater at the center of the northeast wall.

Photo # 6 Description: Interior of 1886 classroom.
Reference (file name or frame#): DSC_0019.NEF

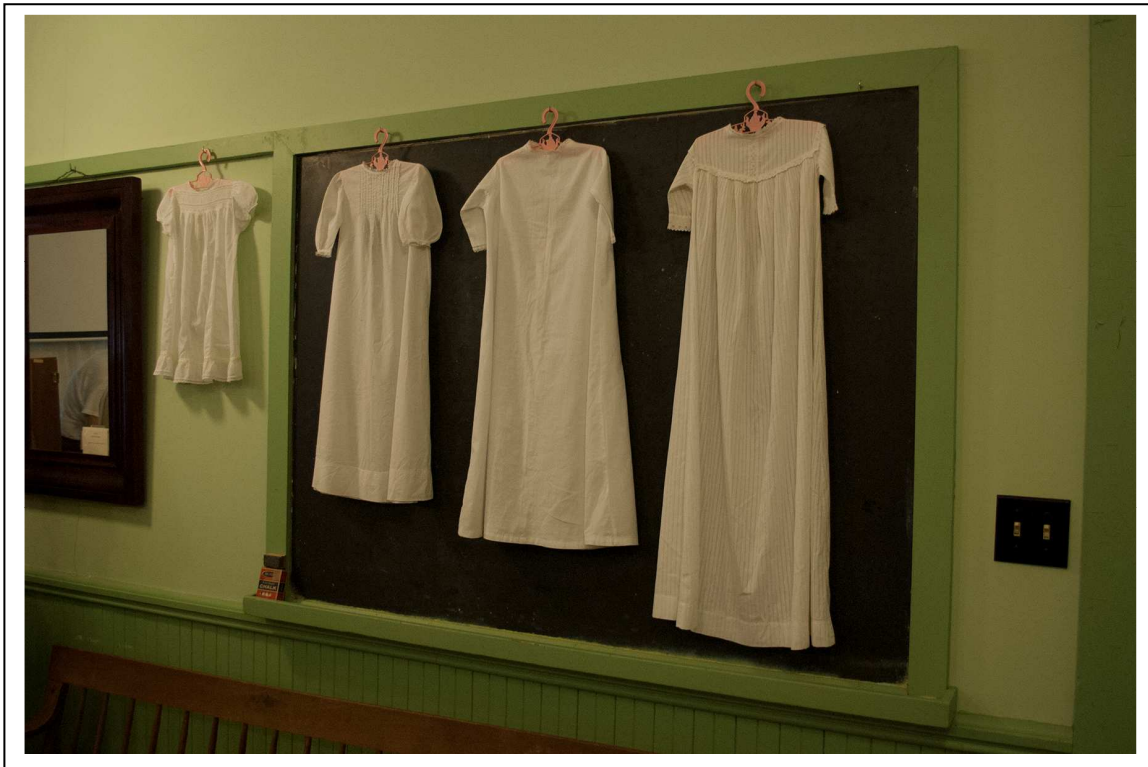
Photo # 7 Description: Chalkboard detail, 1886 classroom.
Reference (file name or frame#): DSC_0023.NEF

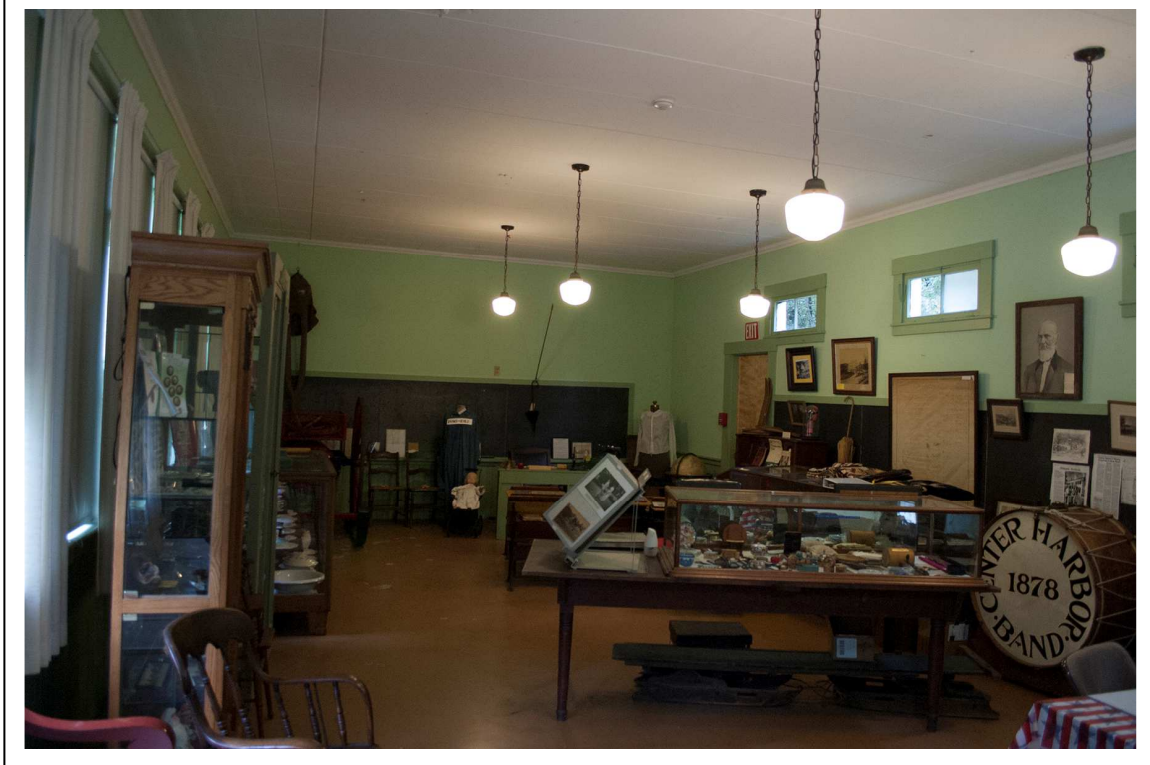
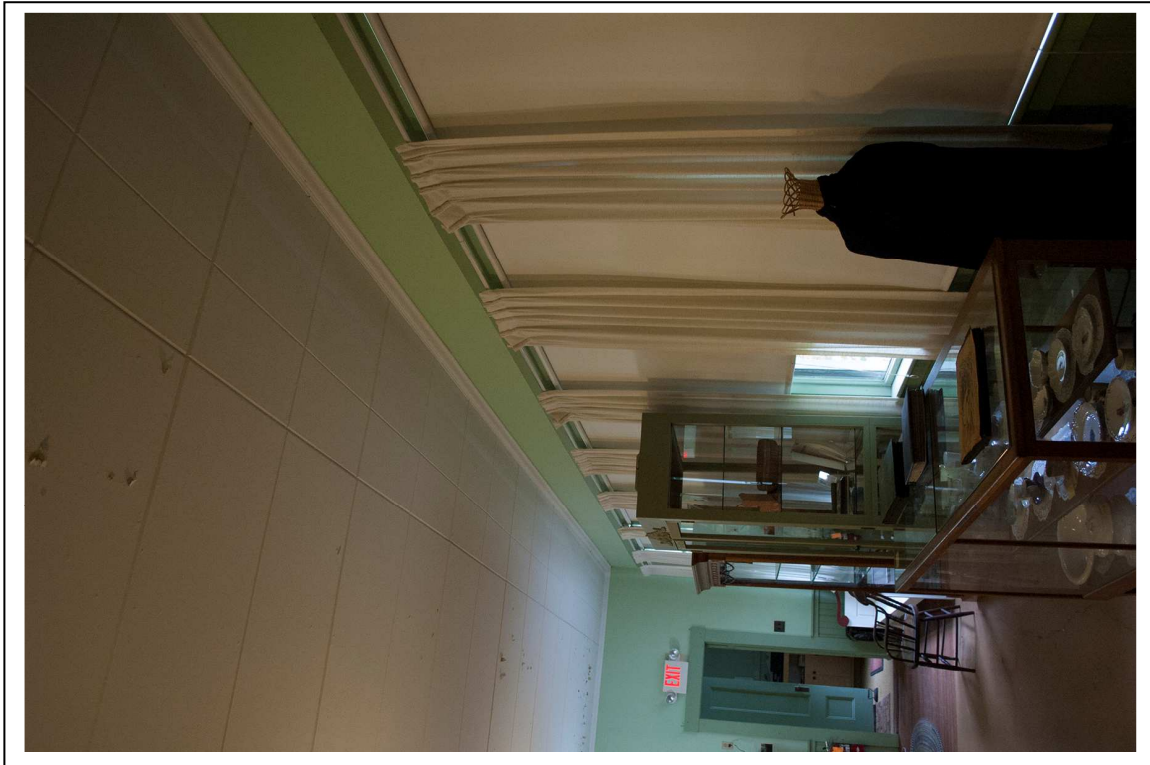
The interior of the 1929 classroom, in the ell, is somewhat similar to the 1886 classroom. (Photos 8 & 9) The walls of this room are plaster, with bead-board wainscot and picture rail. There are also built-in chalkboards in this room and slightly later period light fixtures hanging from the ceiling. The room has a concrete floor that is covered in sheet linoleum. The ceiling of this room is composed of paneled fiberboard (possibly Masonite, which was popular in the late 1930s and 1940s).

Photo # 8 Description: Interior of classroom addition.
Reference (file name or frame#): DSC_0039.NEF

Photo # 9 Description: Interior of classroom addition.
Reference (file name or frame#): DSC_0042.NEF

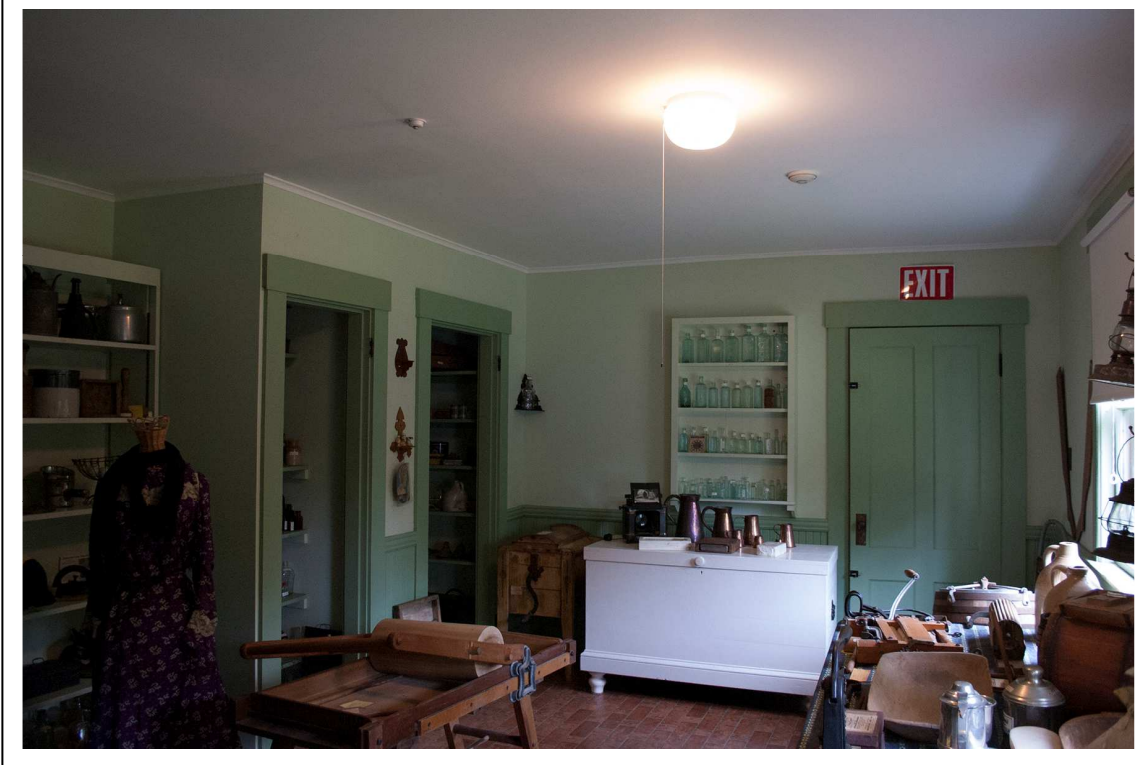
The 1929 kitchen wing has plaster walls and ceiling, beadboard wainscot and picture rail. (Photo 10) This room has a linoleum floor. There is a chimney at the southwest side of the room which has been partly plastered over. Stove flues are visible in this chimney. An additional exterior vent is visible at the center of the northwest exterior wall, indicating the location of a former gas or electric stove. There are two storage closets at the north corner of the room.

Photo # 10 Description: Interior of Kitchen, facing door into "Workroom"
Reference (file name or frame#): DSC_0024.NEF

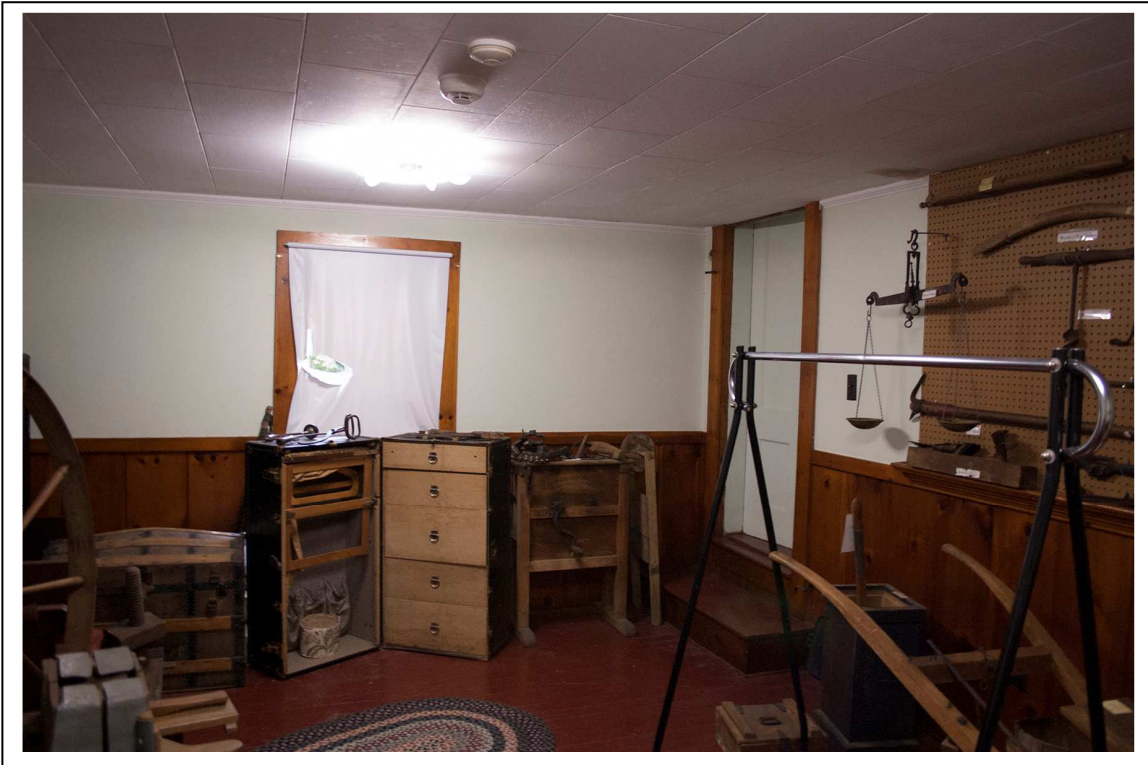
The interior of the "workroom" is very different from the rest of the Village Schoolhouse. (Photo 11) This room has a pine floor, knotty-pine wainscot, sheetrock walls, and fiberboard tile ceiling. The interior treatments of this section of the building are mid-20th century, and suggest that this room was once unfinished space.

Photo # 11 Description: Interior of "Workroom" facing door to Kitchen
Reference (file name or frame#): DSC_0034.NEF
