Office of the Health Officer

Report of Site Inspection

Camp Eagle's Cliff

Date of Inspection: July 15, 2022

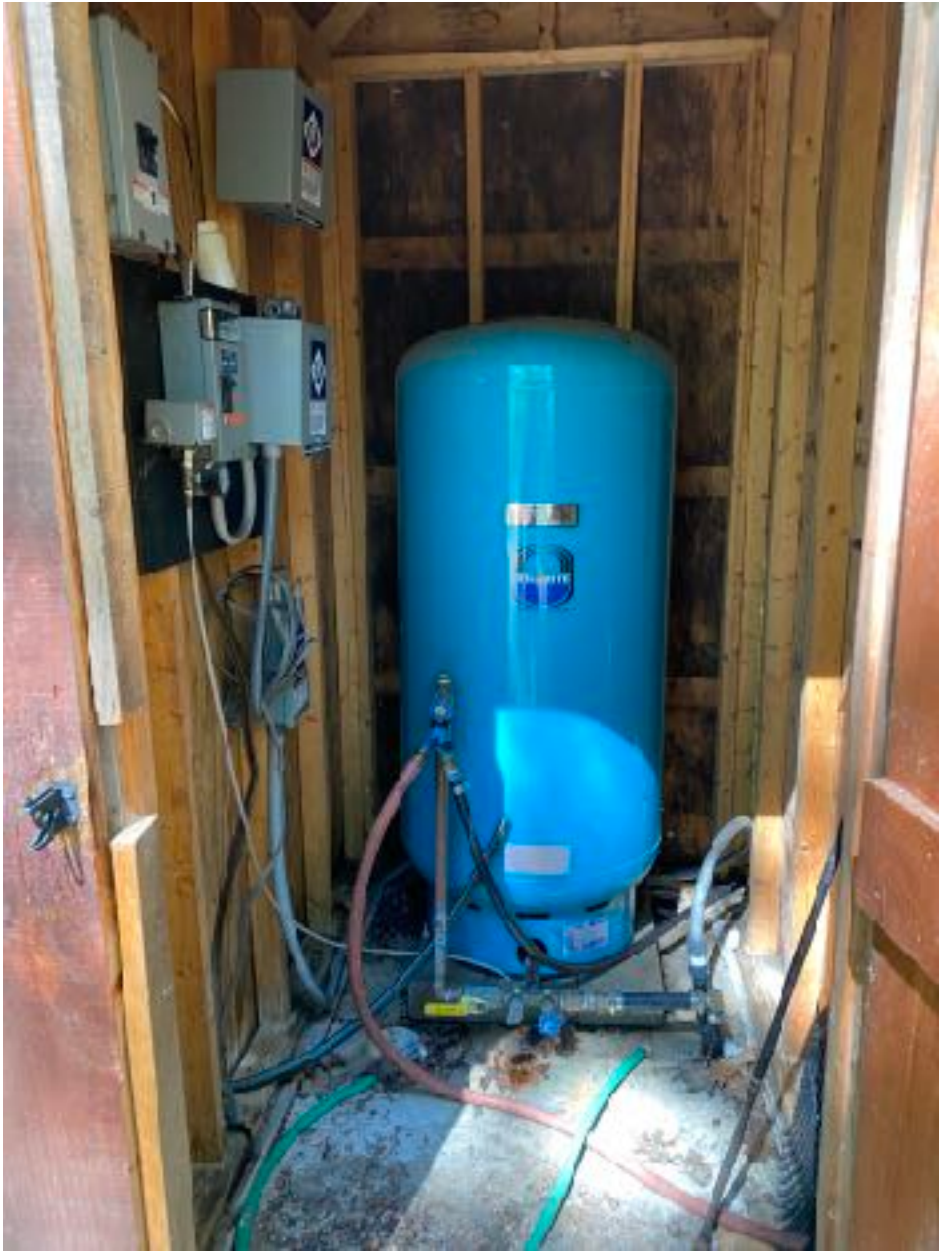
Fig. 2 - Pump House

The first area of inspection was the pump house (Fig. 2). A drilled well was noted to be in place (Fig. 3-4). The pump house appeared to have electrical connections and was operating normally. There did not appear to be any significant leaks, damage, or other hazards in the building. The well was appropriately sited away from any potential sources of visible contamination.

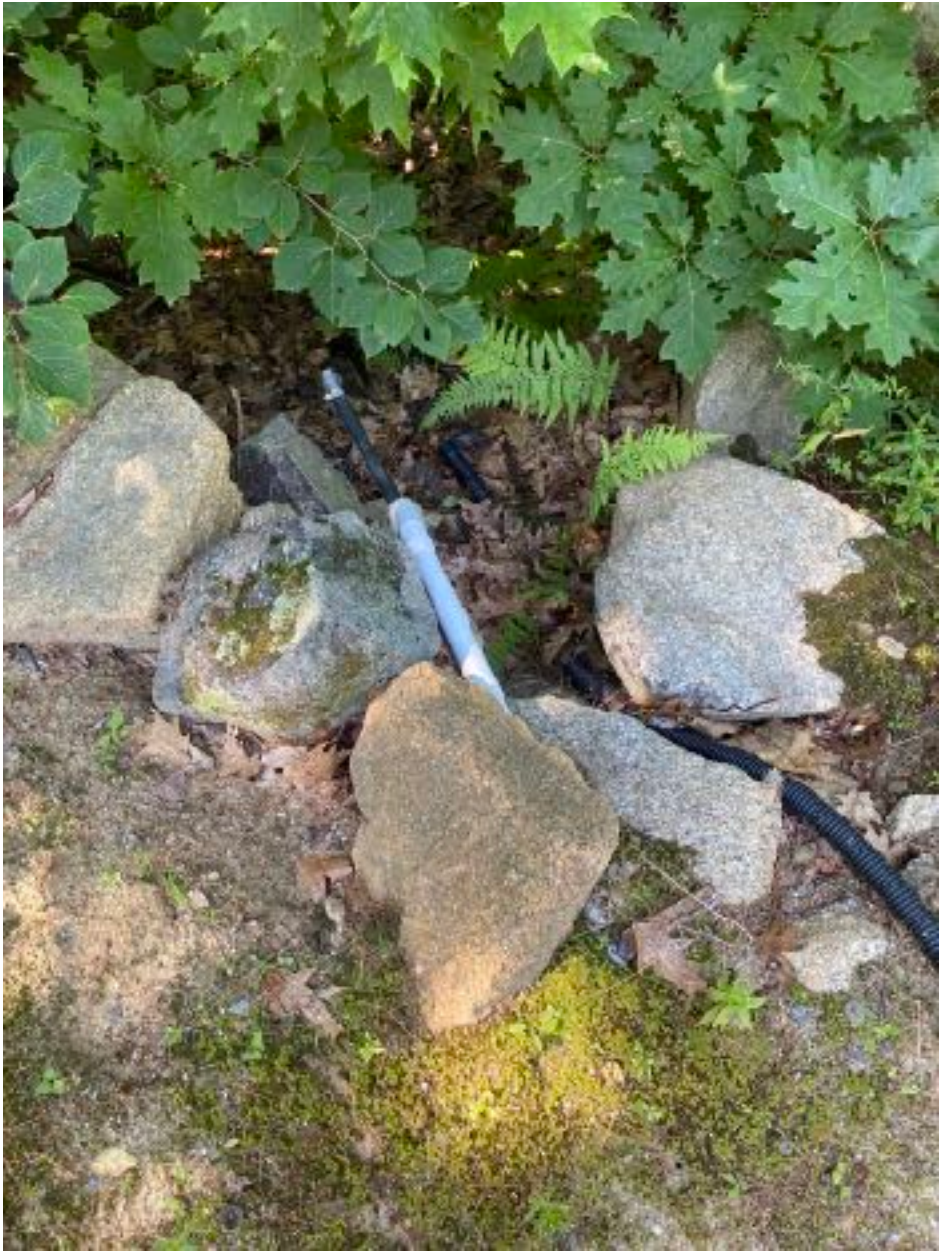
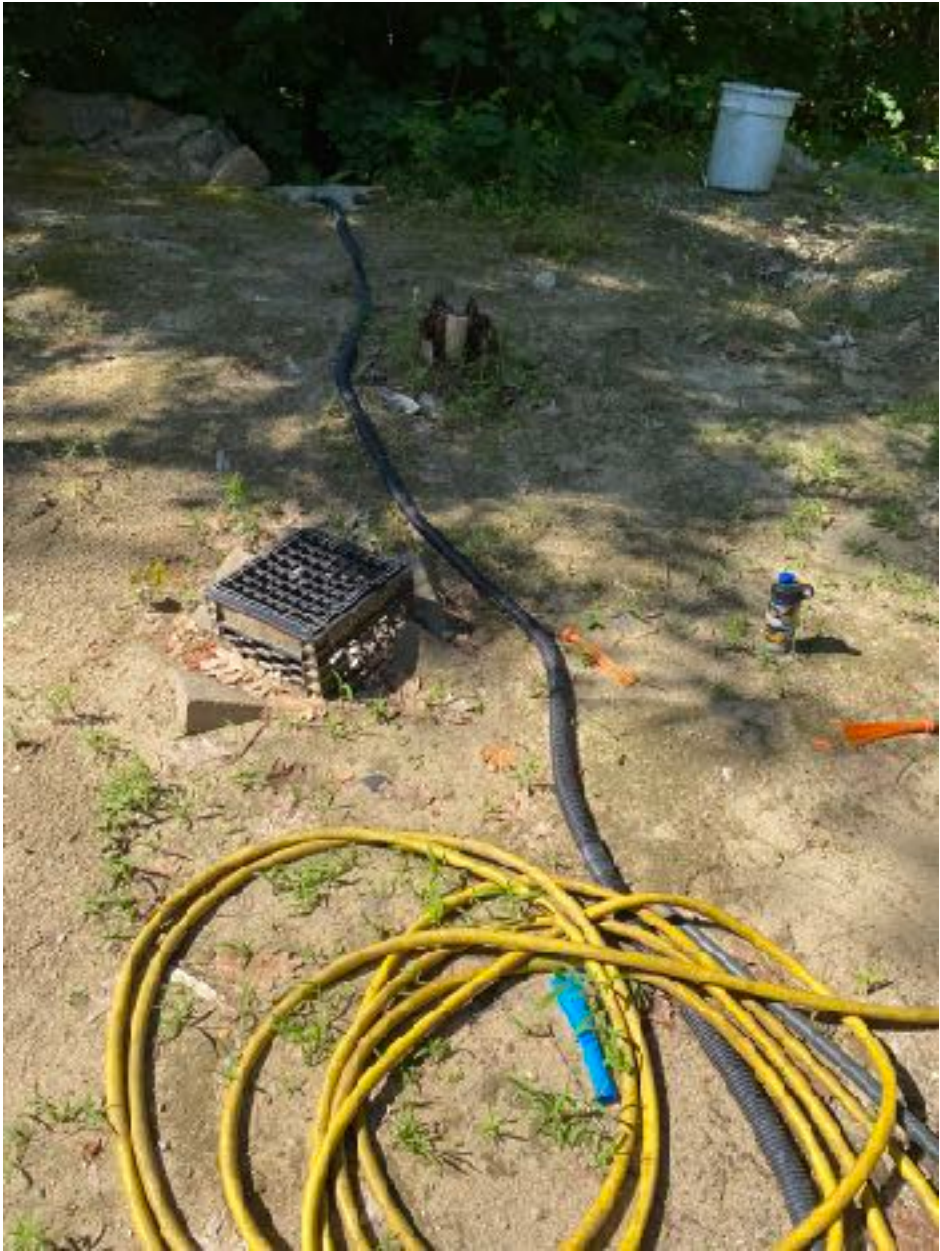
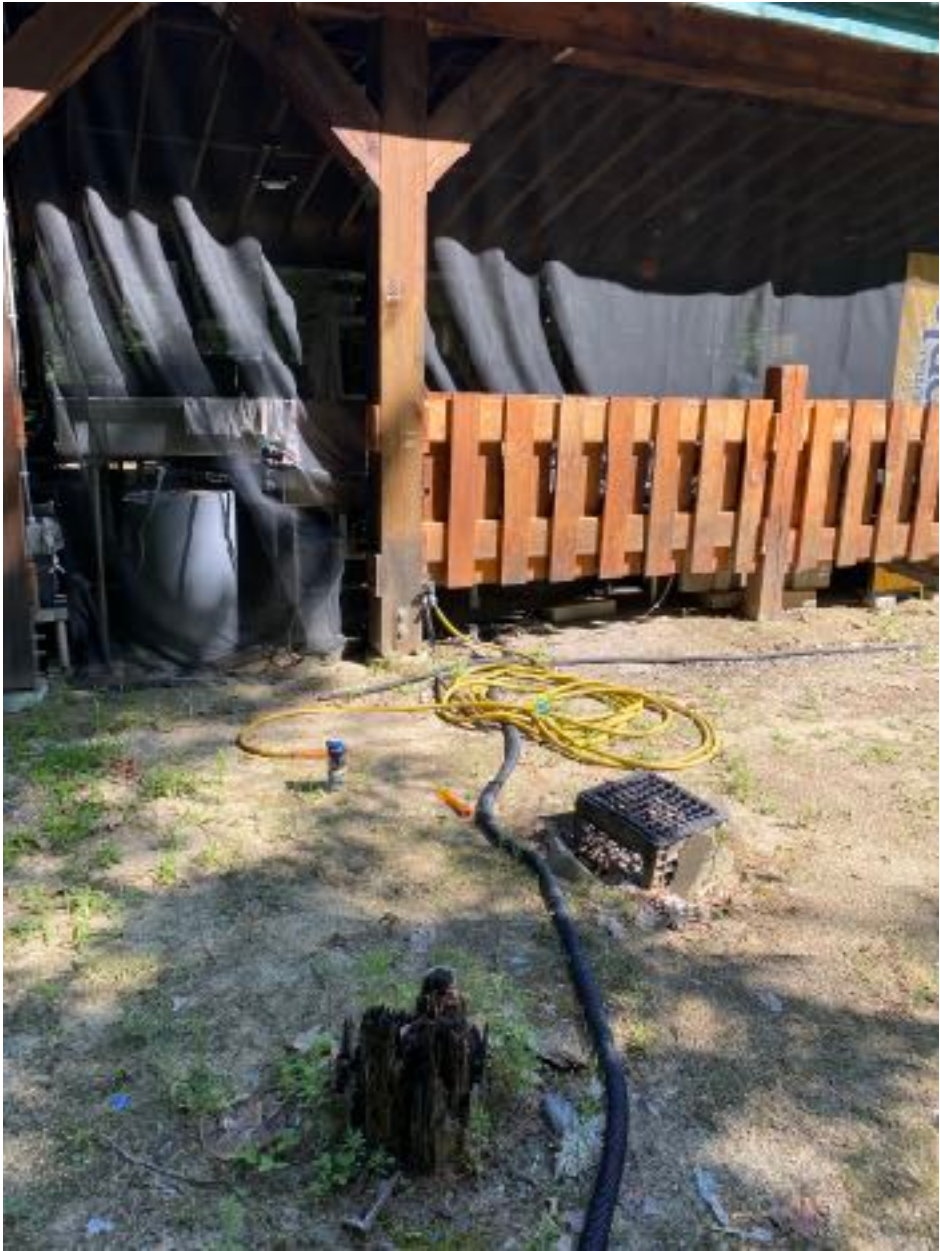
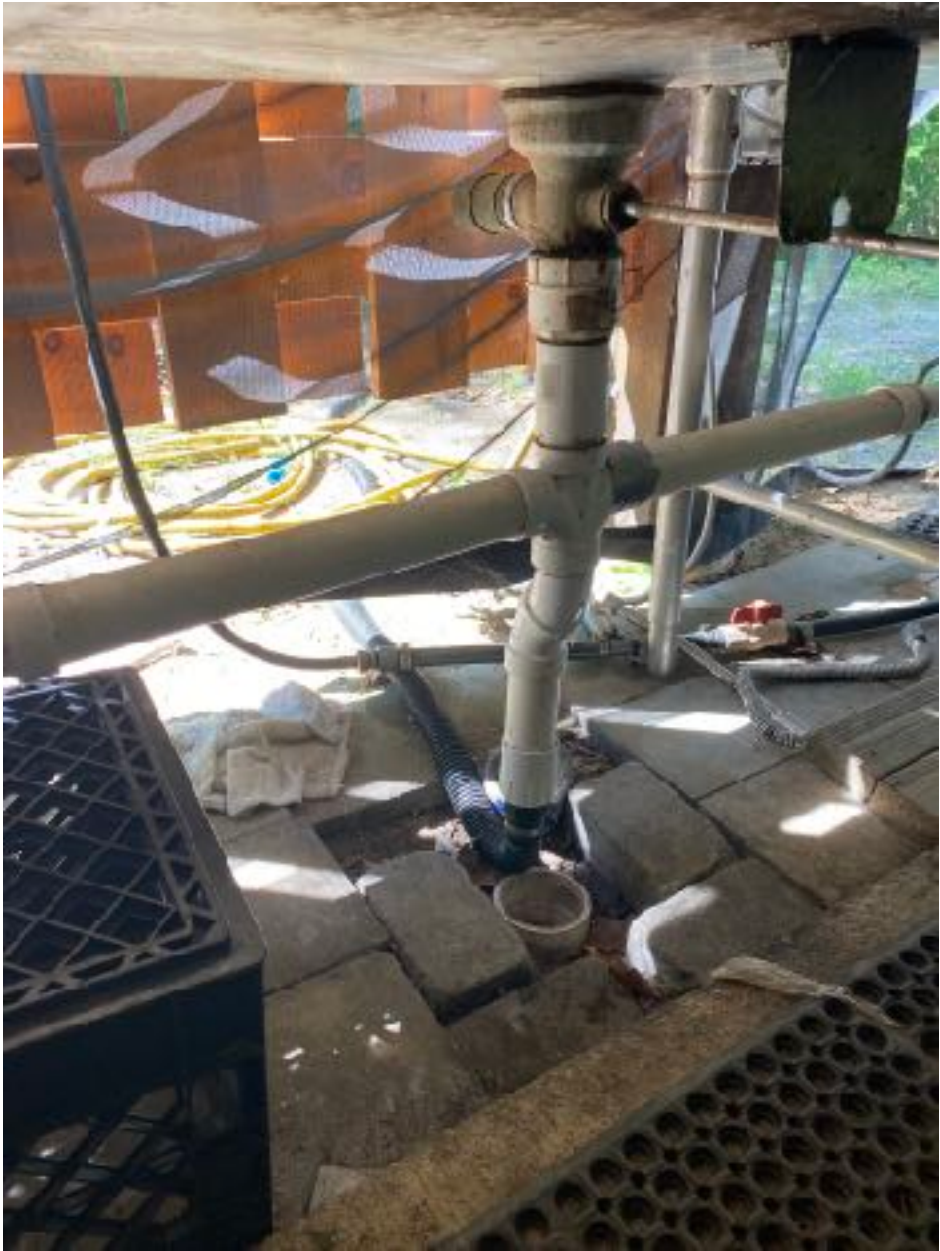
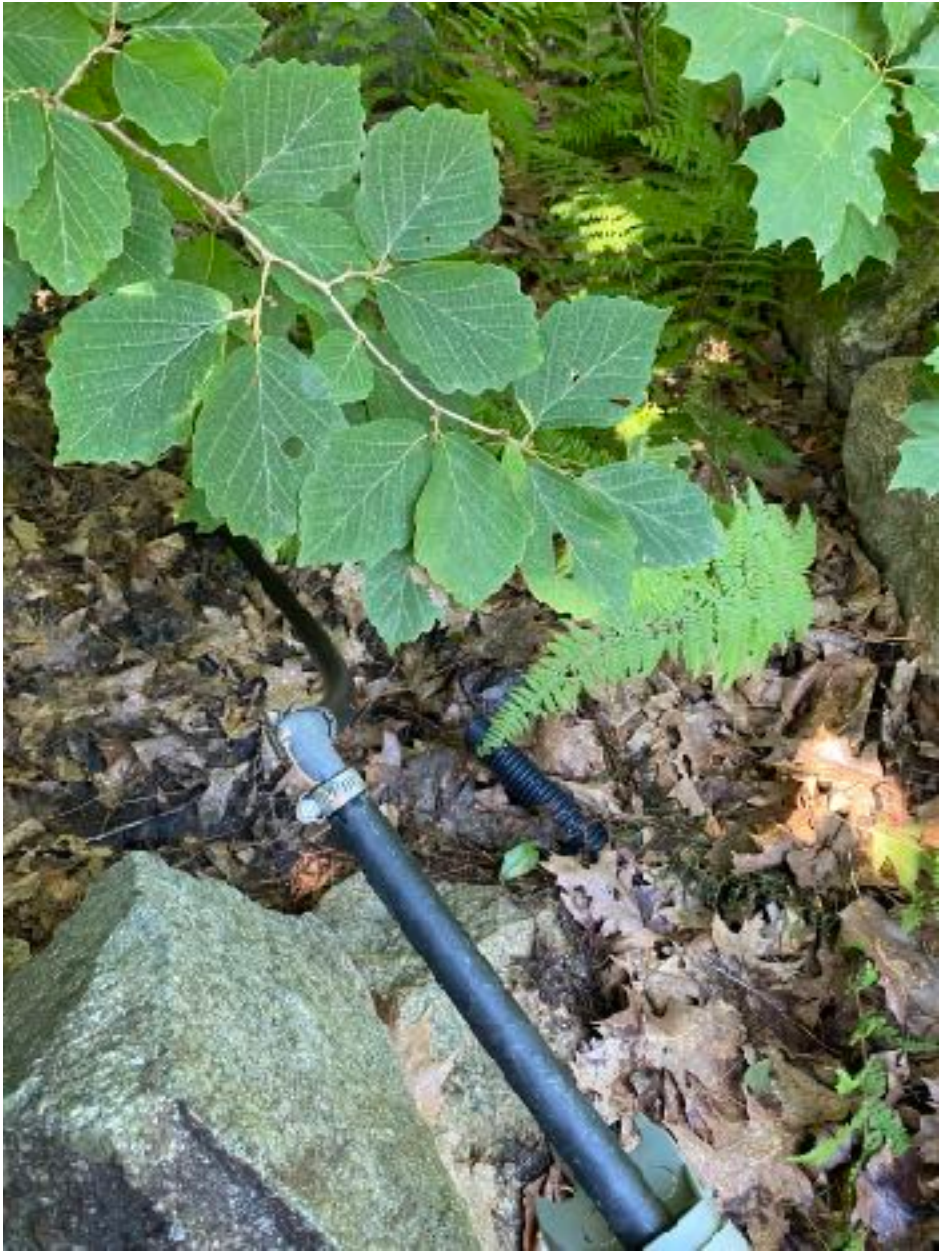
Fig. 5 - Gray Water Discharge and Water Supply

Inspector then moved to the pavilion containing kitchen and eating facilities. The pavilion has open sides, but did have bug netting in place. Upon approach to the area, it was noted that there was what appeared to be a dry well next to the cooking area, but a piece of black corrugated hose was noted to be bypassing this area, draining onto the ground approximately 100' uphill from the drilled well (Fig. 5-7). Subsequent investigation showed that this was a gray water drain from the sinks in the kitchen area (Fig. 8). The gray water drain did drain water which had been run into the kitchen sink (Fig. 9). There was soap and hand sanitizer available (Fig. 10). No evidence of a septic system or leach field was noted in the area. The food preparation area was found to be clean and orderly (Fig. 11-15). There was no evidence of significant contamination other than environmental dust as the area had not been used for 2 weeks. There was a commercial grade sink system with running water and hot water noted. There were multiple functional refrigeration units noted in the area. There was a "bug light" noted to be over the center of the food preparation area. There was not a significant number of insects in the area. No other significant findings were noted. Eating area was enclosed with netting (Fig. 16-17).

The kitchen facility has issues which require correction. First, gray water from dishwashing and food preparation activities is currently being discharged onto the ground. Additionally, the use of a mini well for gray water disposal is only authorized if there is no running water to the facility per NH Env-Wq 1022.02. There is currently running water in the kitchen area which would require a septic system be installed and use of the mini well be discontinued. Second, efforts to prevent contamination of food by insects likely need to be improved. While there is netting around the entire pavilion, there is a bug light located directly over the food preparation areas, and there are no self-closing doors or other features which would limit the entry of insects into the food preparation and consumption areas. It is recommended that the screening around the pavilion be secured, self-closing entry doors be installed, and the bug light be relocated.

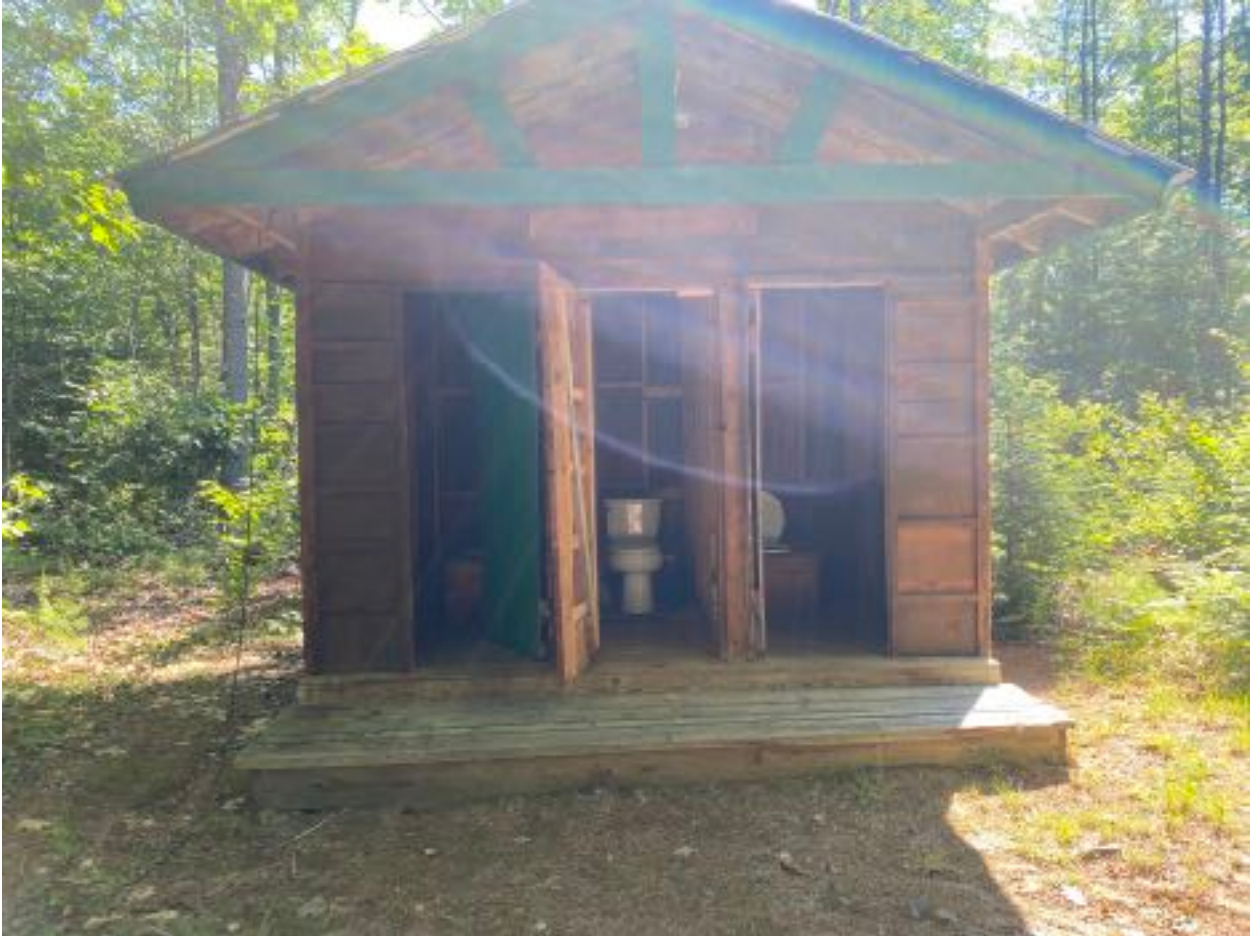
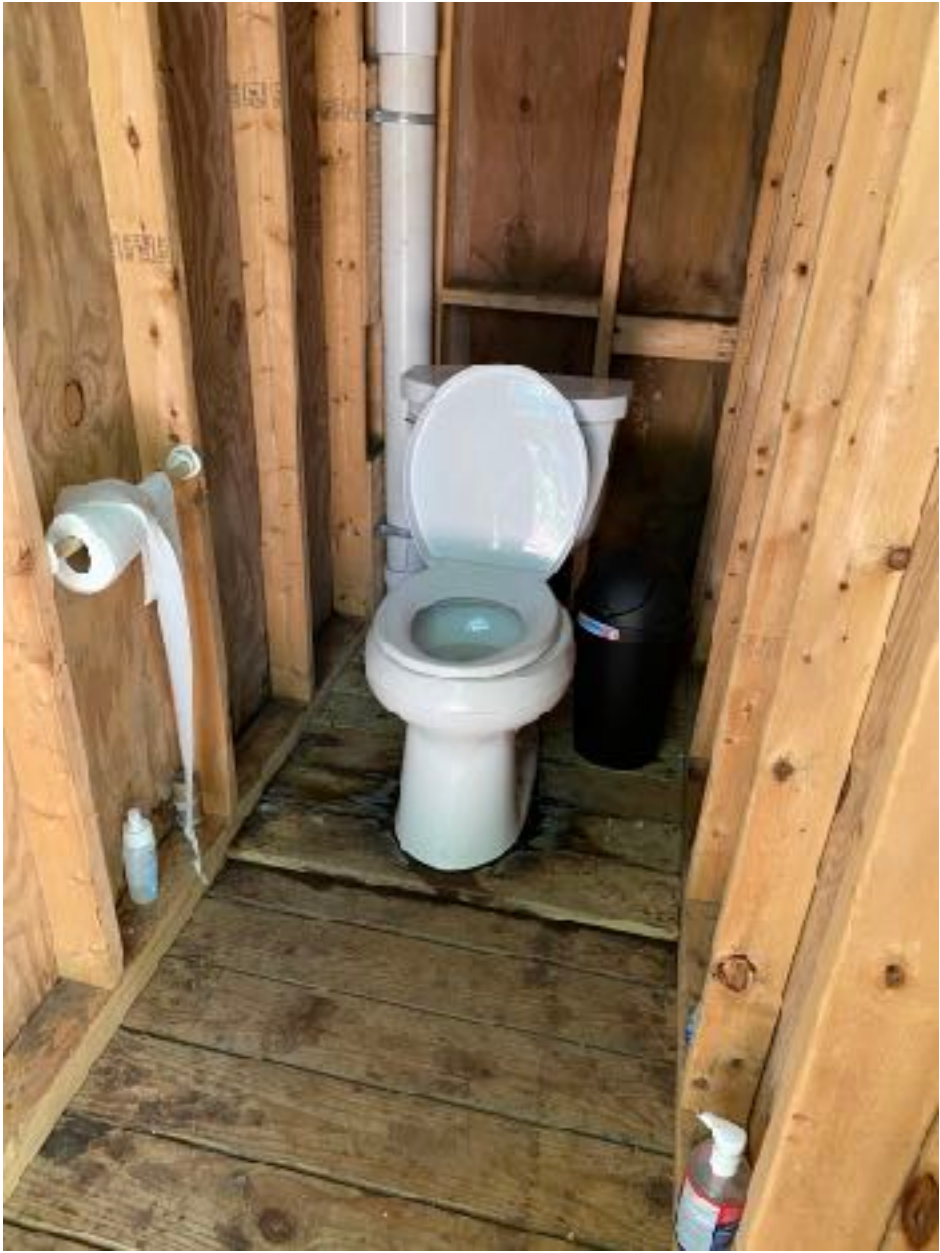
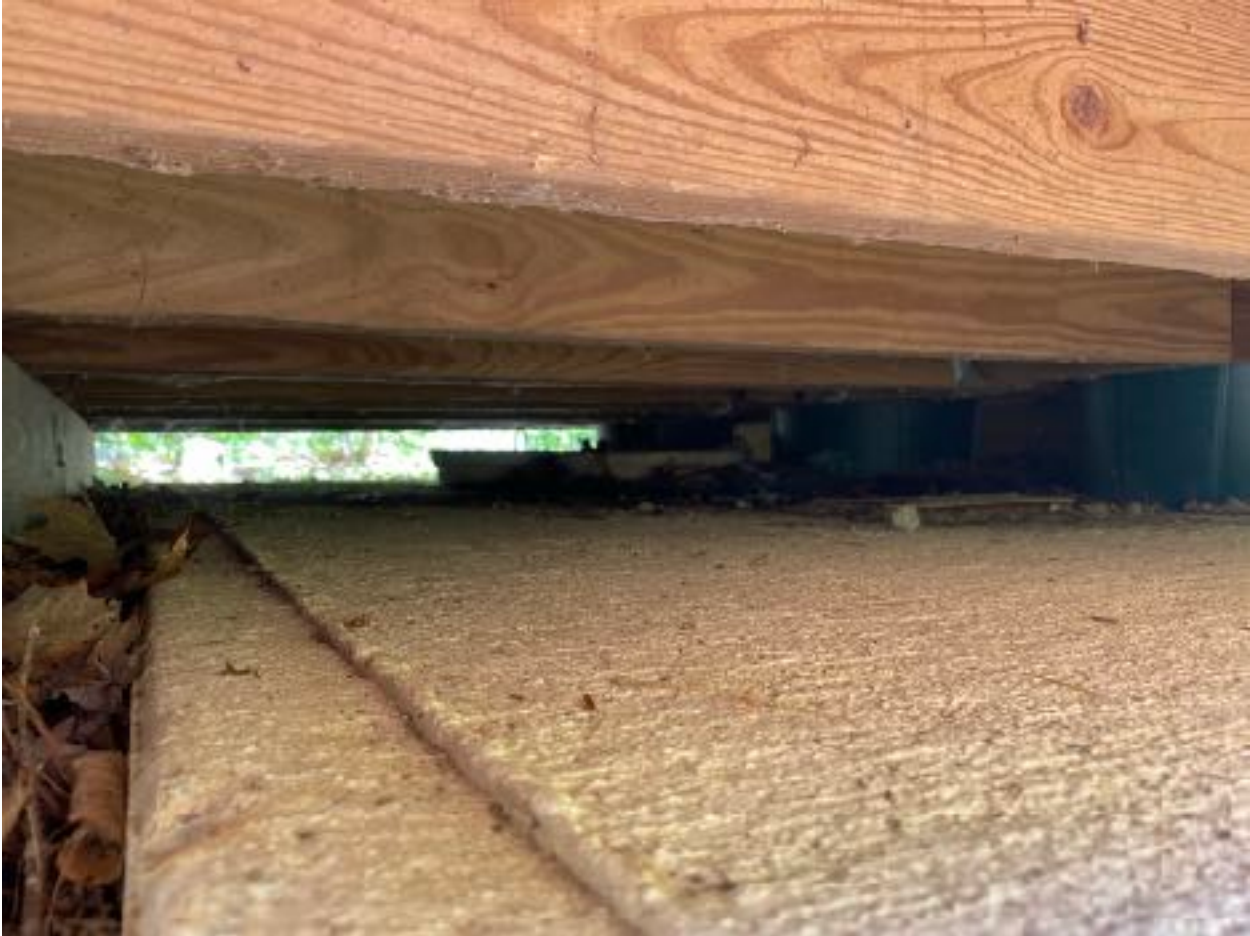
Fig. 18 - Main Area Outhouse

Inspector then moved to a privy-style bathroom facility which was approximately 146' from the nearest food preparation areas (Fig. 18-20). This was a three-stall facility with two pit toilets and one flush toilet. The interior walls were untreated wood. There was adequate toilet tissue and hand sanitizer noted in the area. The stalls did not have self-closing doors nor lids. The tank appeared to be of sealed concrete construction and appeared to be approximately 3/4 full. From records review, the tank size is 1000

gallons. There was no evidence of leakage of the tank around the area. This facility was not located near any visible surface water and was sited more than 200' from the drilled well.

The original toilet facility in the main part of the camp appears to be in good order, but does not appear to be adequately maintained as the pit is nearly full despite reportedly being emptied near the end of the camp session this year. This may be due, in part, to the fact that a flush toilet is operating into the pit. The use of water to remove waste does not comply with the definition of a "privy" and would therefore require a septic system be installed. A temporary holding tank of at least 2000 gallons could be used in place of a septic system, but this is not allowed as a long term solution. Per review of available records, the tank size is 1000 gallons. In addition, while the toilet facility is

appropriately sited away from the food preparation area, there are no self-closing doors or lids that would prevent insects from potentially contaminating nearby areas. It is recommended that the flush toilet be removed from use and that self-closing doors or lids be installed. In order to comply with YRC licensure requirements, the interior walls would need to be treated with paint or other sealant to a height of at least 48" from the floor. It is also recommended that the pit be emptied as soon as possible.

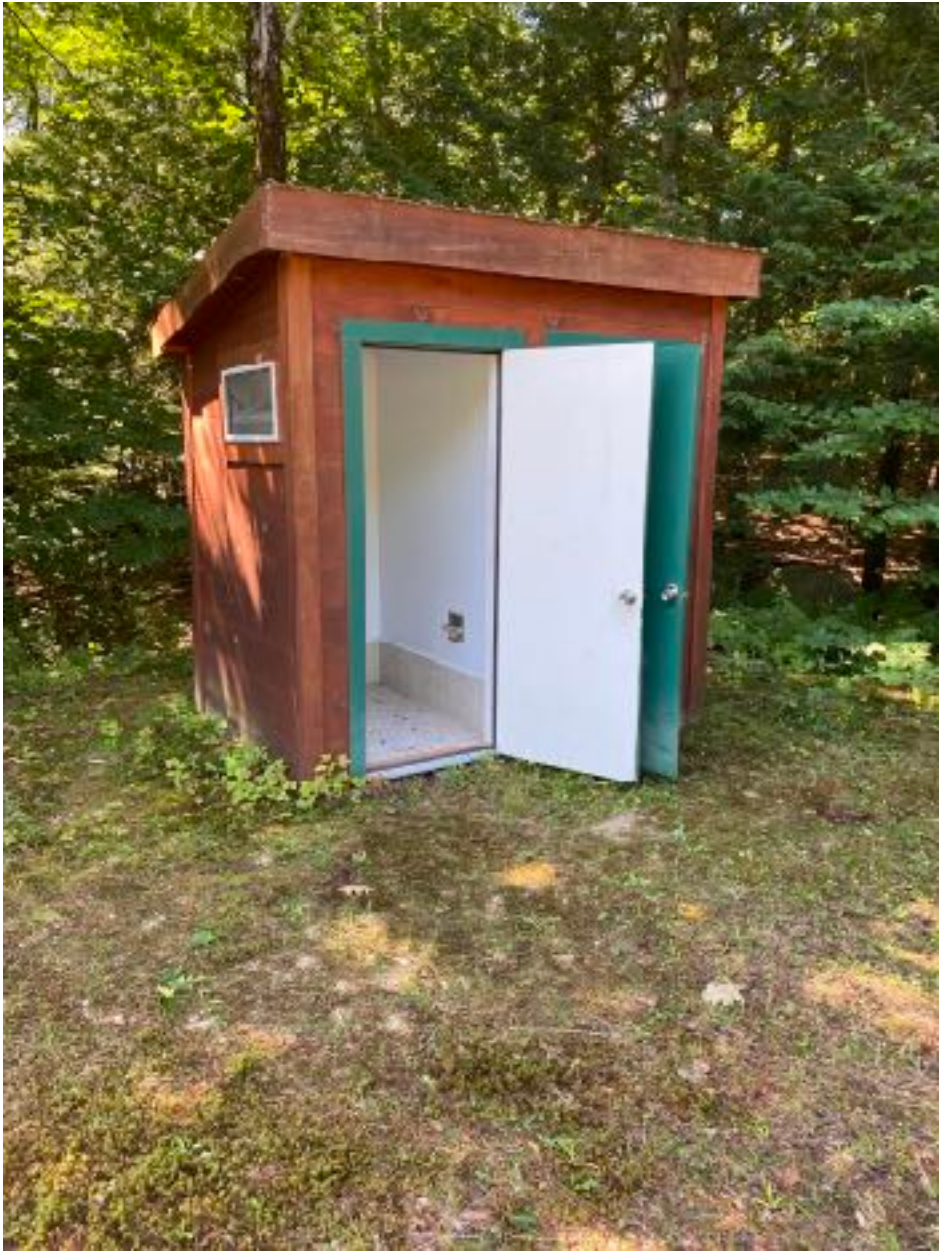
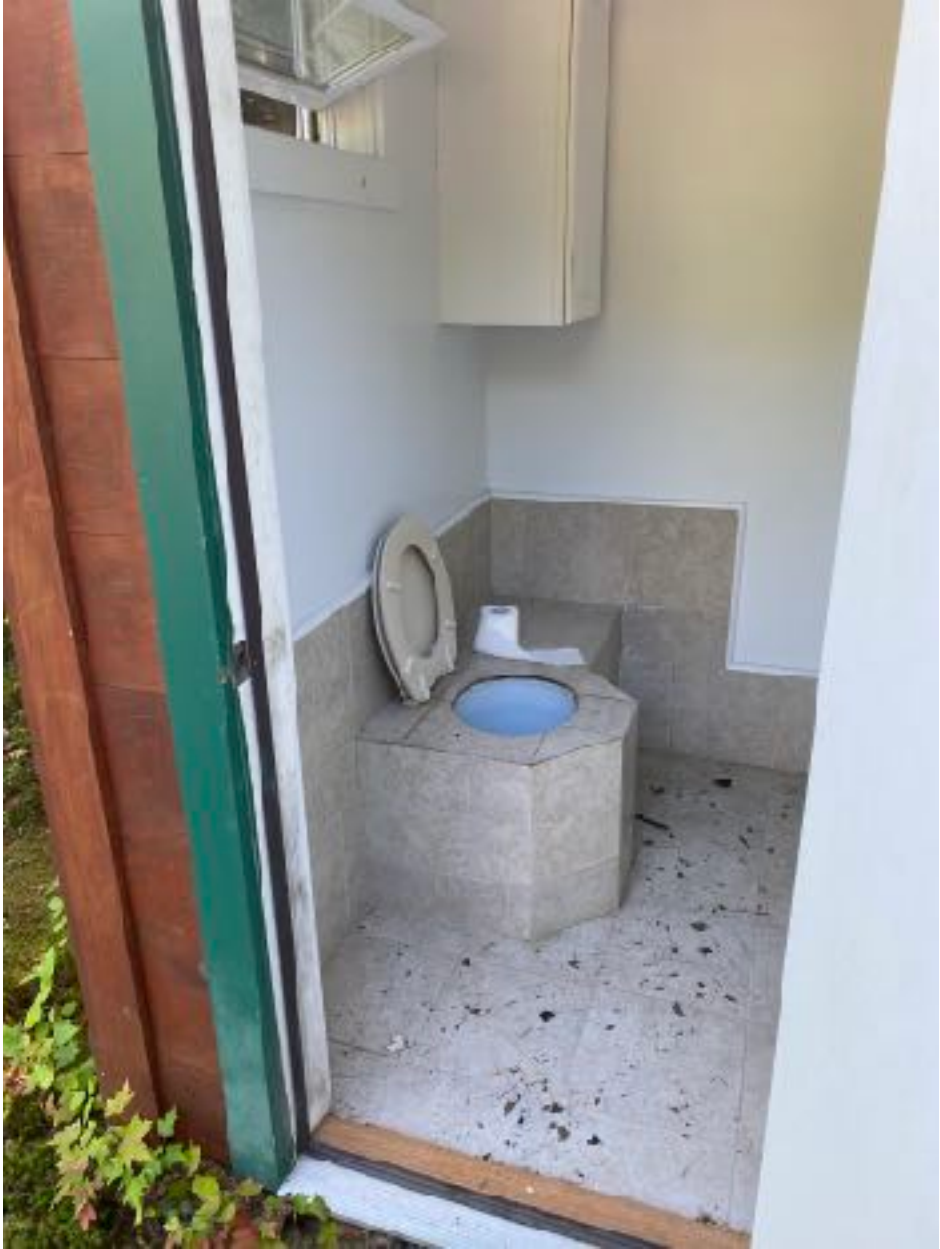
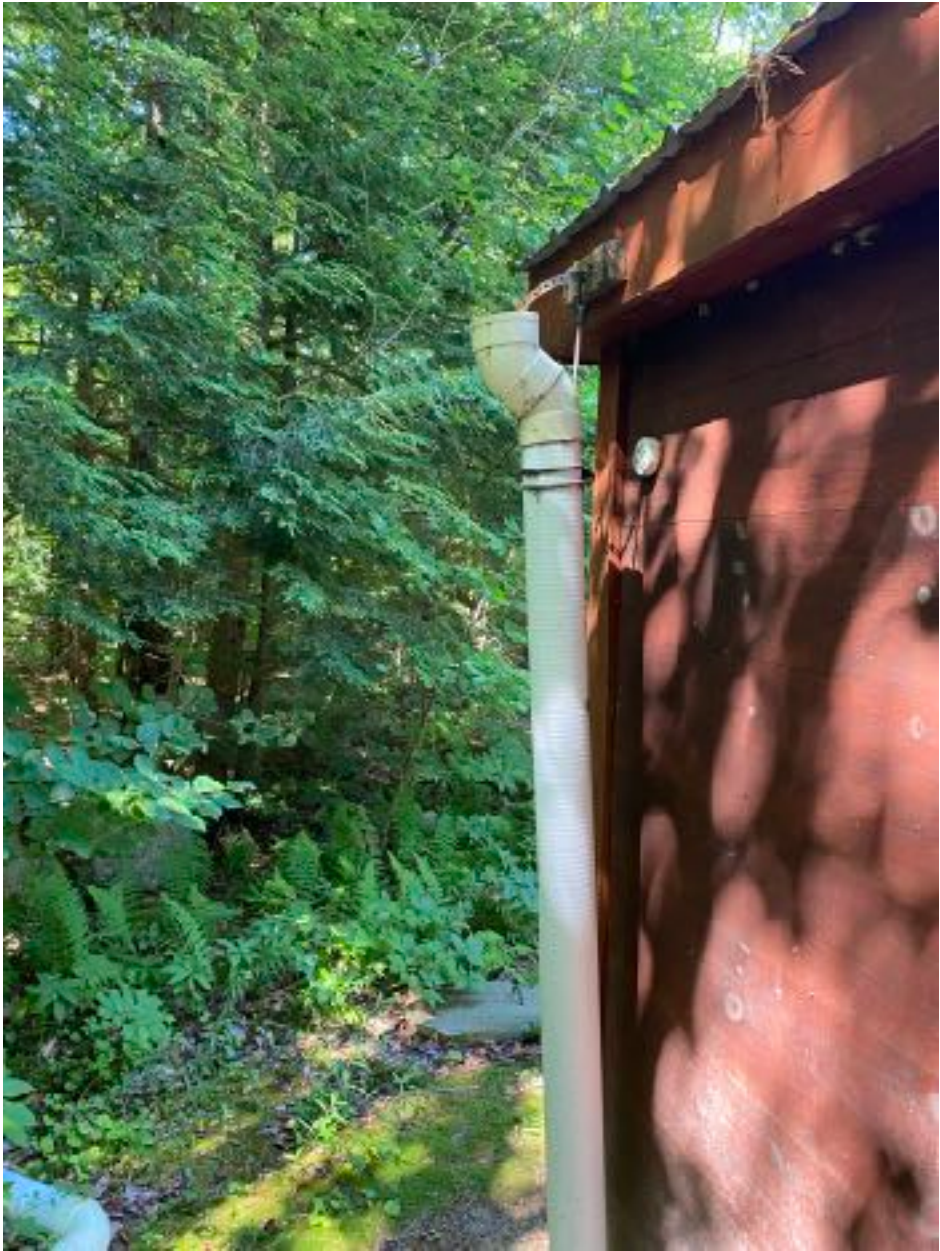
Fig. 21 - Southwest Field Area Outhouse

The bathroom facility at the southwest corner of the field was inspected (Fig. 21-23). This was a two-stall pit toilet type facility. The floors were tiled and the interior walls were painted. There was adequate toilet tissue and hand sanitizer noted. The pit appeared to be of sealed concrete construction and appeared less than half full. The vent pipe on the rear of the building was damaged and did not have a trap in place which appeared to be able to let rainwater into the holding tank. There were not self closing doors or self closing seats noted on the toilets. There was no visible leakage of sewage onto the ground.

The toilet facilities in the upper or field part of the camp do not appear to have appropriate approvals from the Health Officer or Town. Approval for privies from the State is not required. However, they do appear to have sealed vaults and appear to be functioning properly. The toilet facility at the southwest corner of the field does require repair to the vent pipe in order to prevent rainwater from entering the pit. In addition, both toilet facilities in the upper part of the camp should have self-closing doors or toilet lids installed.

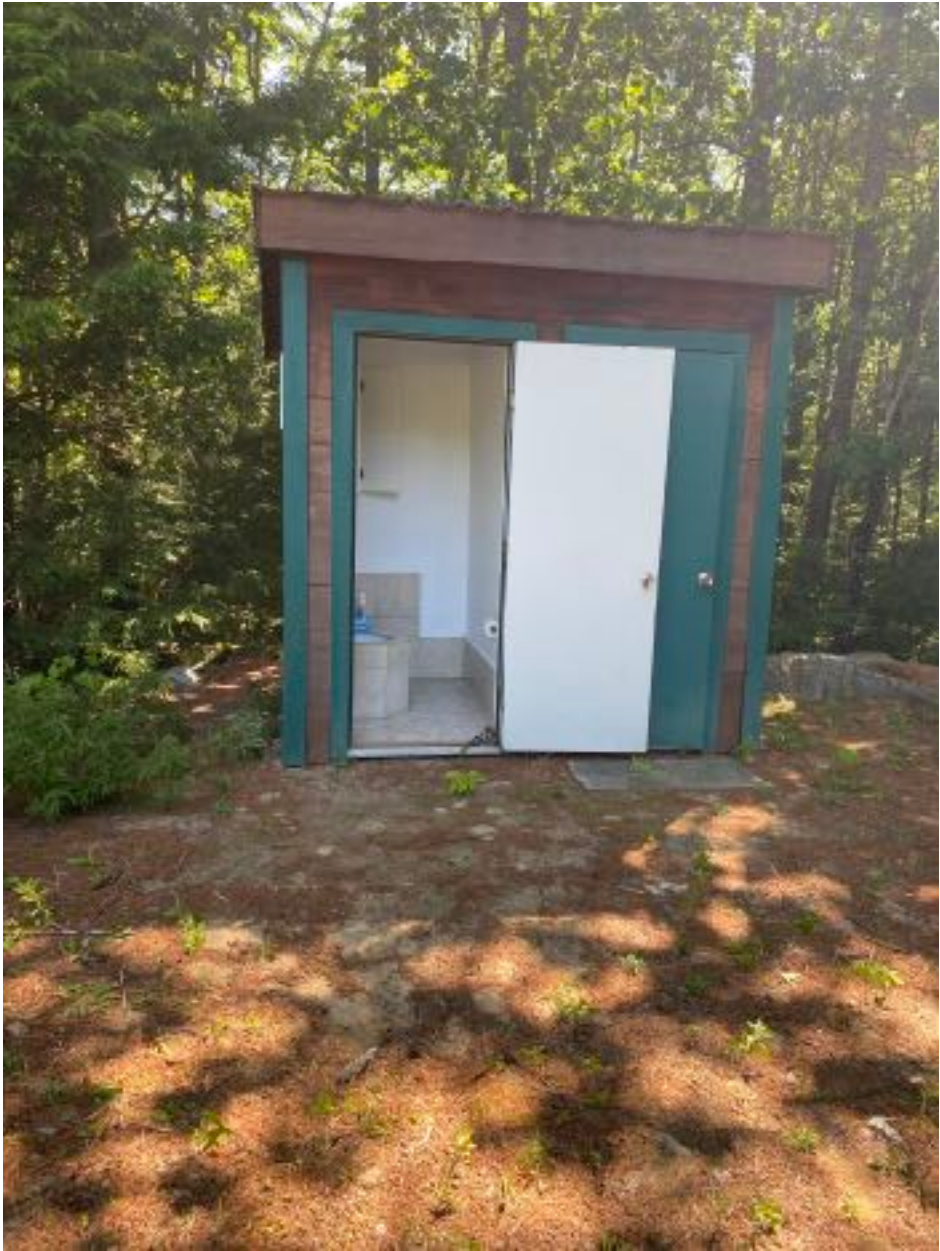
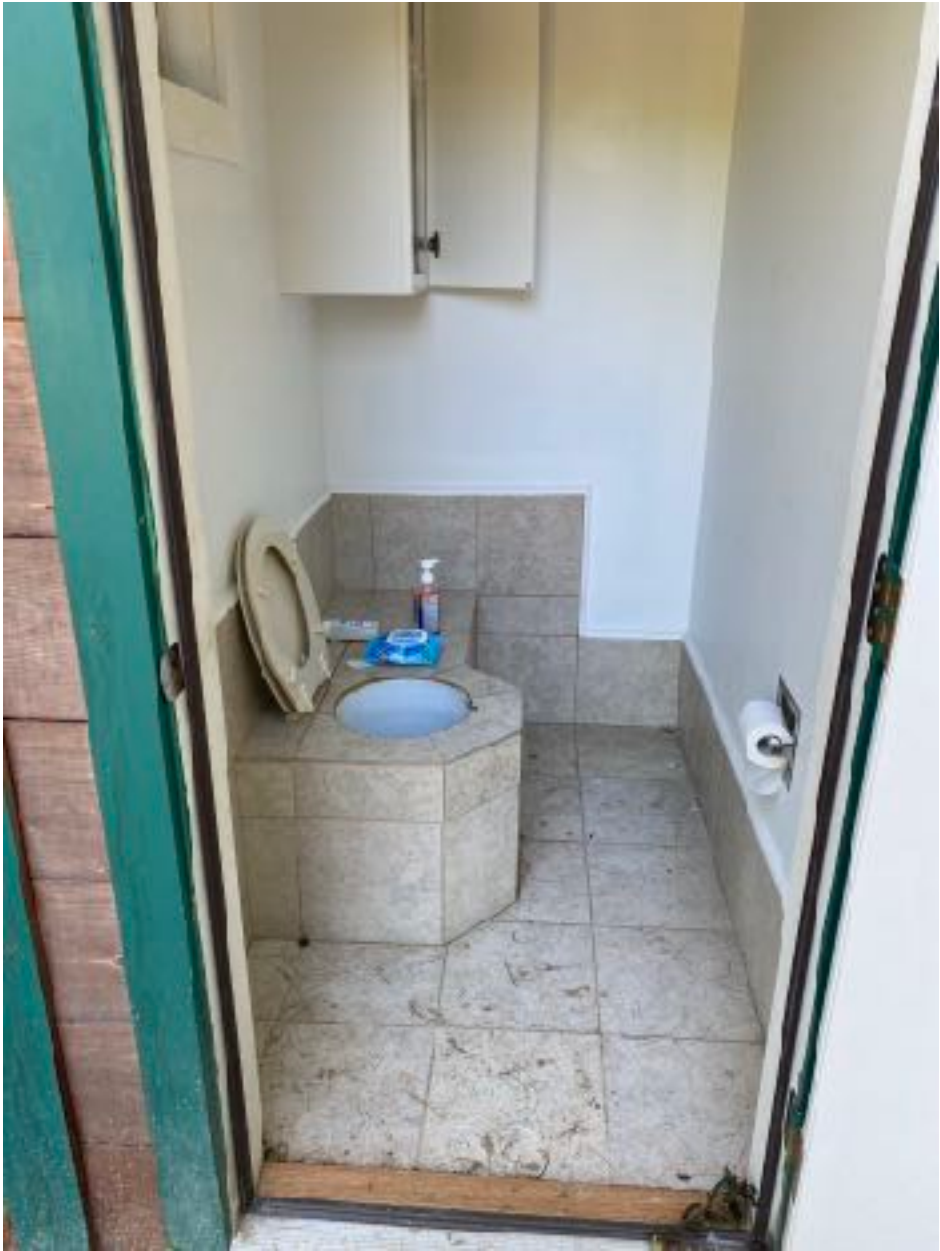
Fig. 24 - Southeast Field Area Outhouse

The bathroom facility at the southeast corner of the field was inspected (Fig. 24-25). This was a two-stall pit toilet type facility. The floors were tiled and the interior walls were painted. There was adequate toilet tissue and hand sanitizer noted. The pit appeared to be of sealed concrete construction and appeared less than half full. There were not self closing doors or self closing seats noted on the toilets. There was no visible leakage of sewage onto the ground.
