# Report of Wastewater Release

183 Whittier Highway, Center Harbor, NH 03226 Date of Release: November 10, 2023 Date of Initial Report: November 24, 2023 Date of First Follow Up: December 7, 2023

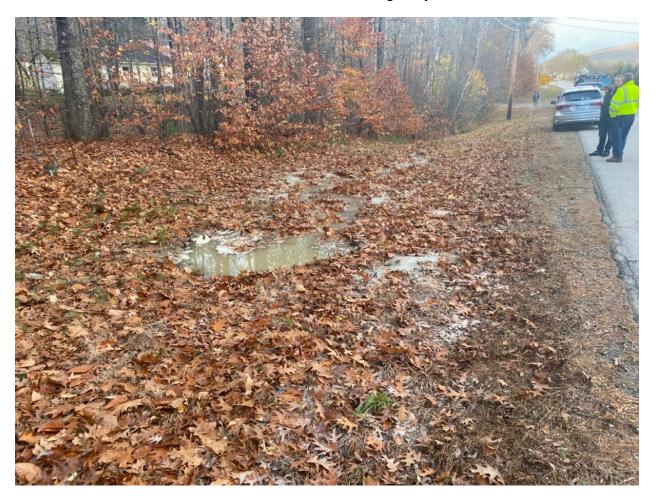
Tyler Driscoll Health Officer Town of Center Harbor Fig. 1 - Clay-colored fluid collecting in and flowing out of an approximately 3 foot diameter hole and downhill in front of 183 Whittier Highway - 11/10/2023

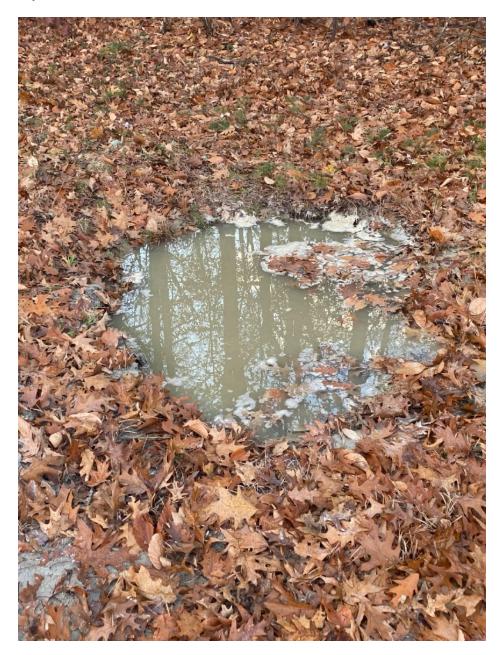
Fig. 2 - Clay-colored fluid collecting in and flowing out of an approximately 3 foot diameter hole in front of 183 Whittier Highway. Additional sediment is noted in an approximately 6 foot diameter area around the hole - 11/10/2023

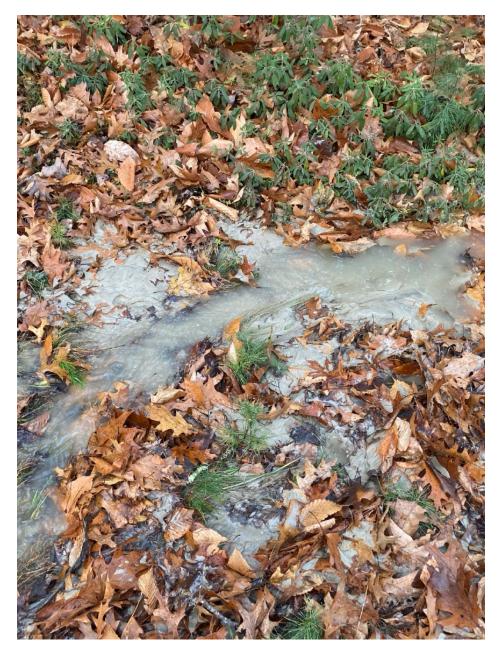
Fig. 3 - Clay-colored fluid moving downhill along Whittier Highway in front of number 183 - 11/10/2023

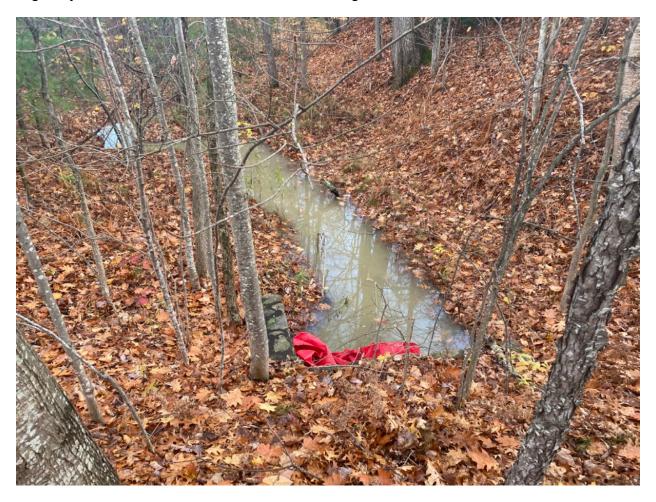
Fig. 4- Clay-colored fluid moving toward culvert under the driveway of 183 Whittier Highway. Culvert has been diked with red salvage cover - 11/10/2023

While the leak appeared to have slowed from its initial rate, actions were taken to mitigate further release. A dike was placed in front of the culvert leading under the driveway at 183 with moderate decrease of wastewater leaving this culvert. Bay District Sewer officials were on site and had requested a vacuum truck to the scene to remove residual wastewater from the diked area as well as the original hole. Once this was completed, all municipal services had left the scene. NHDES had been notified by Bay District Sewer and municipal authorities on scene.

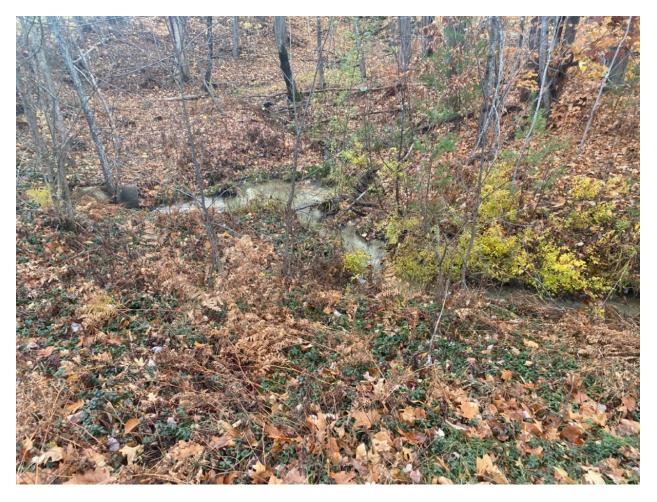
Fig. 5 - Clay-colored fluid moving through culvert under the driveway of 183 Whittier Highway (left side of image) - 11/10/2023

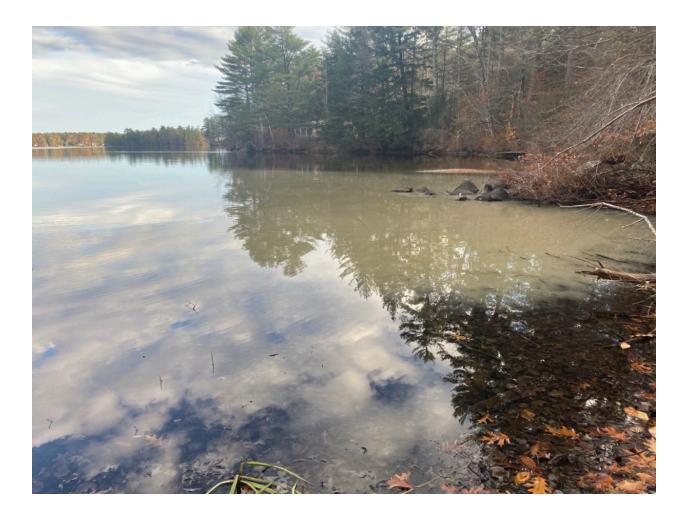
Fig. 8 - Clay-colored plume noted in water of Lake Winnipesaukee south of Hog Island - 11/10/2023

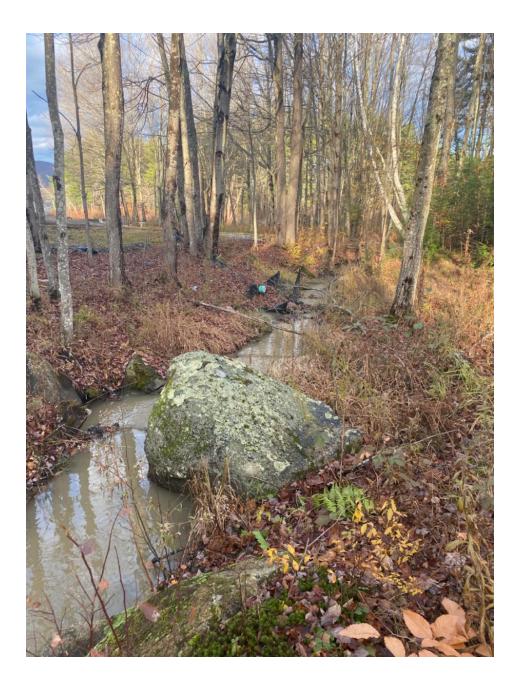
Fig. 9 - Clay-colored fluid flowing in brook just south of 196 Whittier Highway - 11/10/2023

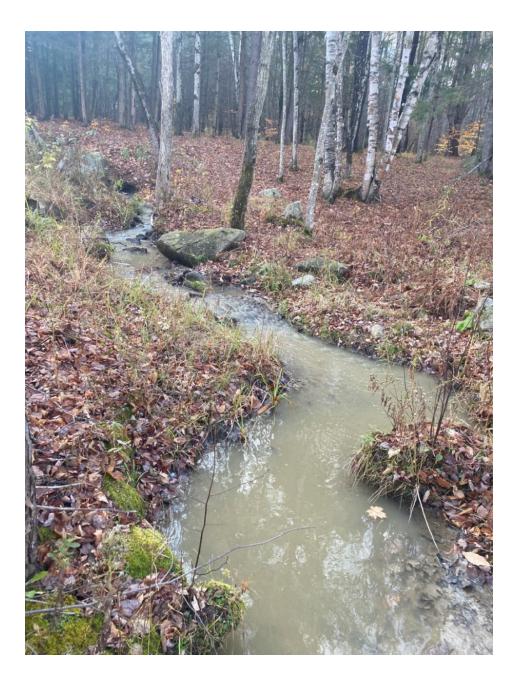
Fig. 10 - Clay-colored fluid flowing in brook just south of 196 Whittier Highway - 11/10/2023

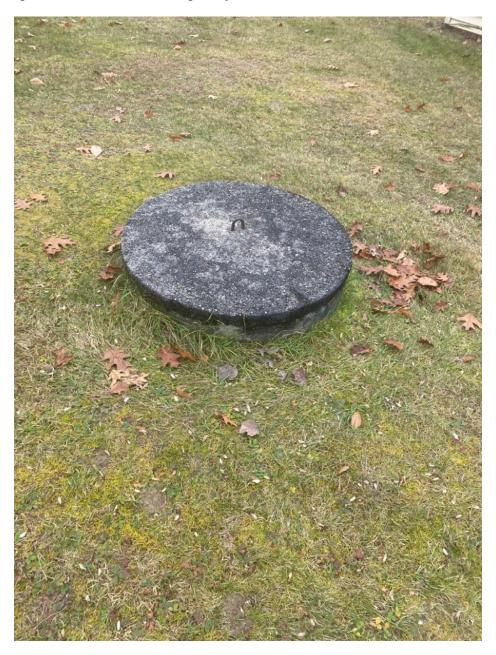
At 183 Whittier Highway, an 18 foot deep dug well was noted. This was uphill from the area of the brook which had contained the release at a distance of 175 feet. The amount of elevation from the stream bed to the top of the well was estimated at 30 feet. This residence was occupied and the occupant was advised of the investigation. Occupant was advised that there was no recommendation for testing of the well, but that she could obtain additional testing if so desired and that any illness should be reported to the Health Officer.

Fig 11. - Dug well at 183 Whittier Highway - 11/17/2023

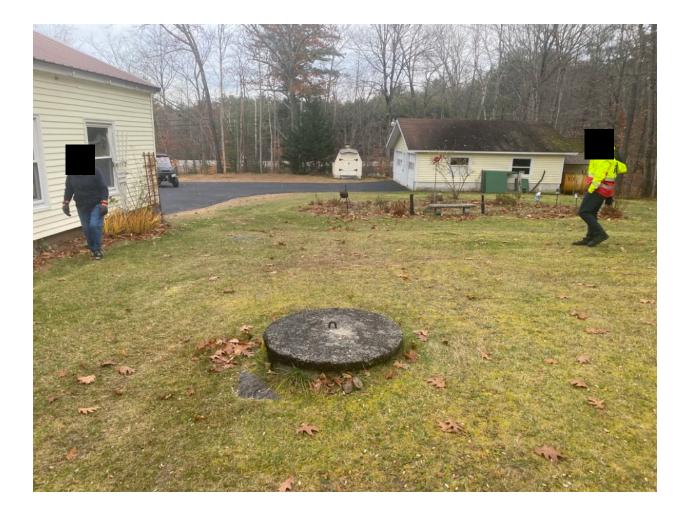
# Fig. 12 - Dug well at 183 Whittier Highway - 11/17/2023

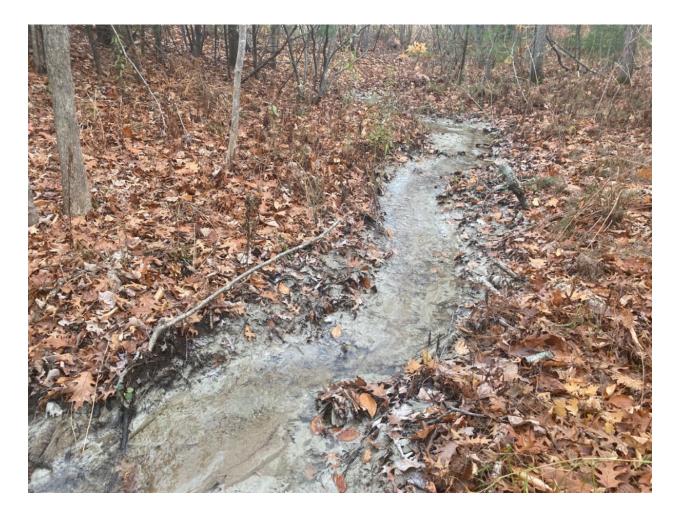
The release site was re-evaluated and found to have been repaired with soil in place as well as sediment-containing booms. There was no residual leak or sewage odor noted. The nearby stream bed was still noted to have clay colored sediment at its bottom, but the water was clear and no sewage odor was noted. This was the case for the entire course of the brook to the lake.

Fig. 13 - Stream bed in front of 183 Whittier Highway - 11/17/2023

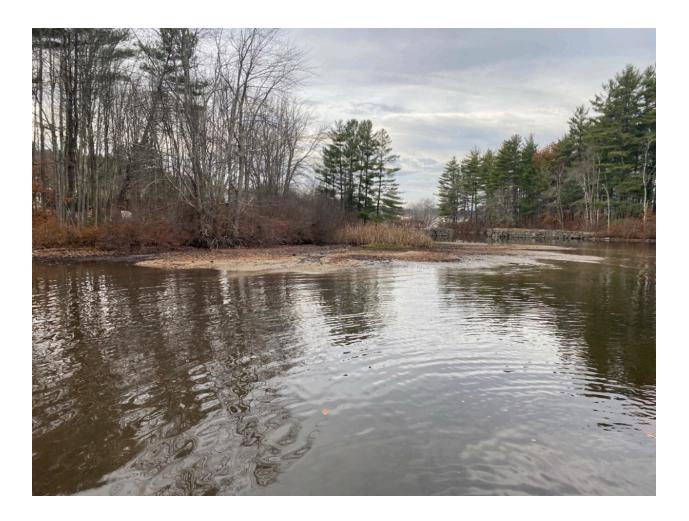
Attention was then turned to the lake itself. Inspection was performed both from the shore and by boat. The cloudy plume in the lake noted on the day of release had cleared, and no odor was noted around the area. There was no evidence of harmed plant or animal life in the area. While exiting the area by boat, it was noted that there was a moderate current moving from the area of release into the lake towards the town beach passing through the two stone piers of an old bridge between the mainland and Hog Island from south to north. The town beach is noted to be approximately 2,300 feet north-northwest of the location of release into Lake Winnipesaukee.

Fig. 24 - Release site into Lake Winnipesaukee. Water is clear - 11/17/2023

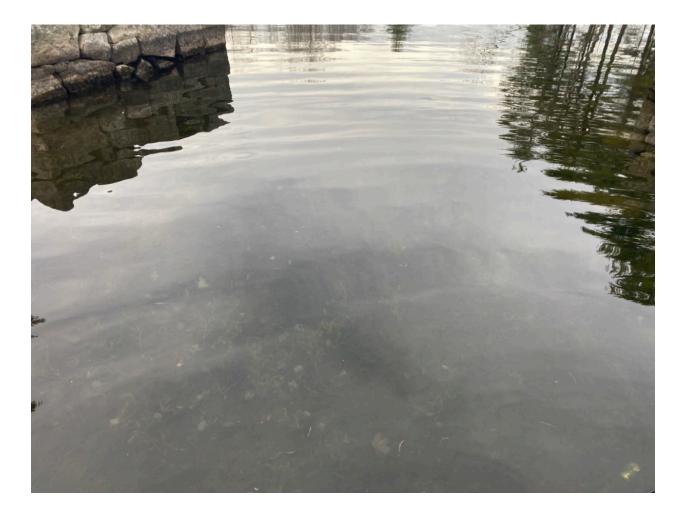
Fig. 26 - Stone piers with gap leading north away from the release site towards the Center Harbor Town Beach. Water is approximately 2-3' deep passing through this gap with prevailing current moving south to north. - 11/17/2023

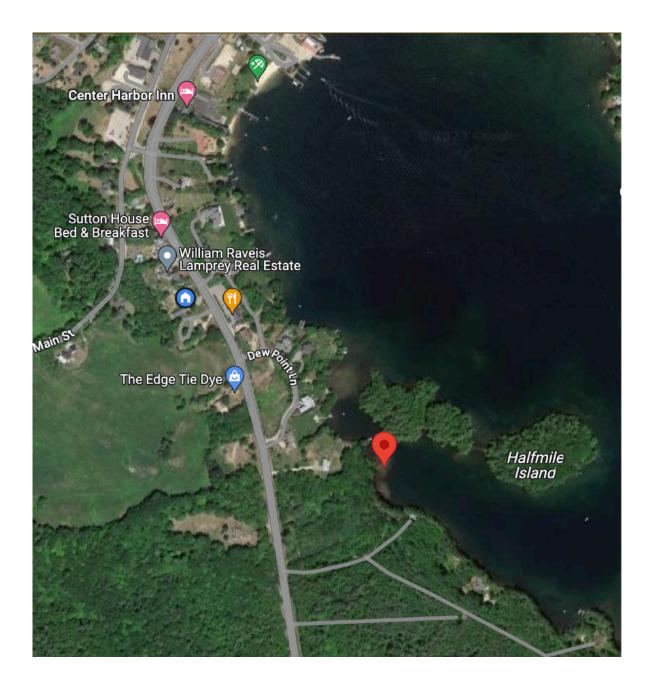
Fig. 27 - Overhead view of release site into Lake Winnipesaukee located at 43°42'06.2"N 71°27'29.8"W. Center Harbor Town Beach is 2,300 feet north-northwest of the indicated location.
