CHRISTOPHER P. WILLIAMS ARCHITECTS, PLLC
PO Box 703 · Meredith, New Hampshire 03253 · 603-279-6513

Historic Building Assessment and Feasibility Study

Center Harbor Town House

March 31, 2016
Revised - May 18, 2016

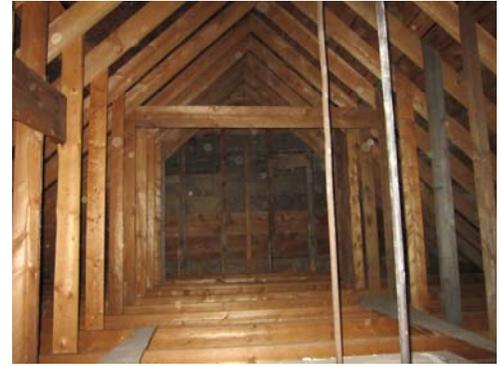
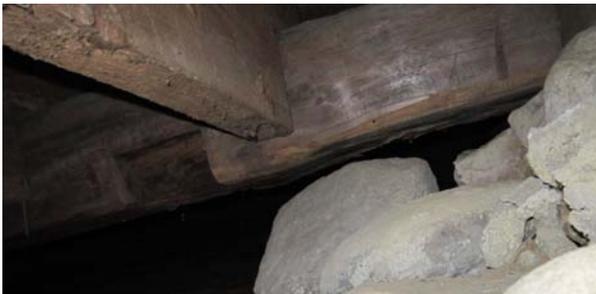
The building frame of the Center Harbor Town House is almost entirely of sawn common softwood with 4" deep balloon-framed exterior walls and a roof assembly of 2" x 7" rafters overlain with board sheathing. The floor frame of the original Town House is composed of recycled hewn timber sills and floor girts across the short dimension of the building at approximate 10' intervals. The floor beams support 1 ¼"x 10 ¼" wood floor joists and bear intermittently on piles of large, loose stones. The specific condition of the floor frame was difficult to evaluate because the crawlspace was inaccessible, but what could be seen seemed in sound condition and the floor feels firm for a building of this age and limited recent use. Structural review by the structural engineer concludes that the joists are appropriately sized but the heavy

notching at their ends make them unacceptably susceptible to splitting. The timbers were determined to be the weak link in the floor system and are only sized to support about half of the 100 lb/s.f. loads required by the NH state building code. The proximity of the floor frame to soil in the shallow crawl space is a cause for concern and the floor frame may be deteriorated from long term exposure to unacceptably high moisture conditions

All of the building's timber sills should be inspected at the time of siding repair and replaced if damaged by insects or rot. At the first floor platform level, the floor joists should be re-supported with a continuous ledger or joist hangers to eliminate structural overstrain on the notched joist ends. The hewn timber beams supporting these joists could be seen at a distance during the inspection. Recommendations for improving their performance up to code standards is discussed in the section following on Foundations. With no way to get into the crawl space, a thorough exam of of the condition of the frame was impossible. The proximity of the exposed soil to the frame members is a cause for concern related to high moisture levels. Elements of the framing should be inspected and any materials damage by moisture or rot should be replaced.

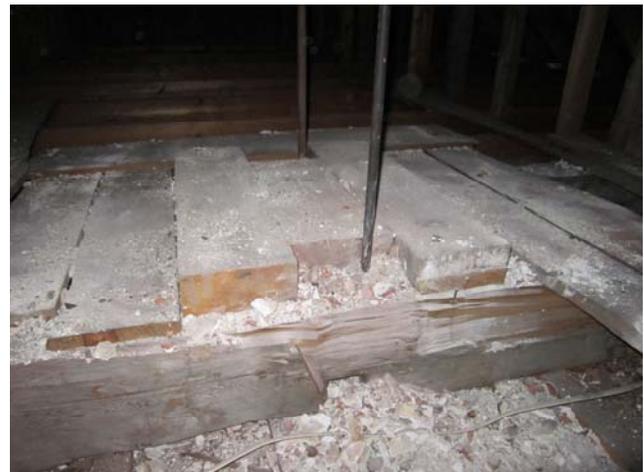
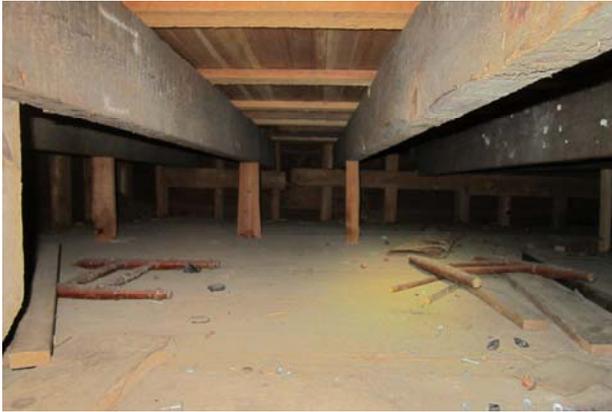
The light roof framing appears in sound and dry condition with limited instances of localized splitting. It was noted that the roof rafters tie to each other in pairs at the ridge with no ridge board and that there are only tow collar ties in the attic. The roof framing also supports the original flat plaster ceiling and a newer acoustical tile ceiling with 1x wood boards side nailed into the rafters and attic joists at their 1/3 points. A curiosity in the attic is a pair of heavy hewn timbers spanning across the middle of the main hall which until recently supported a brick chimney. A makeshift truss and reinforcing iron bars were installed apparently after the original chimney construction as a hole in the original plaster ceiling that allowed for the passage of the stove pipe seems awkwardly placed with the steel tie between it and the chimney location. The chimney itself has been removed and there is no way draw a conclusion about the actual location of the original (or later) stovepipes. An engineering analysis shows the roof is undersized for the snow loads it must carry by code, but the steeply pitched roof has seemingly performed acceptably to date.

The stage and privy addition to the rear of the building are later additions to the Center Harbor Town House. The stage platform is made of recycled vertically sawn 2x10s that clearspan from the original rear wall to a recycled sawn beam at the stage front. The beam and many of the joists are supported intermittently with short wood pieces standing on the original floor. The engineer identifies the limited support of the stage floor without regard to the main level framing as a cause for concern. The small privy seems square and well-built but no evaluation was made of its inaccessible frame.

Wall framing and roof framing in place is generally in good condition. The structural engineer has determined that the roof framing would generally be capable of carrying code required snow loads with the addition of collar ties and gusset plates in the main block. 2x6 collar ties should be installed across rafter pairs in the attic connecting to the rafters just above the vertical ties supporting the ceiling. Plywood gusset plates should be cut to match the roof profile and face nailed to the rafters where they meet at the ridge. In the wood shed addition, new 2x8 attic joists should be installed at the tops of walls to prevent roof spreading.

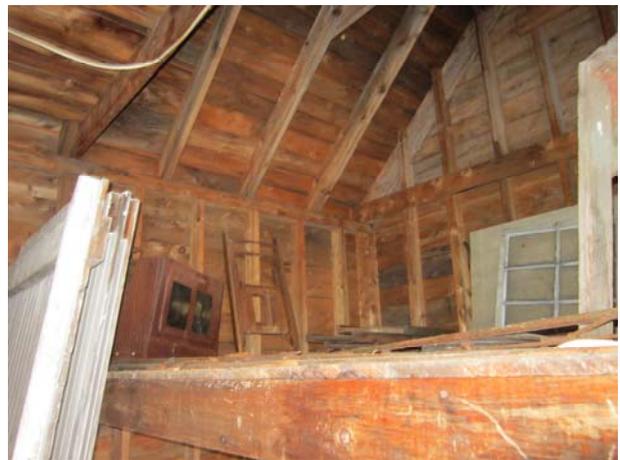
The woodshed addition is constructed of light balloon framing in a slightly different manner than original Town House. 2x4 wood framed walls stand directly on the stone foundation instead of on a wood platform. Two independent wood floor systems are framed with 2x floor joists spanning east to west across ledger boards on the north and south walls. On the south side, a floor aligns with the stage floor and an attic floor bears on the walls top plates above. On the north side, a floor is installed about half-way between these levels. The roof of the woodshed is framed with 2"x7" roof rafters with a 2x ridge board and few collar ties, all in sound condition. This roof is also calculated to be undersized to meet current code requirements for loading and shear stresses.

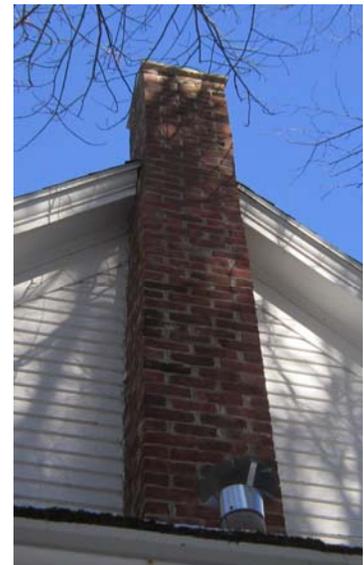
Only one chimney remains of the two previously extant in the Center Harbor Town House. The one-flue chimney of brick masonry appears to have been previously repointed with fair results. A small stone cap adorns the chimney top and there is no interior sign of water leakage, though the chimney itself is completely hidden within the building. Built to serve the woodstove in the main hall, the chimney may not be lined as would be required to be able to continue its original purpose.

The original chimney stood on the roof frame at the center of the main block and a woodstove here tied into the chimney above the ceiling line. Chimneys are often a source for moisture infiltration through a building's envelope and demolition of the abandoned chimney above the roof occurred prior to the last re-roofing. The remaining portion was removed very recently. A large quantity of stone materials in the crawlspace at the center of the building might once have composed an

While it appears from the ground that the existing chimney has been previously repointed, the pointing work appears to have over-filled the masonry joints or been trying to repair spalled bricks with mortar. The work in place should be inspected for new cracking or spalling and any problems found repaired appropriately.

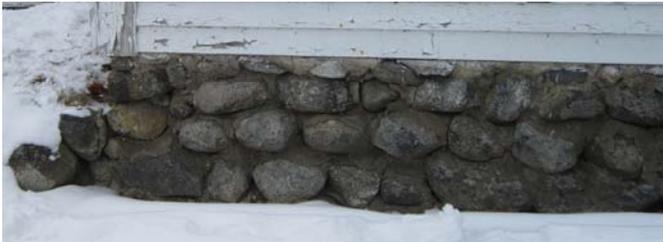
The foundation of the Center Harbor Town House is entirely composed of small to medium fieldstone likely laid to a depth of less than three feet below grade. All of the stonework is in fair to good condition. The stones of the main block were originally dry laid but these walls were later pointed with mortar at the exterior side only, likely because of the inaccessibility of the

The engineer has commented that replacing the building's fieldstone foundation with a new reinforced concrete foundation would be a very expensive approach to bring the building's foundation up to the requirements of a new building. Because the existing foundation appears stable, he does not recommend any substantial upgrades to the existing foundation. This outlook is completely in line with preservation Standards for Rehabilitation, which would seek to maintain the fieldstone foundation, a Character Defining Feature of the Center Harbor Townhouse. An area of the stonework at the northeast corner should be rebuilt to properly support the corner of the the frame. Adding two feet of rigid insulation buried below grade at a 45 degree angle could help to protect the likely shallow footings against the kind of frost action that has affected this small portion of wall. The rest of the exterior walls should be inspected and open mortar joints re-pointed. Any openings in the walls large enough to allow animal entry to the building should be completely filled.

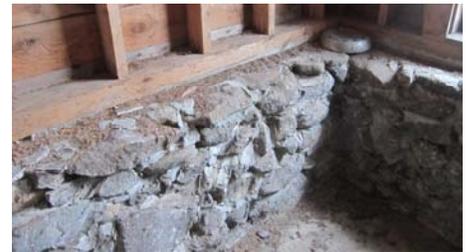
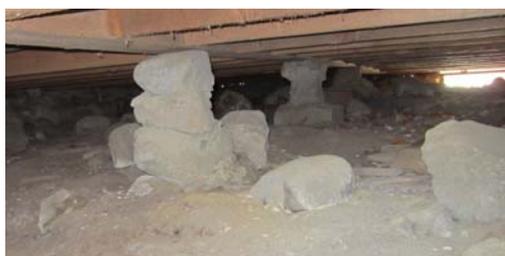
crawl space. The foundation of the wood shed addition was constructed with full bed mortar setting and is in good condition and as seen from both sides. Foundations of fieldstone are prone to moving under frost action, but there is only limited evidence of such movement here, predominantly found in the north foundation wall of the main block near to the east building corner. Interior plaster damage at each side of the south facing bank of windows in the meeting hall indicate some additional foundation movement at these locations along the bearing wall. The privy foundation seems similarly constructed to the woodshed wall, but this foundation is only minimally exposed and visible only from the exterior.

The piers at the interior of the crawlspace were also inaccessible, but observation from the locations of the limited vent spaces in the perimeter foundations reveal that these are the weakest components in the foundation system. These piers serve to support the beam floor beams that span north to south across the crawlspace and are typically composed of two or three stones stacked together. Because there are no footings for these piers below grade, they are the most subject

to movement under frost conditions. Some are raising the floor beams higher than necessary and introducing curvature to the floor above, and others fail to even support the beams at all, leaving air gaps under their intended bearing points. Four vents into the crawlspace are provided with fixed louvers, removal of which does not allow an adult to enter the crawlspace. No standing water was observed in the crawl space, though the proximity of soils to the building floor frame is a concern. Grades around the building appear to pitch more than the minimum of 3" in six feet that would be desirable.

At the foundation level, there are significant additional challenges with the building structure that need to be addressed: moisture in the crawl space and frost action under the building's central piers. The following recommendations should greatly improve the building's current moisture problems. In the crawl spaces, all soil within 18" of the wood frame should be removed by hand (8" +/-). A vapor barrier should be installed over the dirt floor of the crawlspace, taking care to allow for a wide overlap and taping of all vapor barrier components under all structural work. Once the ground is covered, vents in the foundation should be rebuilt to allow them to be opened in the late spring and early fall and closed in the remaining seasons.

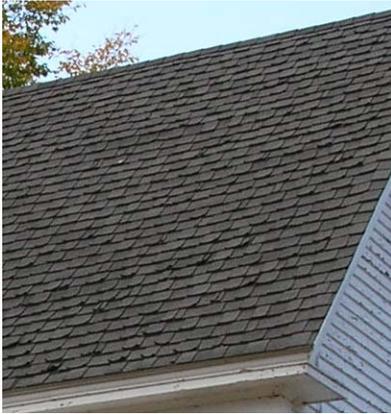
The roof of the building was inspected from the ground and through photographs as it was covered with snow during the season of this investigation. The architectural asphaltic shingle roof is reportedly fifteen years old and is showing signs of localized curling with no failures of performance noted at the interior. The patch made where the chimney was removed is well done and not readily observable from the ground. The type of roofing installed is capable of providing good protection for an extended period of time, but can be affected by building movement, wind damage, and poor installation techniques. The cupping of the shingles is concerning and should be watched carefully.

Keeping water out of any historic structure like the Center Harbor Town House is always a high priority and it seems like the architectural asphalt shingle roof has been doing that job well. Excessive curling of the roof shingles may be indicative of premature failure of the roofing system. The main roof and those of the additions should be inspected by a qualified roofer and any damaged materials replaced. Extra attention should be paid to the likely locations of failure around roof penetrations (like the chimney), the valleys, and any areas of previous repair such as where the central chimney was previously removed. The roof's ridges, eaves and any horizontal joints should also be reviewed.

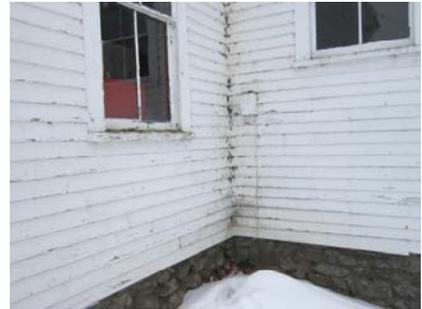
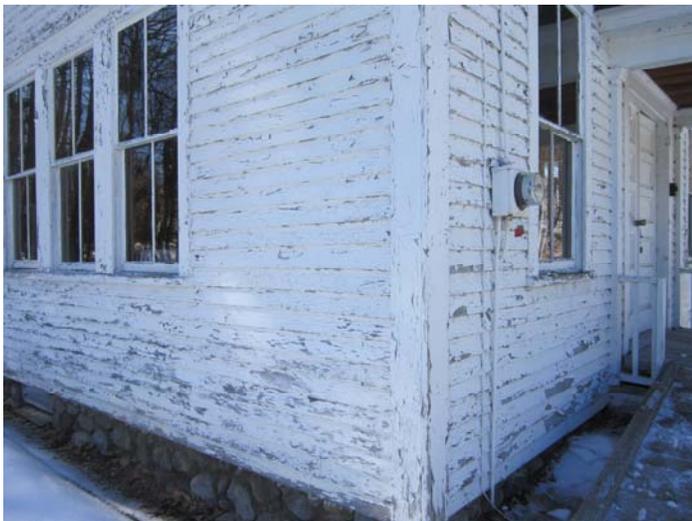
The clapboard siding on the building is generally in poor to fair condition with the greatest degree of deterioration at the interior corner where the woodshed meets the original structure. Additional damage to the clapboard finish is concentrated at areas near the lower portions of the walls where splashback from roof stormwater repeatedly wets the wood. Additional damaged materials may be found with additional inspection in areas where roofs and the chimney meet sidewalls of the west side of the original structure. Inspection from the ground did not reveal problems in these areas.

The paint finish on the exterior is in poor to extremely poor condition, with paint failure a primary concern on the north, east, and south elevations of the main block and woodshed addition. The west façade is in better condition with fewer complete paint failures. At large areas of the clapboard siding and trim, paint is heavily peeling with substantial areas of bare wood visible. Paint is peeling off in large flakes and falling on the soils around the building, a concern because all paint applied prior to the mid-1970s is likely to contain lead, a known hazardous material with special state and federal handling requirements.

It is preferable to retain existing siding material and remove damaged paint finishes than to replace the siding wherever possible. On all areas of the north, east, and south elevations of the building where paint is peeling to bare wood, remove all remaining existing paint by hand and apply a quality latex primer and two coats of finish paint. On the west side, where the existing paint condition is better, painting preparation should be as appropriate for localized conditions. Painting in fair to good condition should be lightly sanded to assure that new paint binds adequately to the

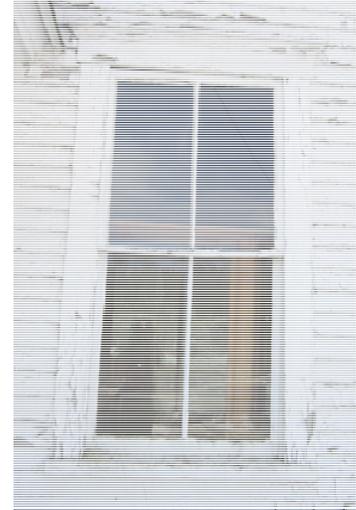
Paint on doors and windows is in mixed condition, generally similar to that of the clapboard finishes on the same facades. The window glass in the window at the rear of the stage north of the privies has been broken and temporarily secured with a plywood cover on the exterior. The paint on the double entry doors and trim is in fair condition as these doors are protected from the weather by the porch roof. Paint on the lower panels is in worse condition and has started to peel at the left side.

Paint finishes on the Center Harbor Townhouse should be undertaken with care appropriate to specific conditions identified elsewhere in this report. The age of the building indicates a very high likelihood of lead paint being a part of the failing paint and appropriate steps should be taken in the removal of lead paint according to state and federal standards. All trim and decorative wood on the Town House should be retained, as should the wooden windows and doors. Heavily damaged wood should be repaired with an epoxy consolidant after paint removal and before repainting. Window sash should be removed and refurbished, not replaced, and the window at the west (back) side of the stage should be reglazed. The exterior doors with missing panels should be fitted with new panels to match the original intent. The entry door with the cracked or split bottom panel should be repaired.

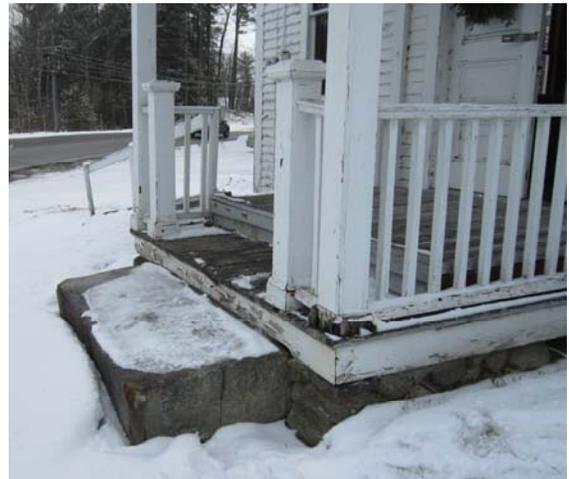
The floor of the entry porch and the bottoms of the decorative posts that support it the porch roof are suffering from structural deterioration as well as finish failures. The shallow porch frame is even closer to the soils beneath than is the floor of the main block to the crawlspace dirt and is therefore exposed to even higher levels of continuous moisture. Compounding that, the porch floor is laid to allow water through the porch floor deck, but the space below the porch is closed in at the porch perimeter with stonework. The addition of the ad-hoc handicapped accessible ramp over the top of the porch floor all conspire to allow moisture into the cavity beneath the porch and then trap it there without adequate ventilation of the space to allow for drying. The porch floor is deteriorating and crushing where it bears on the corner stones and elsewhere. The column bases and lower portions of the railings are suffering from rot as well as paint failures.

The closed stonework under the entry porch has likely contributed to the deterioration of the porch frame. These walls should be removed and replaced with deep concrete cast footings and single stone blocks above grade to support the corner posts. Once the porch floor has been reconstructed, the stone step should be re-set on an 8" minimum bed of 1 ½" stone to a level 7" below the porch floor.

It appears that the entry porch floor and the porch's corner columns require rebuilding because of water damage. The existing molded railings, balusters, and post trim should be carefully removed and set aside. The porch roof assembly is in good condition and should be supported in place while the existing ramp, the water damaged porch floor, and the porch frame are replaced. Use pressure treated pine with painted pine trim for the the porch floor and vertical grain douglas fir with a clear finish for the flooring. Coordinate foundation work described elsewhere in this report to be done in conjunction with the porch repair. Damage to the corner posts may be limited to the decorative base moldings only or may include damage to the structural post as well. To the highest degree possible, retain or reinstall original post materials. Once the posts are secure, fabricate additional materials to rebuild the railings to match the original intent. Regrade across the front of the building to provide good access to the reset stone step at the front of the porch.

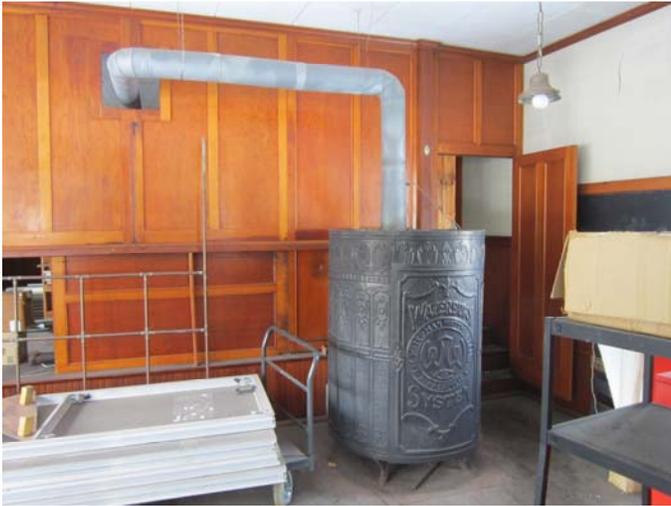
The existing building is furnished with a 1930's vintage Waterman-Waterbury wood stove wrapped in an enormous metal heat shield. While attractive to look at, this stove was reportedly finicky to use even when it was new and is inadequate to meet the heating needs of a modern structure without a major servicing and a dedicated individual to keep it running well. Combustion air is provided to the stove through an intake vent under the window in the west wall behind the stage and through ductwork under the stage. A single-walled stove pipe is intended to carry waste gasses to the chimney at the privies with a horizontal stove pipe two feet or so below the ceiling.

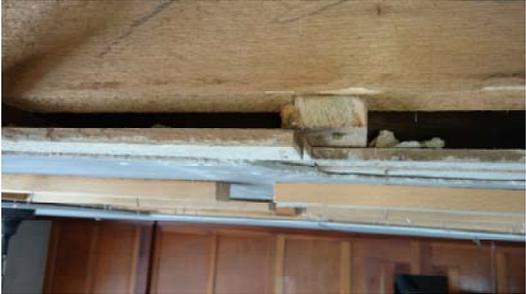
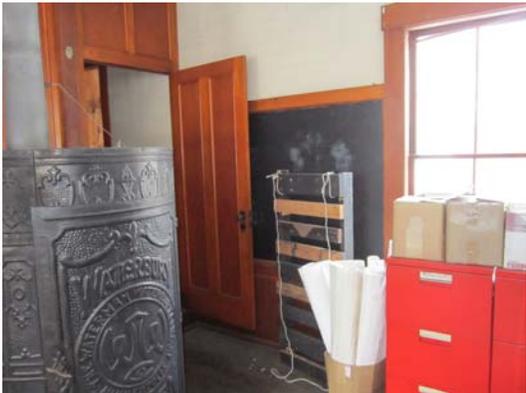
unknown date. This new ceiling was significantly damaged during the recent demolition of the chimney above the ceiling, resulting in an open hole into the attic. The acoustic ceiling is installed on strapping attached to the face of the original ceiling plaster, the condition of which is unknown. Plaster ceiling failure is often an issue in buildings subject to movement on stone foundations and the new ceiling may cover loose or failing plaster. Alternatively, the new ceiling may also simply have been installed to dampen the acoustics in what would be a noisy room with lots of hard surfaces. Either way the original ceiling plaster is likely in poor condition.

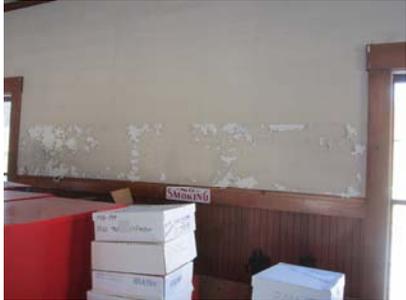
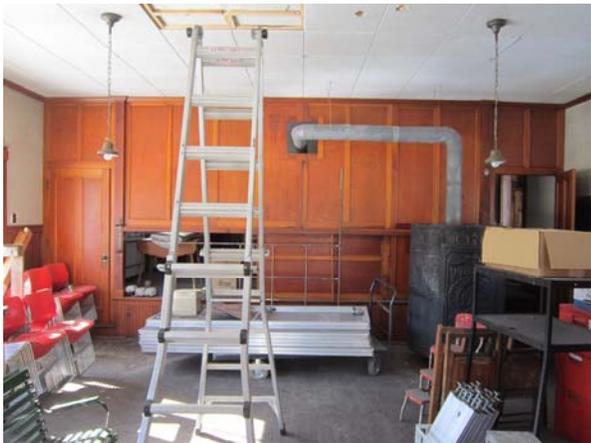
black board installed on the north wall adjacent to the stage door. There is an incidence of dramatic paint failure on the plaster at the north wall between the windows and above the wainscot. Previous replacement of the wainscot cap on this wall and bonding cement on the wainscot indicate that this portion of the wall was once covered with a blackboard or bulletin board, now removed.

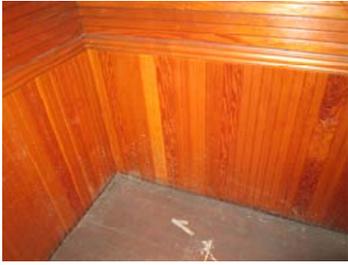
or perhaps used for both. The wainscot and plaster finishes in the stage area seem to be intact and in fair to good condition. There is marked cracking in the plaster above the doors probably relating to the infill patching of these areas where windows were replaced with the five panel doors. The makeshift kitchen without running water at the southwest corner of the stage area is poorly made and unrelated to the historical aspects of the Center Harbor Town House.

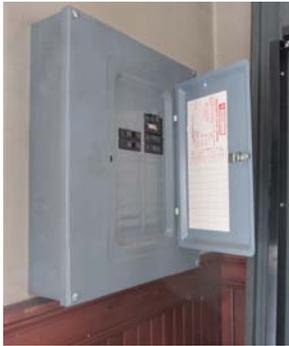
Electrical service in the building is of mixed quality. Electrical systems have been updated to provide grounded service at the limited locations convenience outlets are located, but much of the older wiring remains within the ceilings and likely the walls. Out of service wiring should be removed and the service panel on the wall should be opened and the wiring inspected to confirm that any dangerous wiring is out of service. The service entrance wiring outside the building to the meter is cloth jacketed and the jacketing is failing. This wiring should be replaced immediately, as it poses a fire risk to the building.

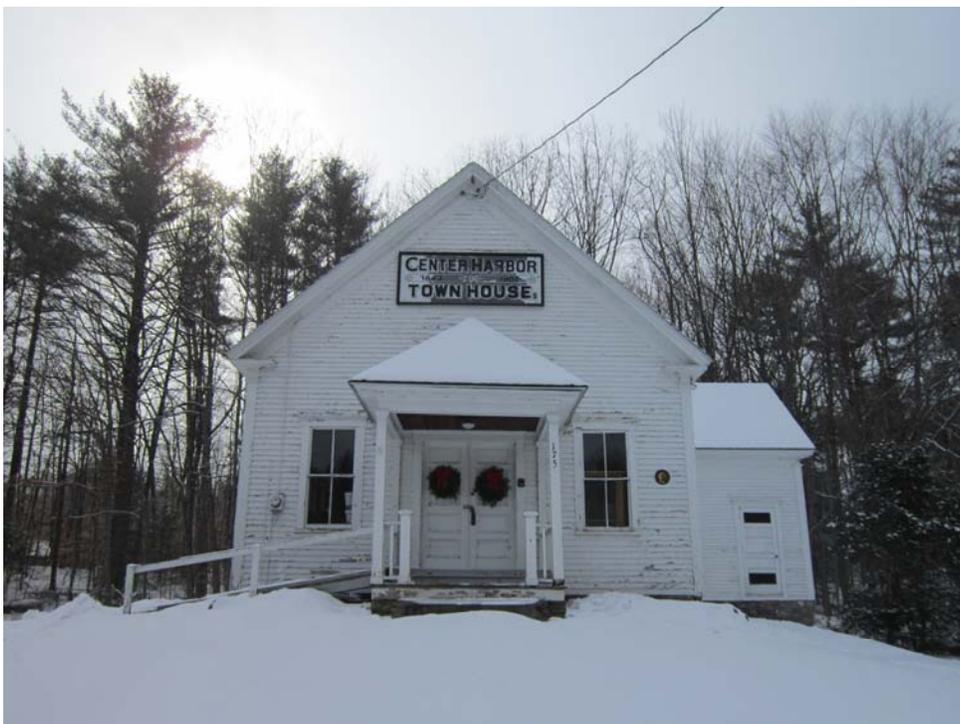
East elevation of Greek Revival Center Harbor Townhouse showing 2/2 windows and entry porch

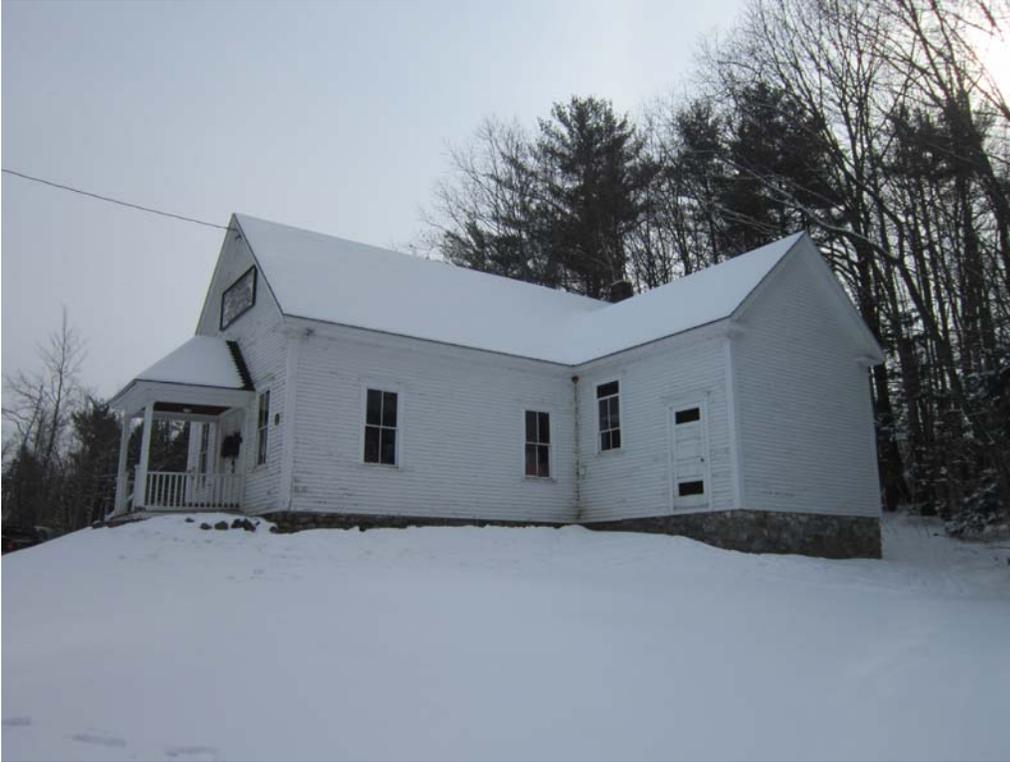
North side elevation showing strong relationship to ell. Note window of woodshed is placed at level of stage

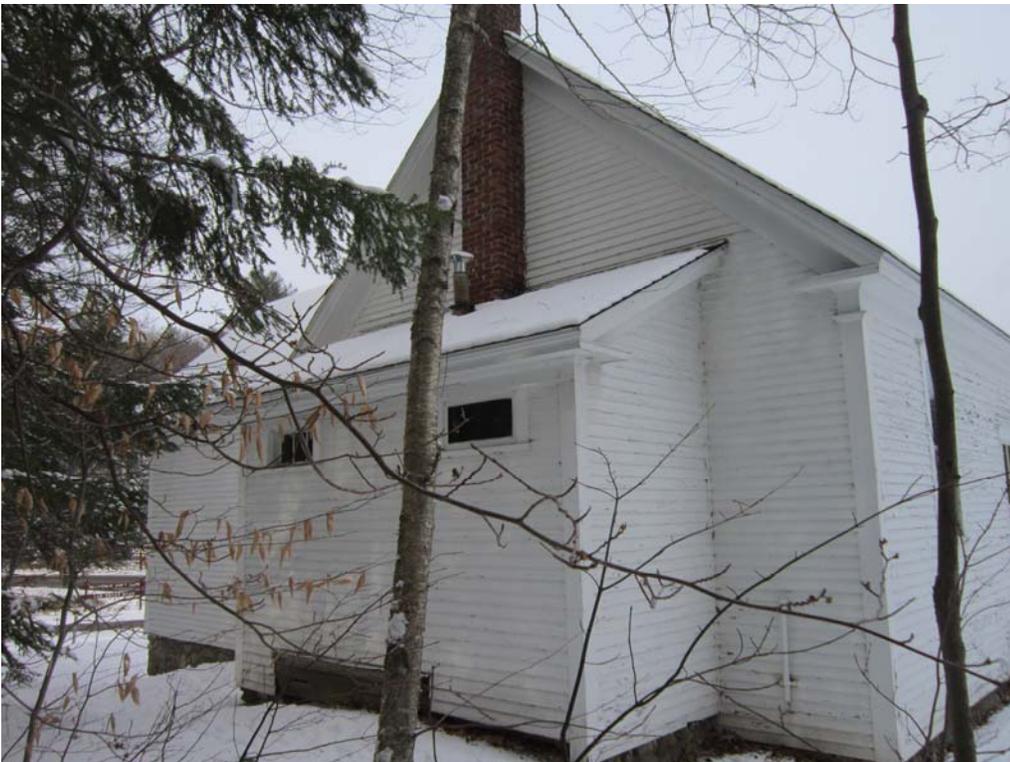
West end of main block showing Privy addition at rear of raised platform and chimney

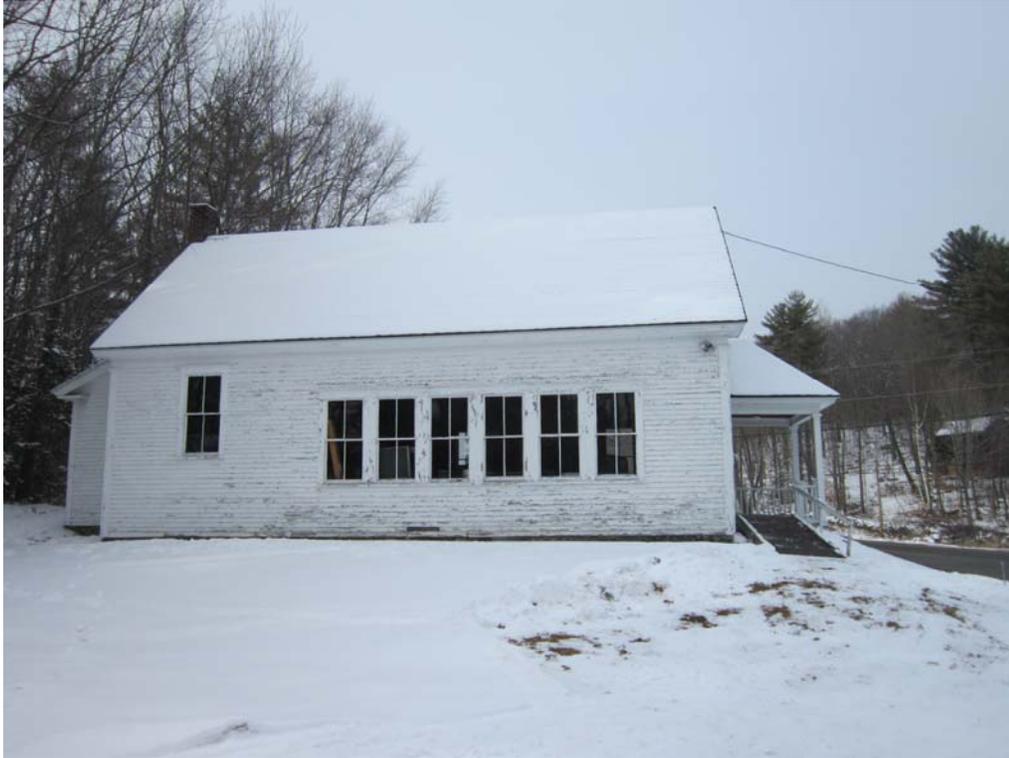
South elevation of main block with the privy seen to the left and the entry porch on the right side with its overlaid non-conforming ramp.

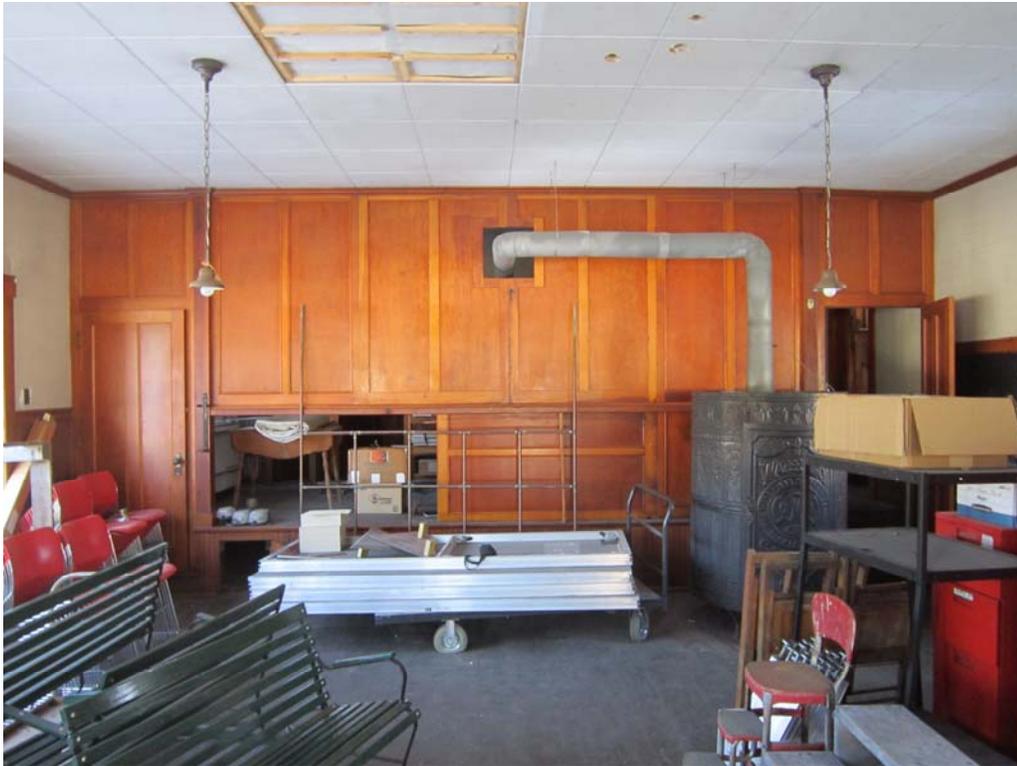
Interior of hall with removable solid panels on the railing separating the stage area

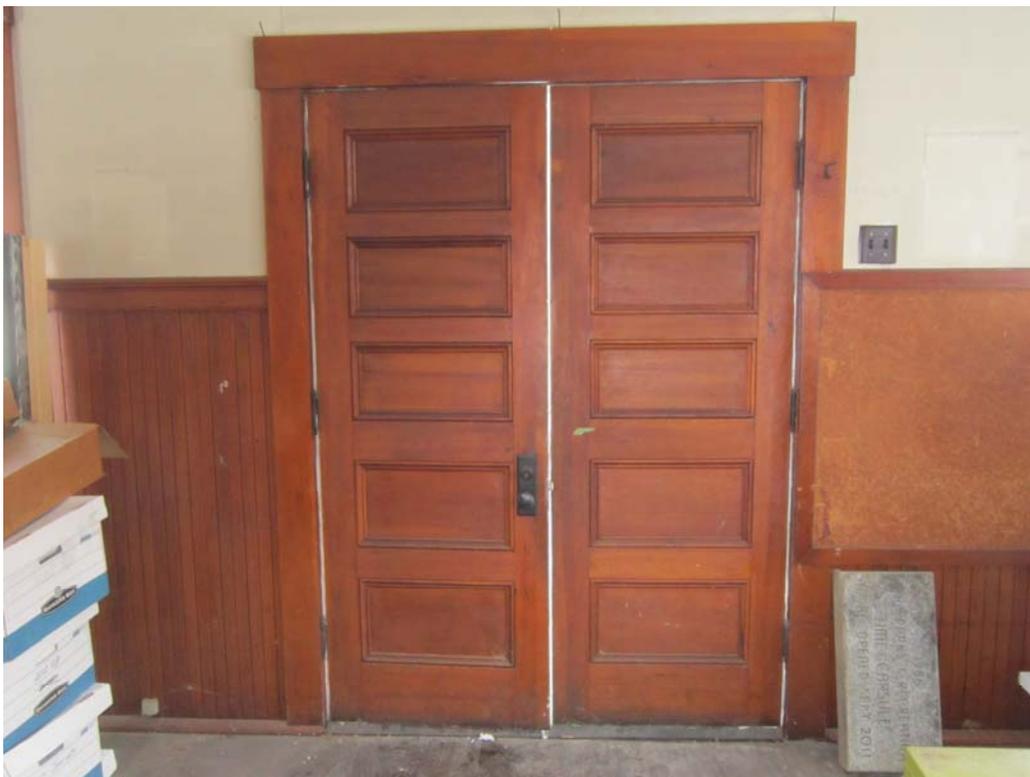
Interior side of 1907 double doors

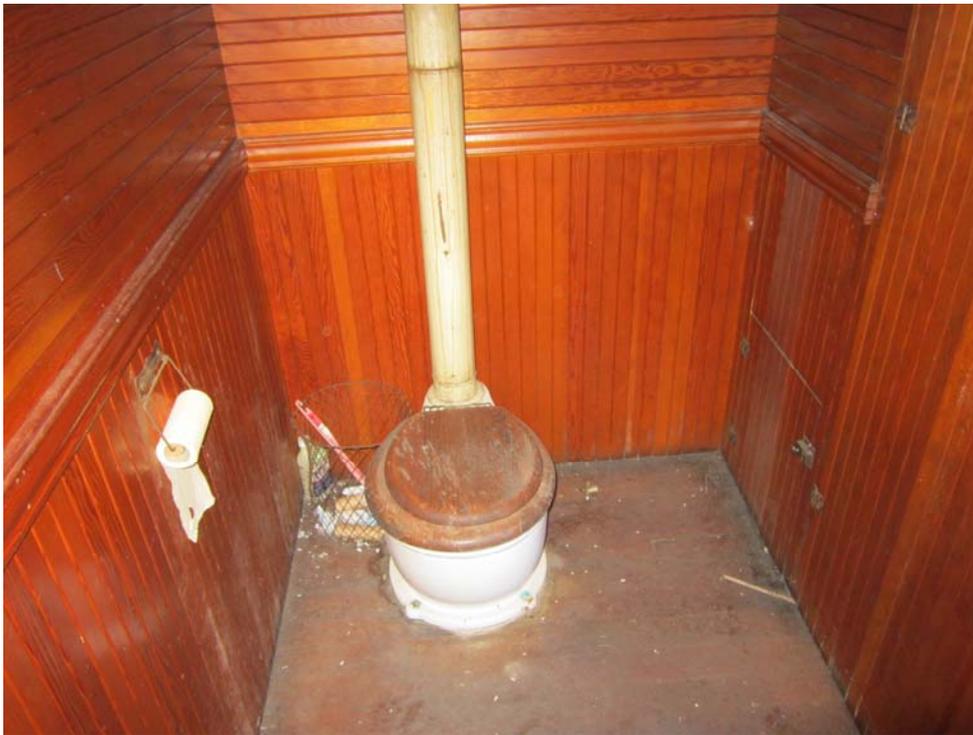
Privies are no longer working. Note that no plumbing in this bathroom impact the original wall finishes.
