**CENTER HARBOR VILLAGE SCHOOLHOUSE**

**94 DANE ROAD, CENTER HARBOR, NH**

**EXISTING CONDITIONS REPORT & ASSESSMENT**

**8 JANUARY, 2018**

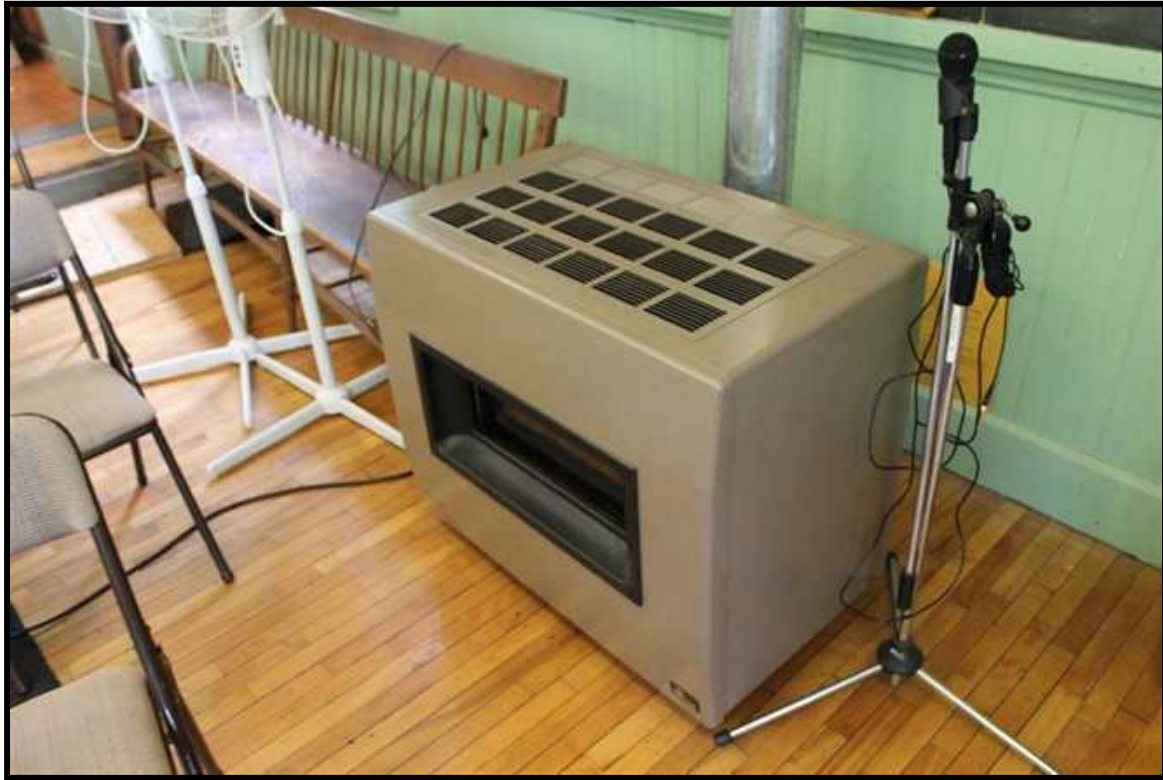
Image Interior Detail 003 – Furnace in 1886 Schoolhouse

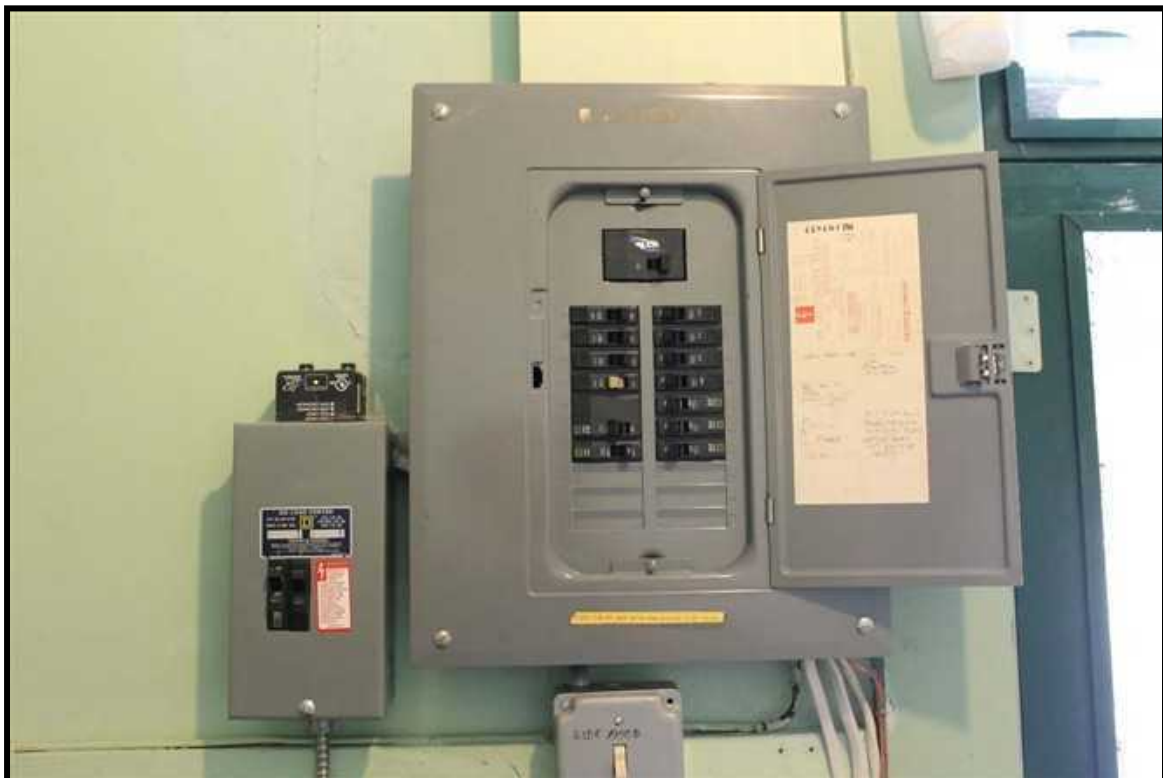
Image Interior Detail 010 – Existing Electrical Panel

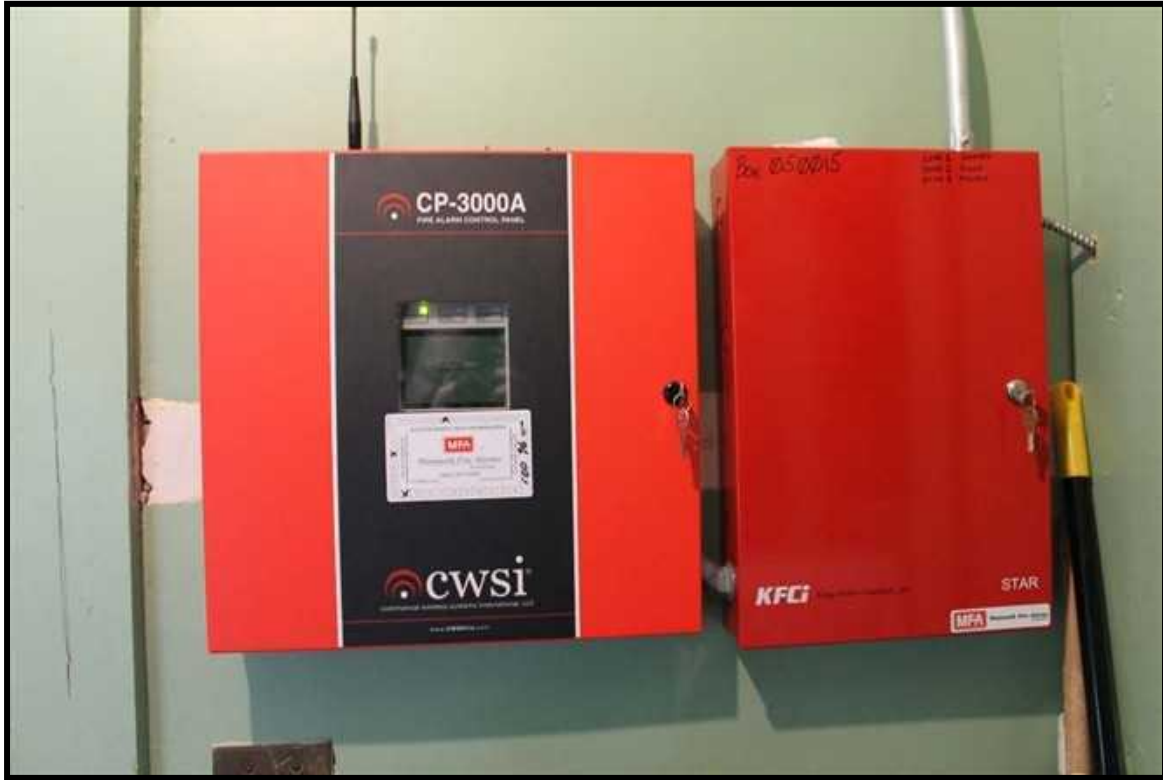
Image Interior Detail 011 – Existing Alarm Panel

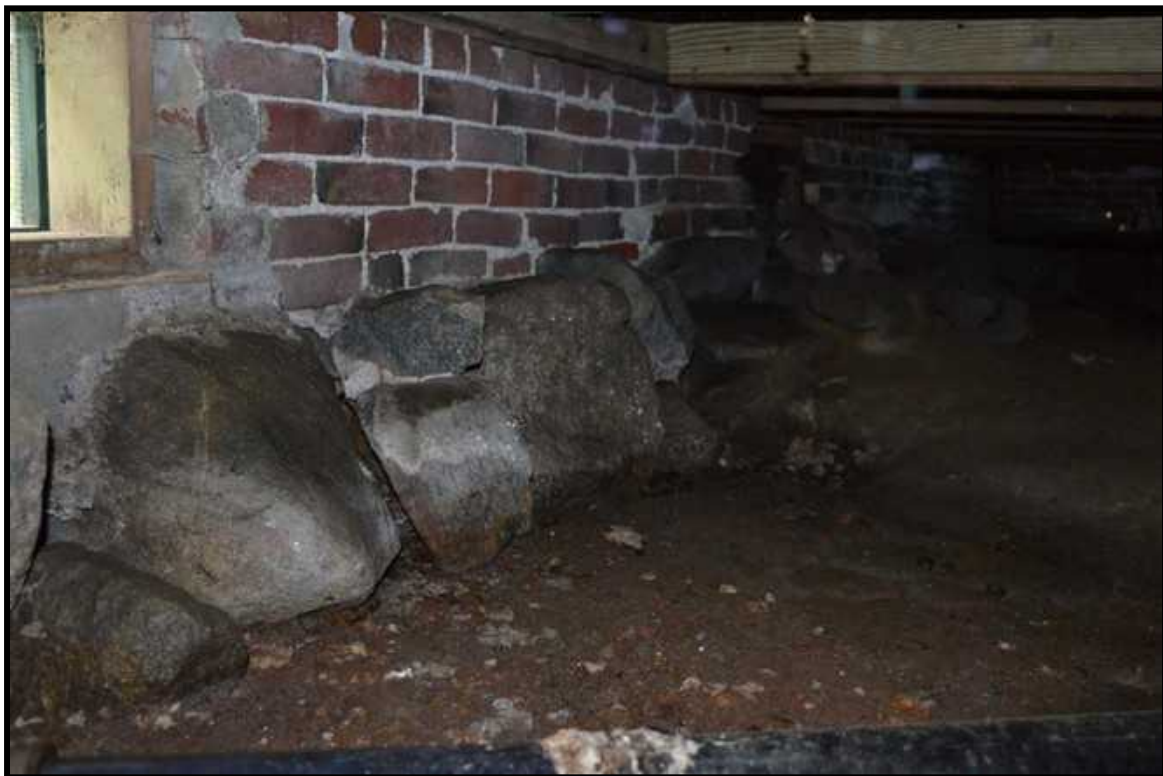
Image Interior Detail 012 – Crawl Space under 1886 Schoolhouse

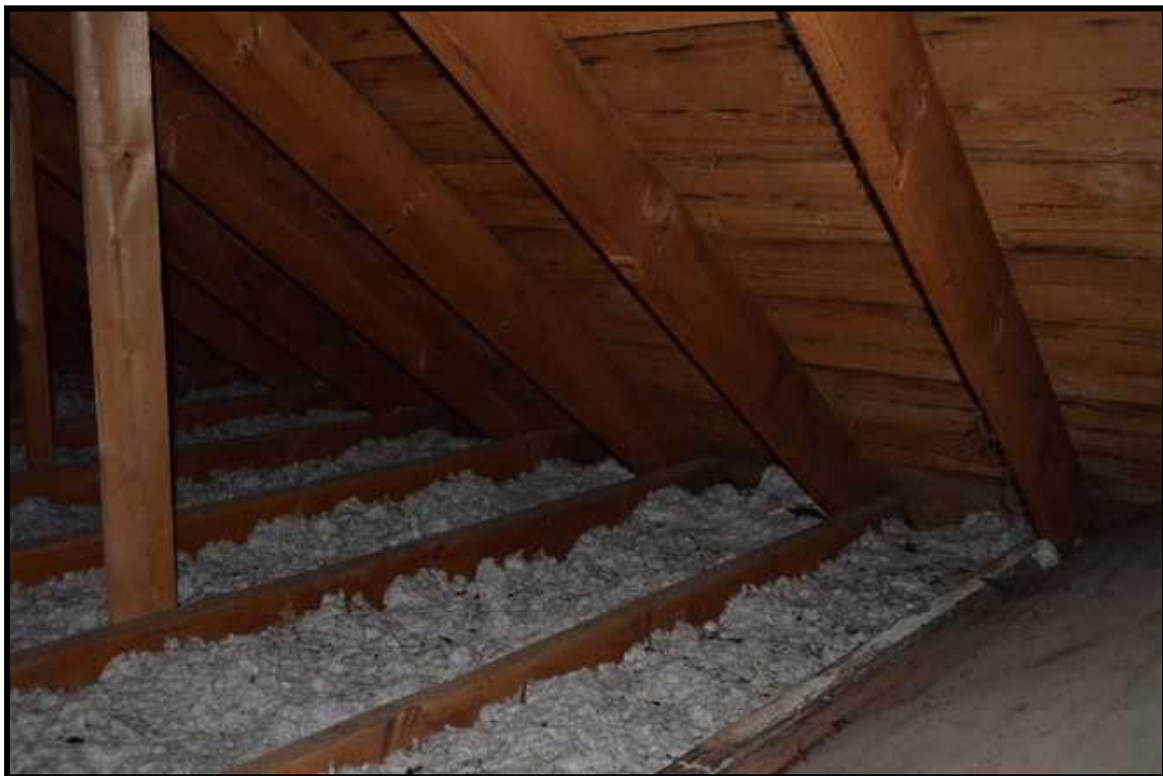
Image Interior Detail 014 – Attic above 1886 Schoolhouse

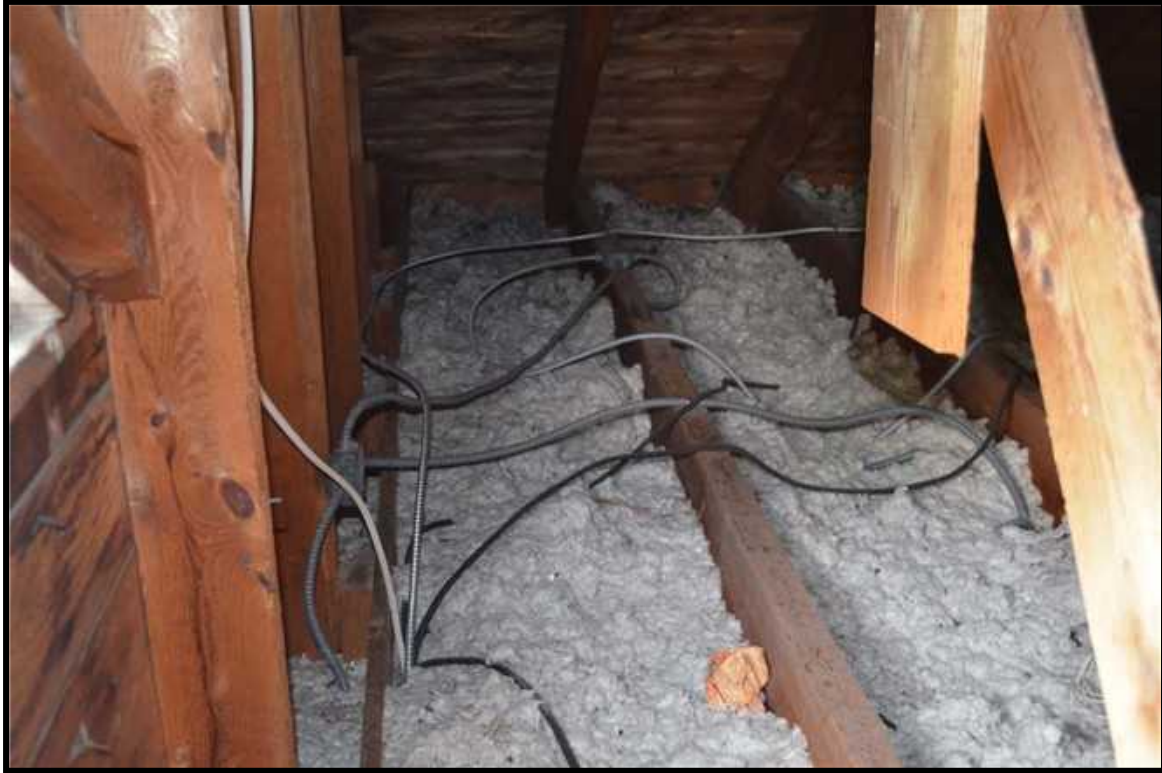
Image Interior Detail 015 - Attic above 1886 Schoolhouse
