Office of the Health Officer

Report of Wastewater Release

183 Whittier Highway, Center Harbor, NH 03226
Date of Release: November 10, 2023
Date of Initial Report: November 24, 2023
Date of First Follow Up: December 7, 2023
Date of Second Follow Up: May 10, 2024

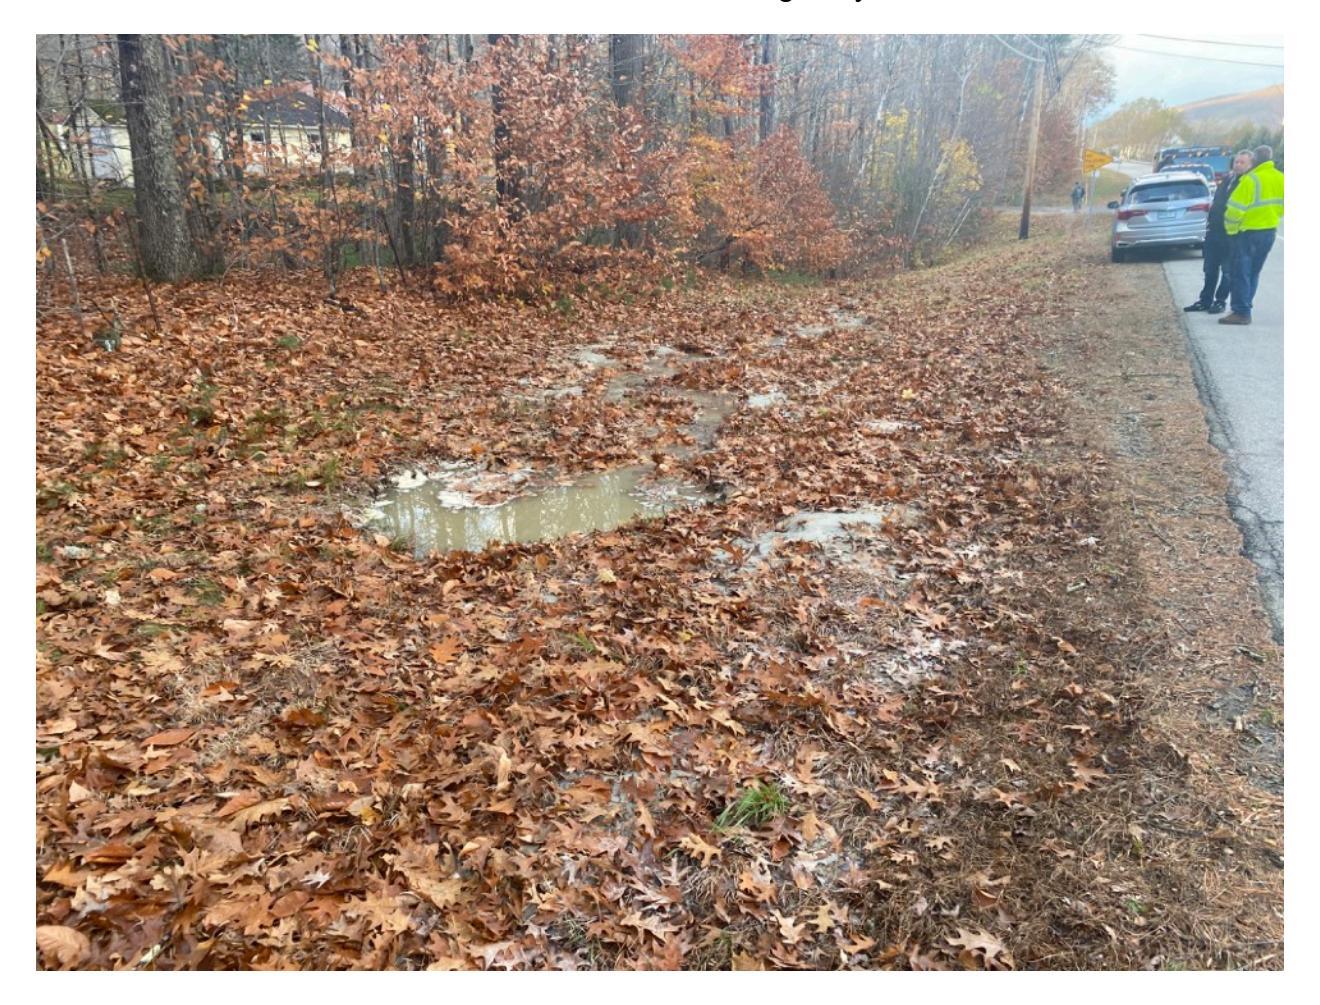
Deputy Health Officer Rudolph A. Cartier III was on duty with the Center Harbor Fire Department on this day and responded at the time of the request for fire department assistance. Upon arrival, a cloudy, clay-colored fluid was noted to be flowing from an approximately 3' diameter hole just off the shoulder of NH Route 25 (Whittier Highway). There was a strong odor of sewage around the area, and a clay-colored sediment was noted in an approximately 6' diameter area around the hole, indicating that the flow had been higher prior to his arrival. The fluid was noted to be traveling down the roadside to a small brook located in front of 183 Whittier Highway, passing through a small culvert under the driveway of that address, and continuing through a second culvert under Whittier Highway. The brook continued approximately 1000 feet to Lake Winnipesaukee with an outlet due west of Half Mile Island located adjacent to the property at 196 Whittier Highway. There was an approximately 100 foot diameter plume of similarly cloudy fluid noted in the lake. Upon return up the driveway of 196 Whittier Highway, one residential building was encountered which appeared unoccupied and under construction. The presence of wells at either affected property was not determined at that time.

Tyler Driscoll Health Officer Town of Center Harbor firechief@centerharbornh.gov Fig. 1 - Clay-colored fluid collecting in and flowing out of an approximately 3 foot diameter hole and downhill in front of 183 Whittier Highway - 11/10/2023

While the leak appeared to have slowed from its initial rate, actions were taken to mitigate further release. A dike was placed in front of the culvert leading under the driveway at 183 with moderate decrease of wastewater leaving this culvert. Bay District Sewer officials were on site and had requested a vacuum truck to the scene to remove residual wastewater from the diked area as well as the original hole. Once this was completed, all municipal services had left the scene. NHDES had been notified by Bay District Sewer and municipal authorities on scene.

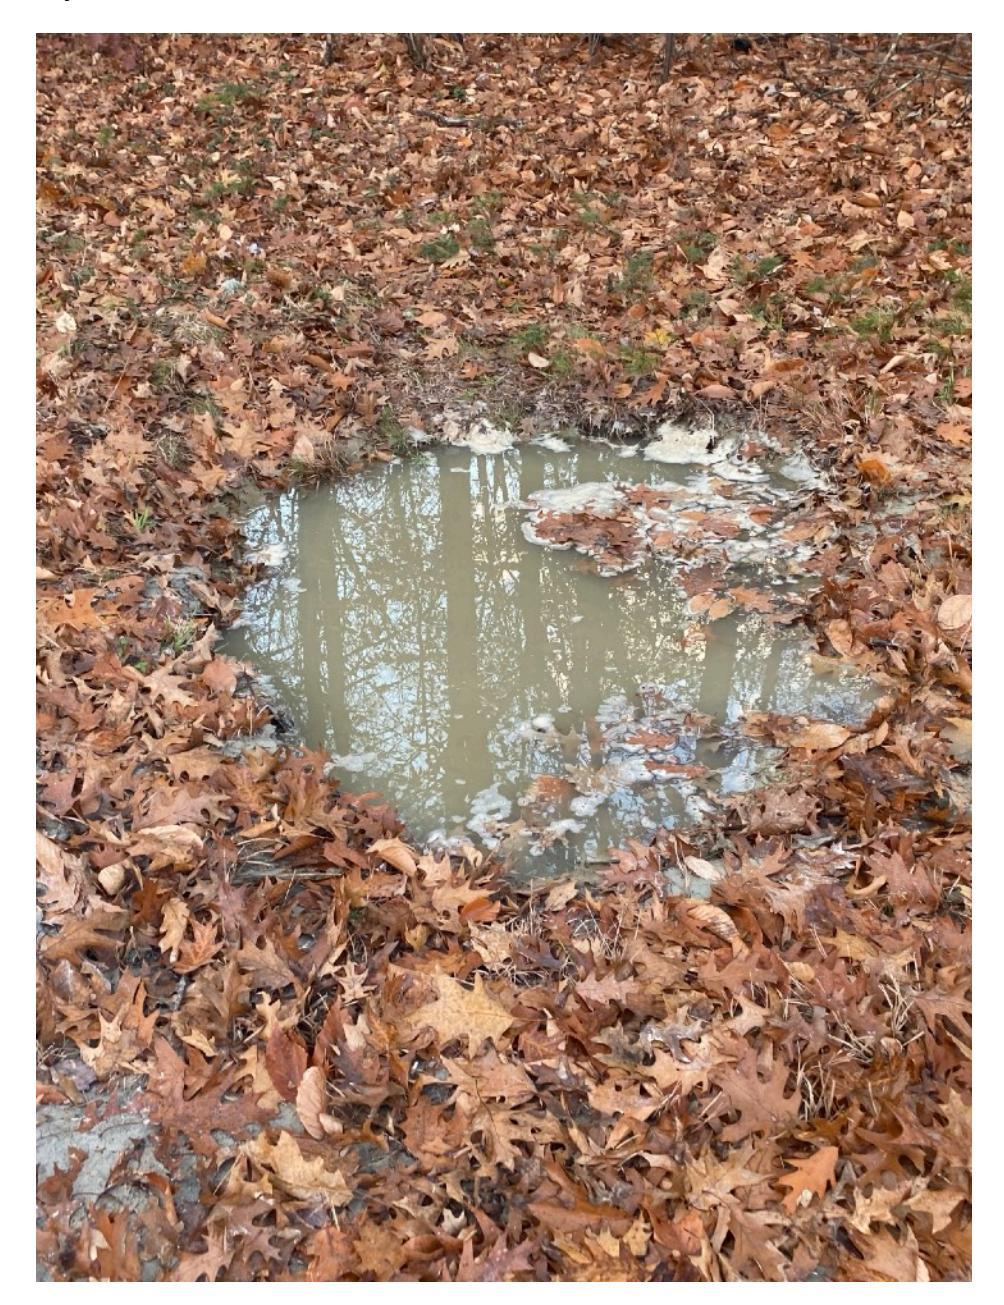
Fig. 2 - Clay-colored fluid collecting in and flowing out of an approximately 3 foot diameter hole in front of 183 Whittier Highway. Additional sediment is noted in an approximately 6 foot diameter area around the hole - 11/10/2023

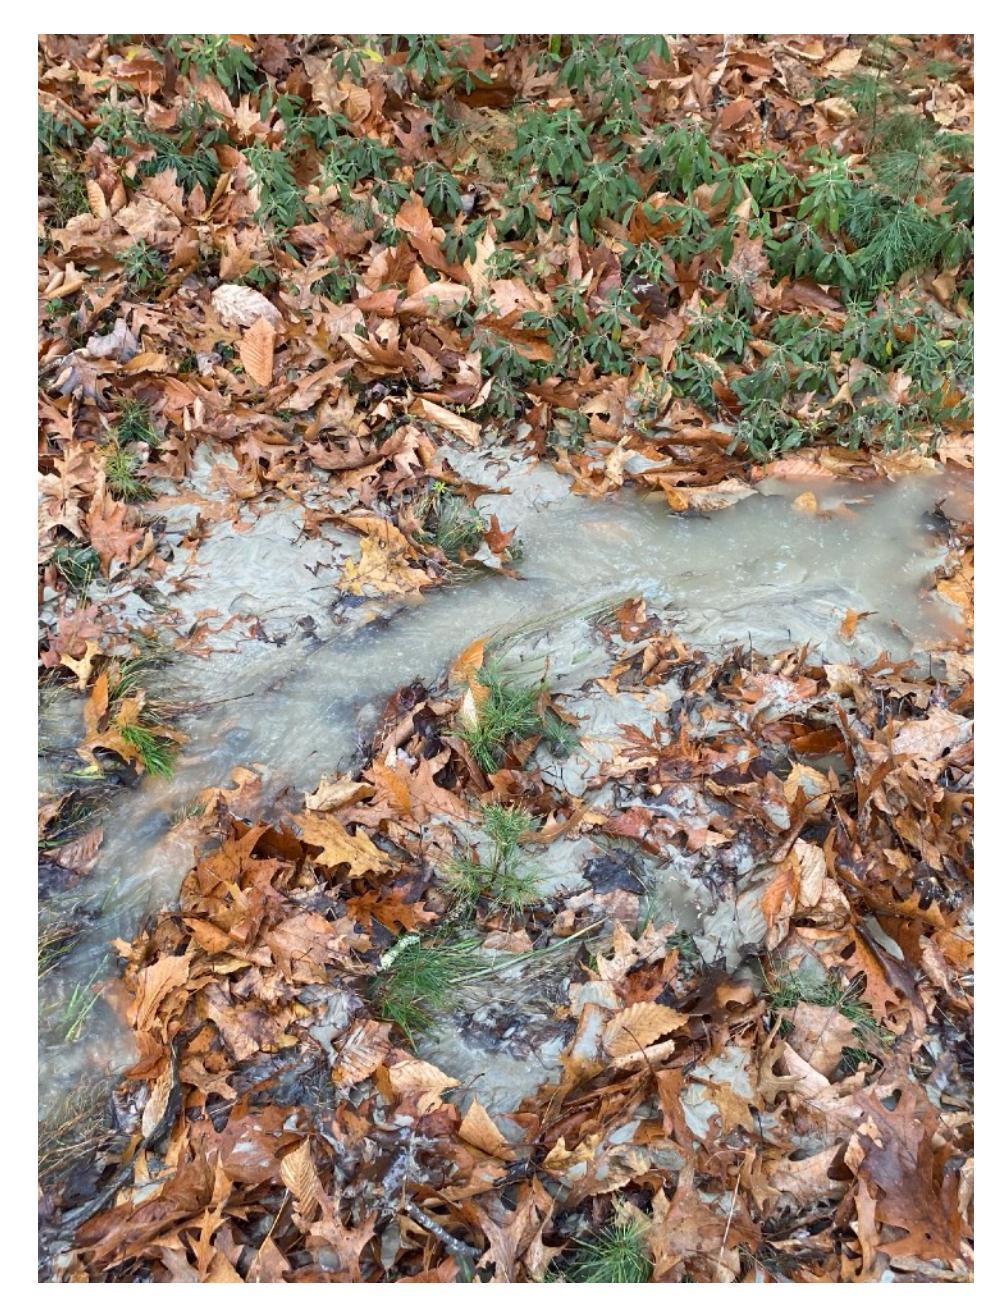
Fig. 3 - Clay-colored fluid moving downhill along Whittier Highway in front of number 183 - 11/10/2023

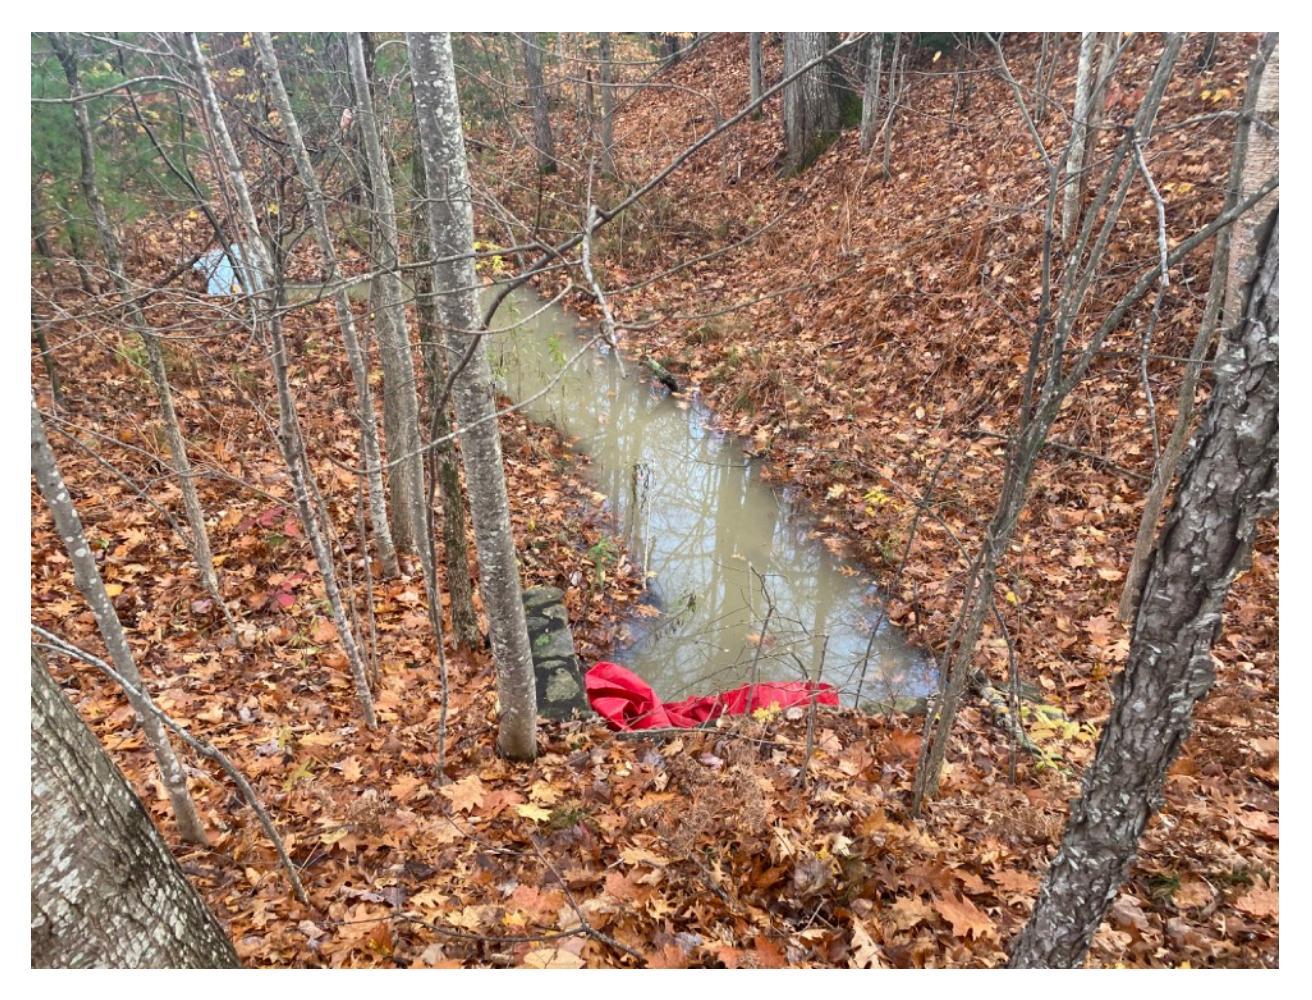
Fig. 4- Clay-colored fluid moving toward culvert under the driveway of 183 Whittier Highway. Culvert has been diked with red salvage cover - 11/10/2023

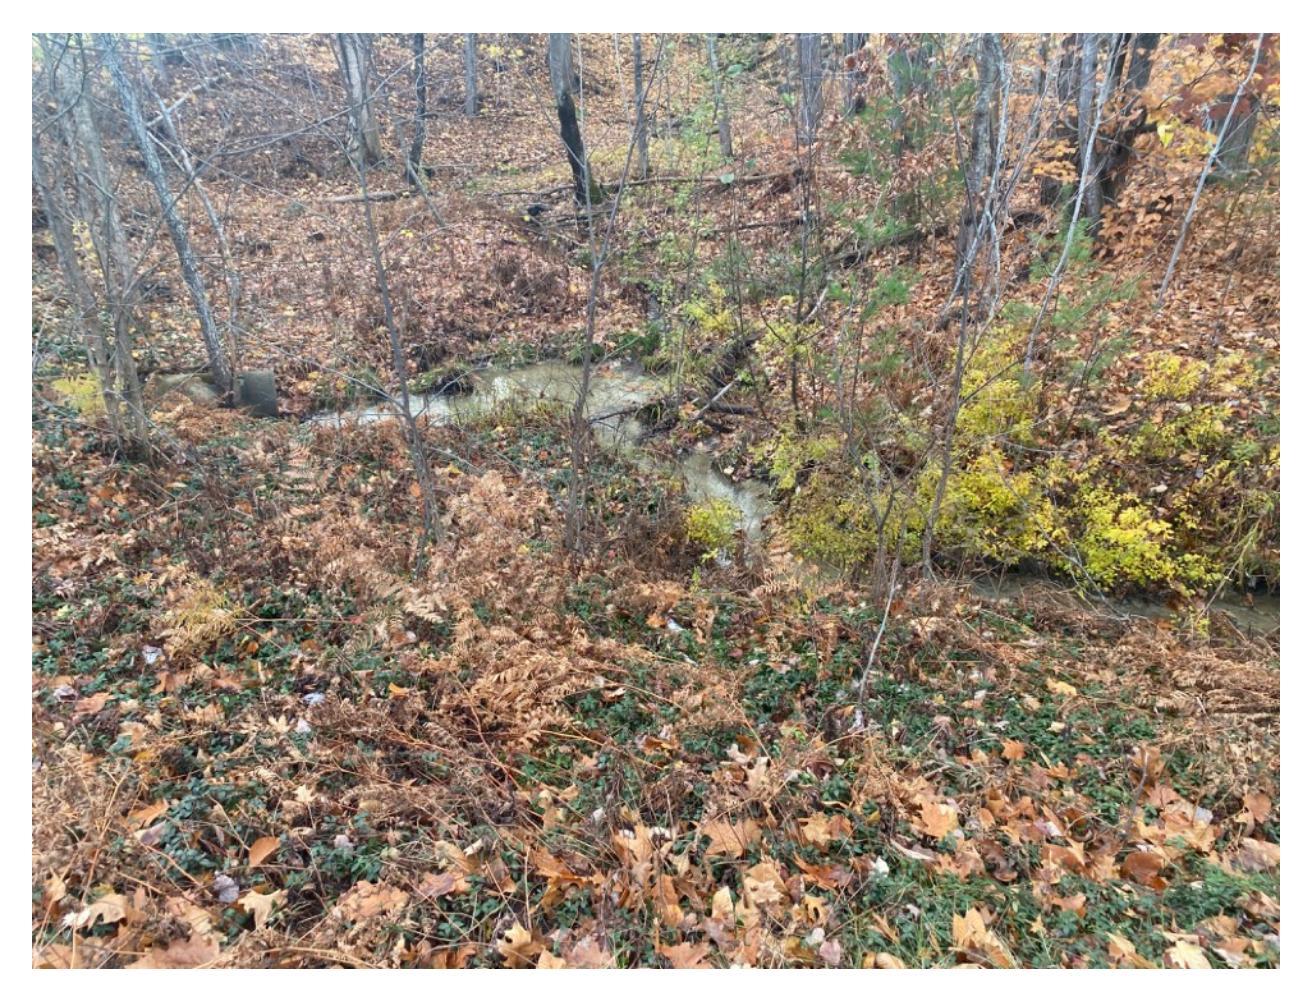
Fig. 5 - Clay-colored fluid moving through culvert under the driveway of 183 Whittier Highway (left side of image) - 11/10/2023

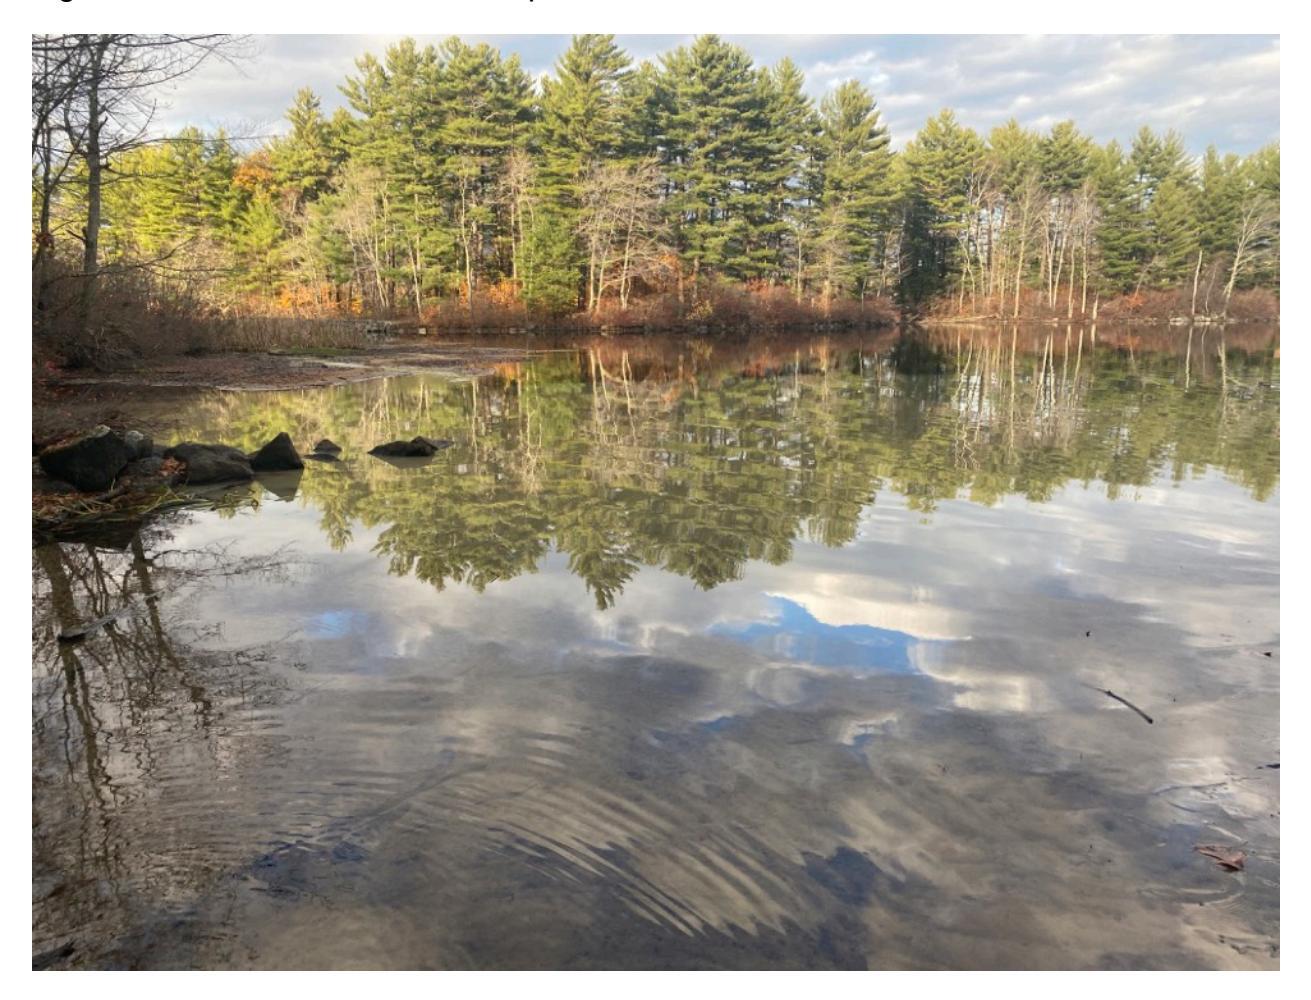
Fig. 6 - Release site on Lake Winnipesaukee - 11/10/2023

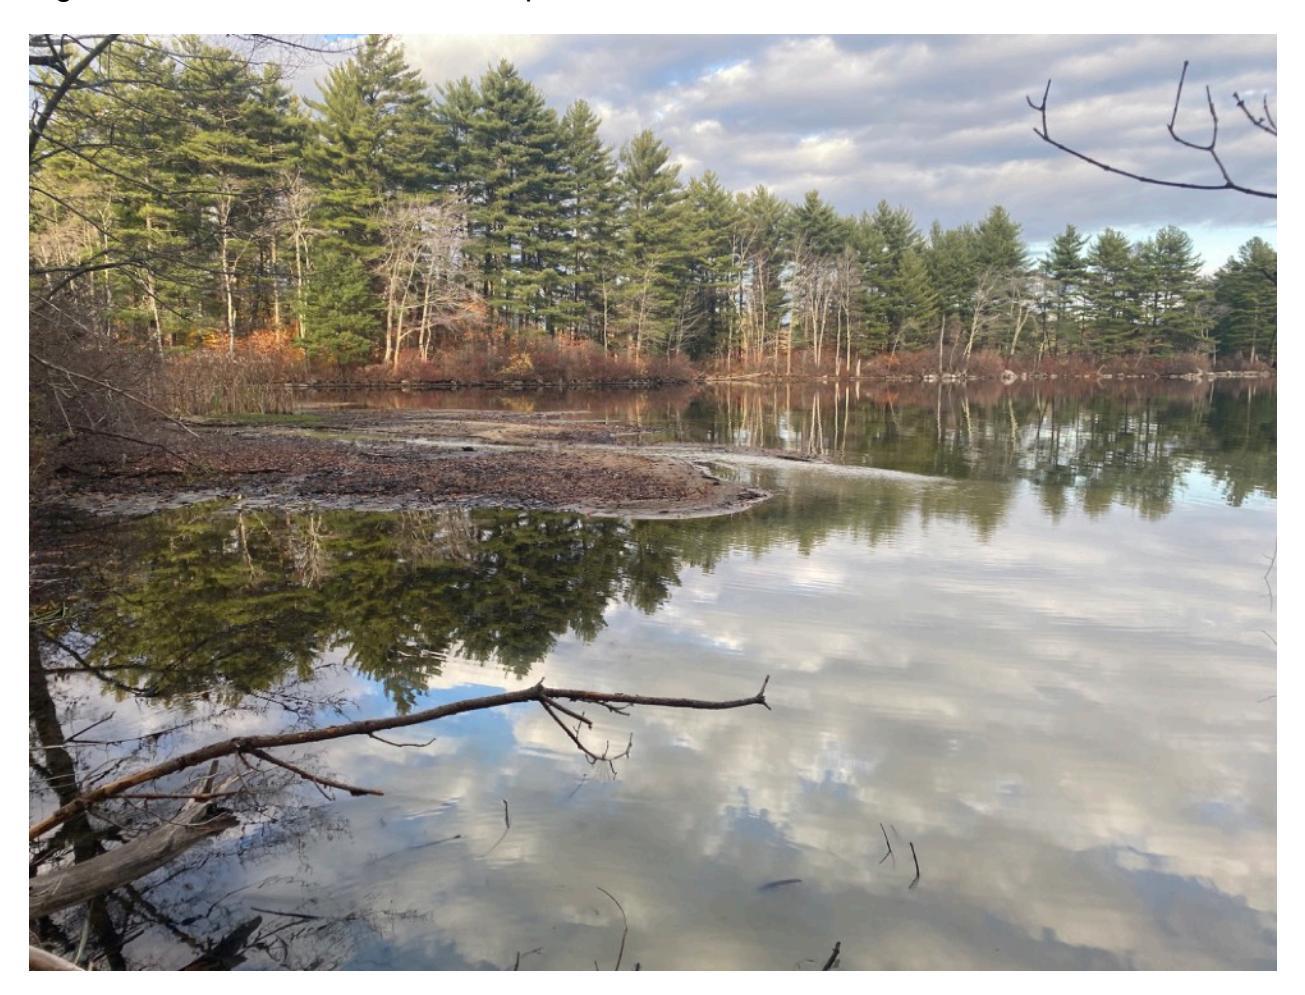
Fig. 7 - Release site on Lake Winnipesaukee - 11/10/2023

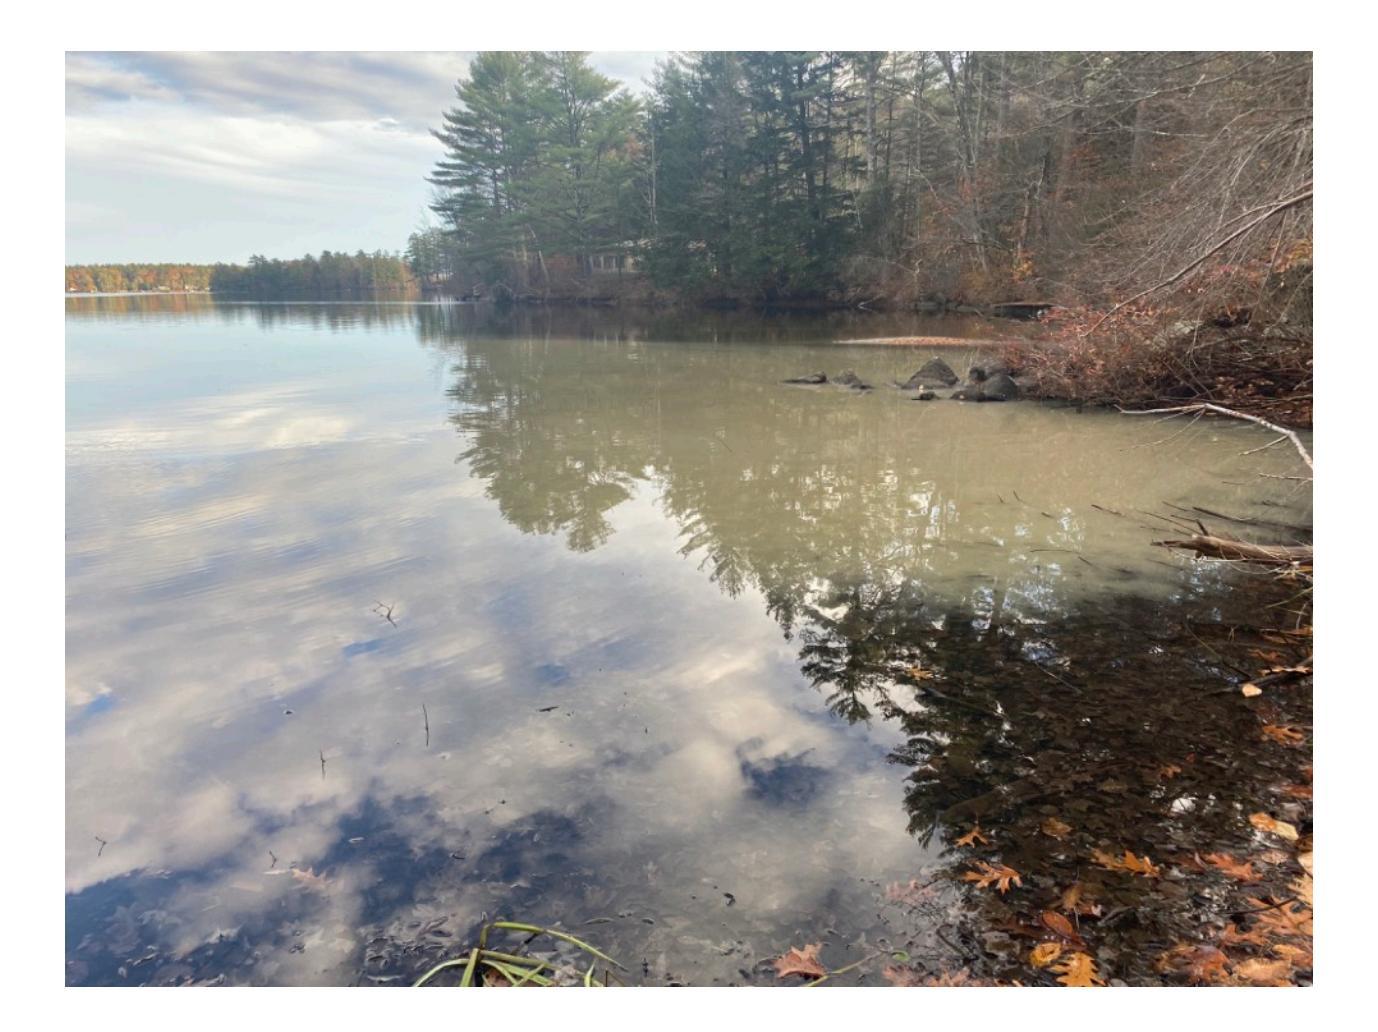
Initial testing on November 28, 2023 showed very low levels of E. coli at the Town Beach, but unacceptably high levels of E. coli in the area of Hog Island. Cold weather and the time of year limited the likelihood of water usage in this area, but recommendations were made to avoid water usage in the area of Hog Island until further testing is completed.

Fig. 8 - Clay-colored plume noted in water of Lake Winnipesaukee south of Hog Island - 11/10/2023

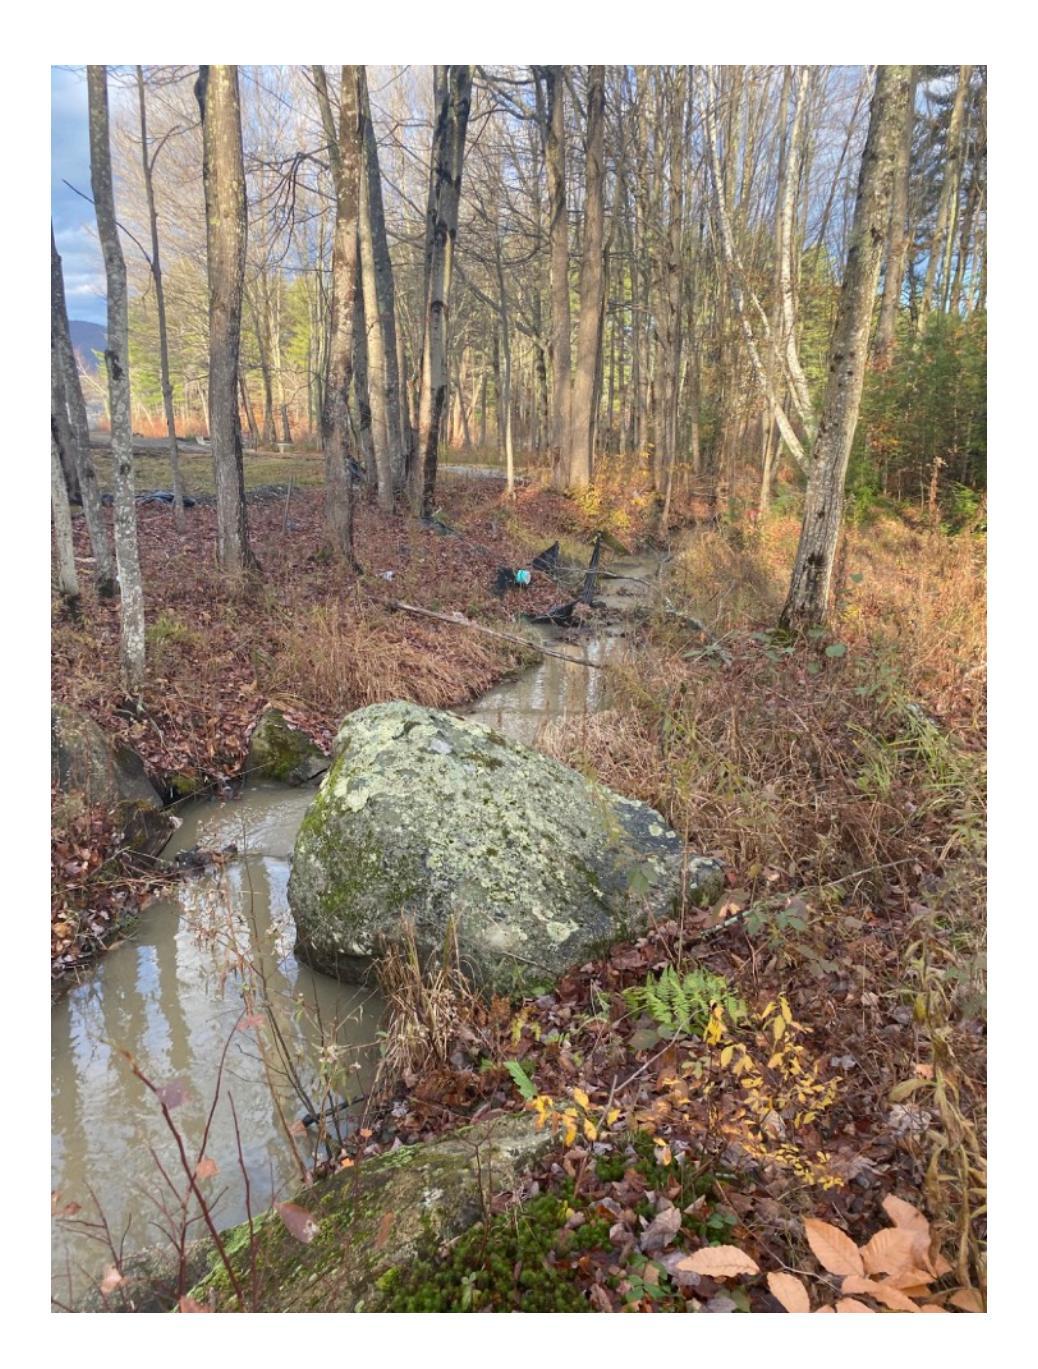
Fig. 9 - Clay-colored fluid flowing in brook just south of 196 Whittier Highway - 11/10/2023

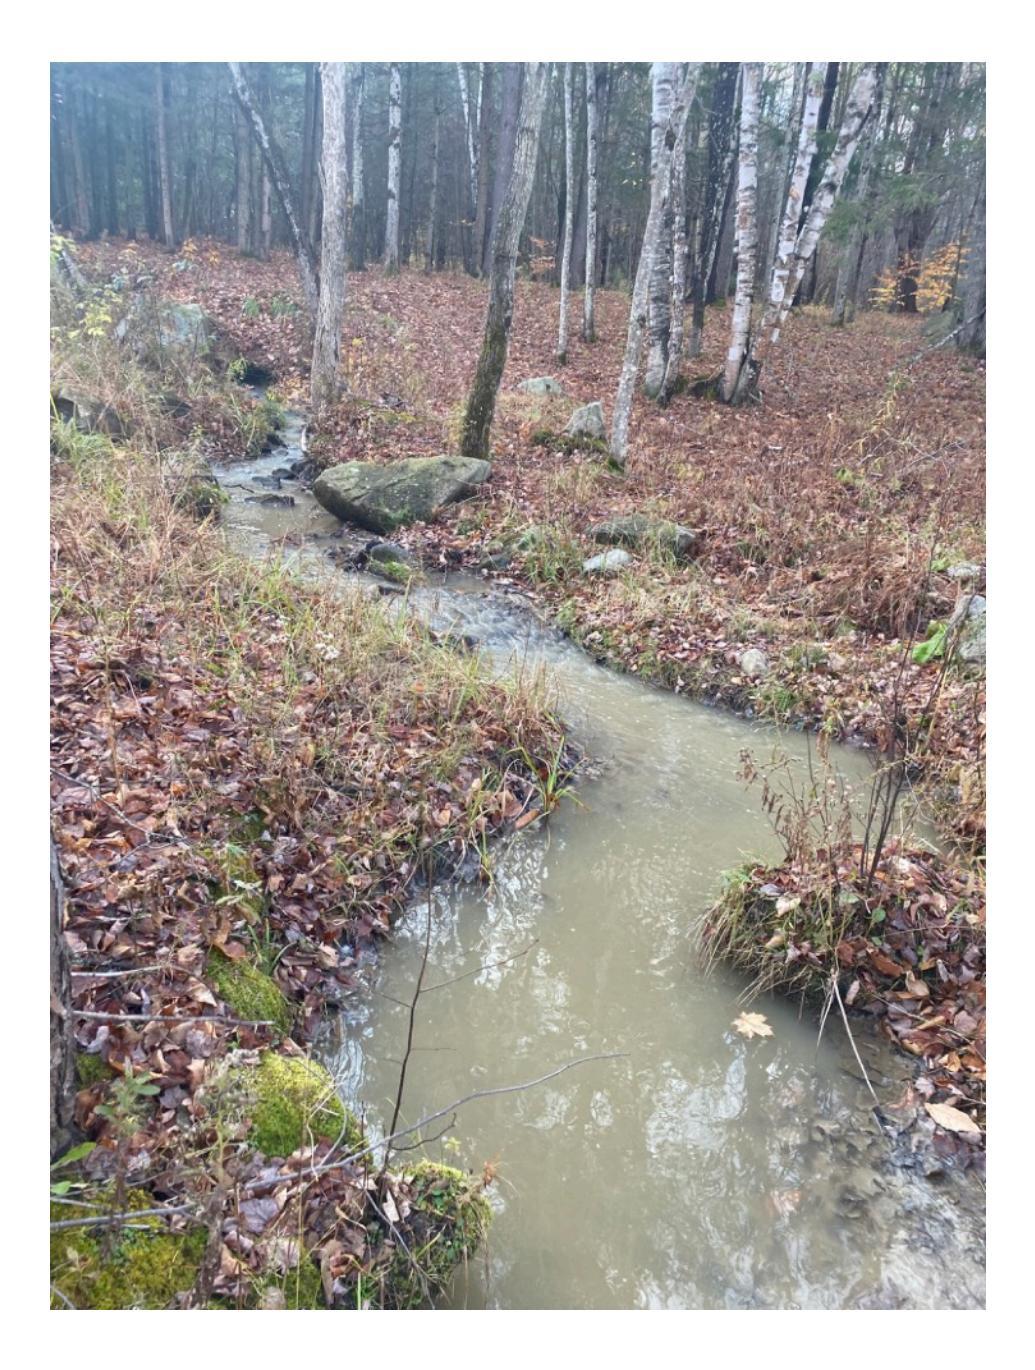
Fig. 10 - Clay-colored fluid flowing in brook just south of 196 Whittier Highway - 11/10/2023

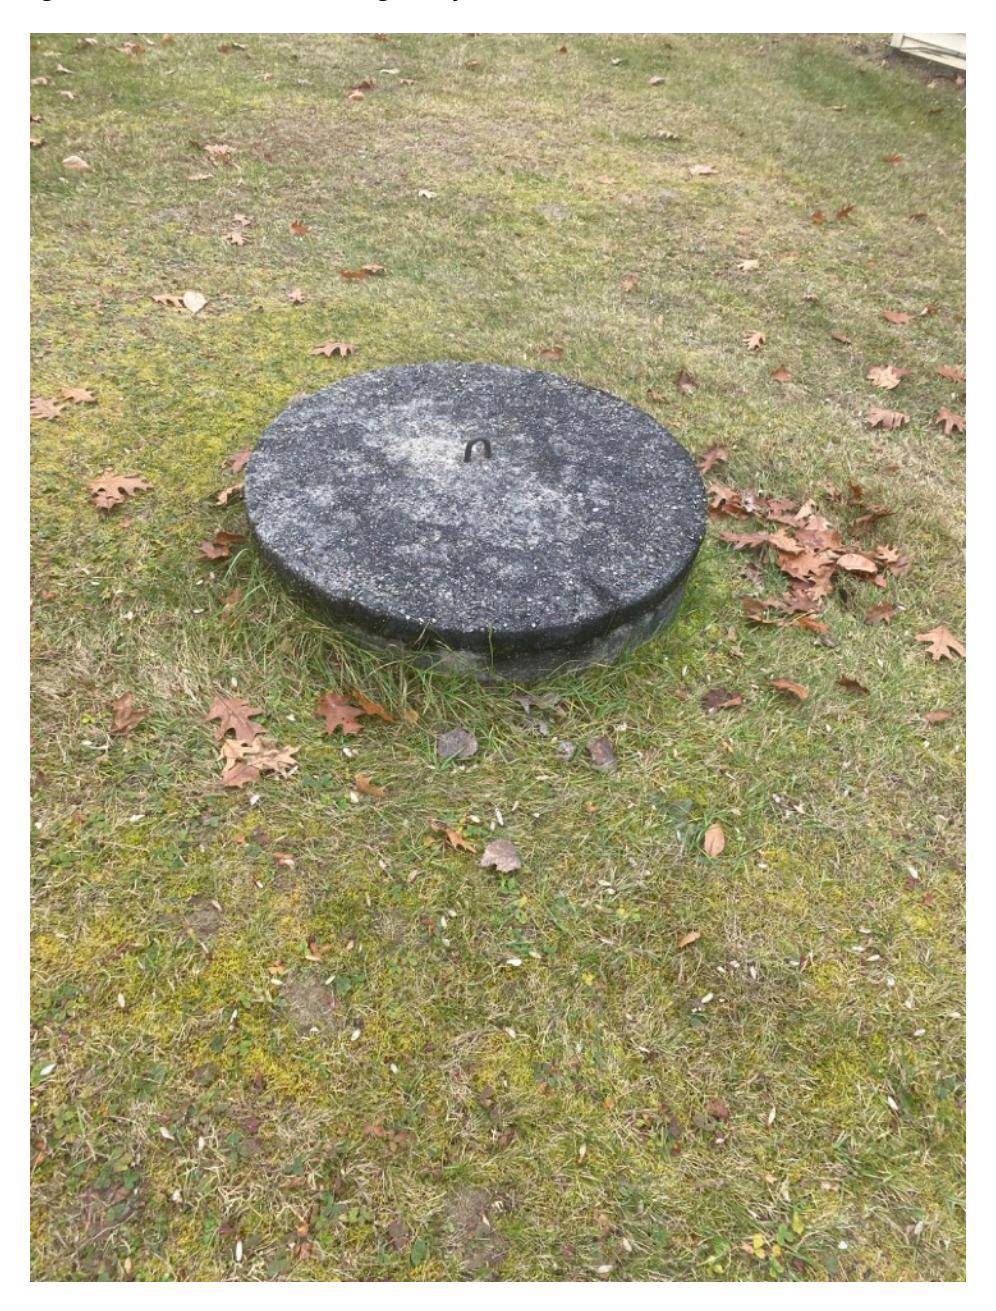
At 183 Whittier Highway, an 18 foot deep dug well was noted. This was uphill from the area of the brook which had contained the release at a distance of 175 feet. The amount of elevation from the stream bed to the top of the well was estimated at 30 feet. This residence was occupied and the occupant was advised of the investigation. Occupant was advised that there was no recommendation for testing of the well, but that she could obtain additional testing if so desired and that any illness should be reported to the Health Officer.

Fig 11. - Dug well at 183 Whittier Highway - 11/17/2023
