JAMES E. NICHOLS MEMORIAL LIBRARY
35 PLYMOUTH STREET, CENTER HARBOR, NH
EXISTING CONDITIONS REPORT & ASSESSMENT
27 FEBRUARY, 2019

PROLOGUE

4.0 CONDITIONS ASSESSMENT

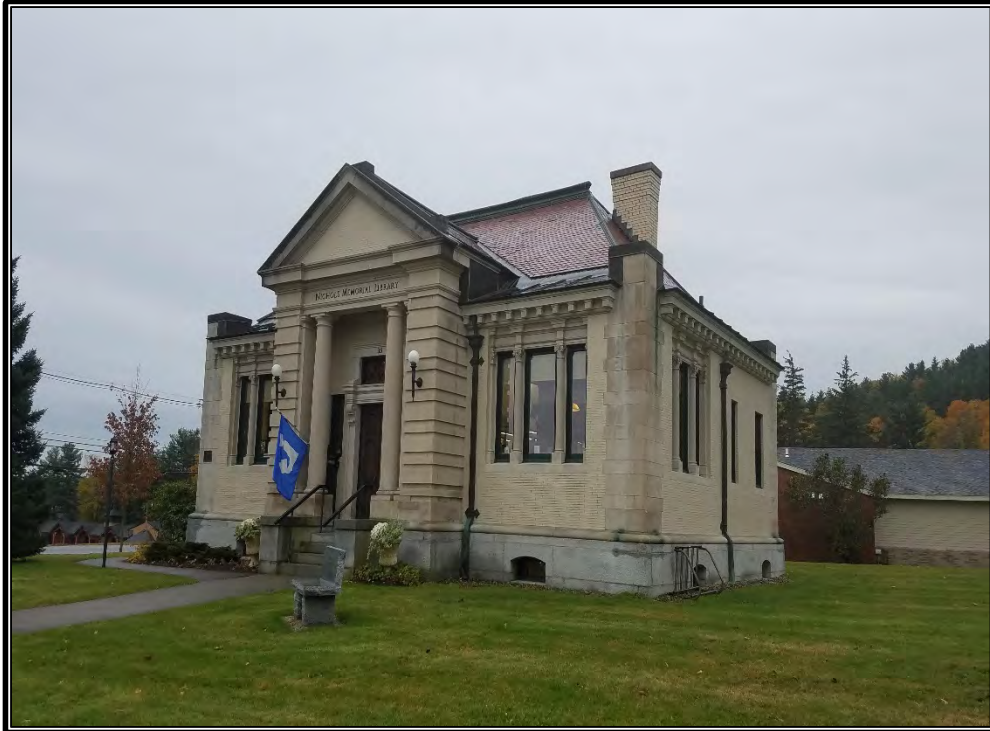
Photo 1: View of front of building.

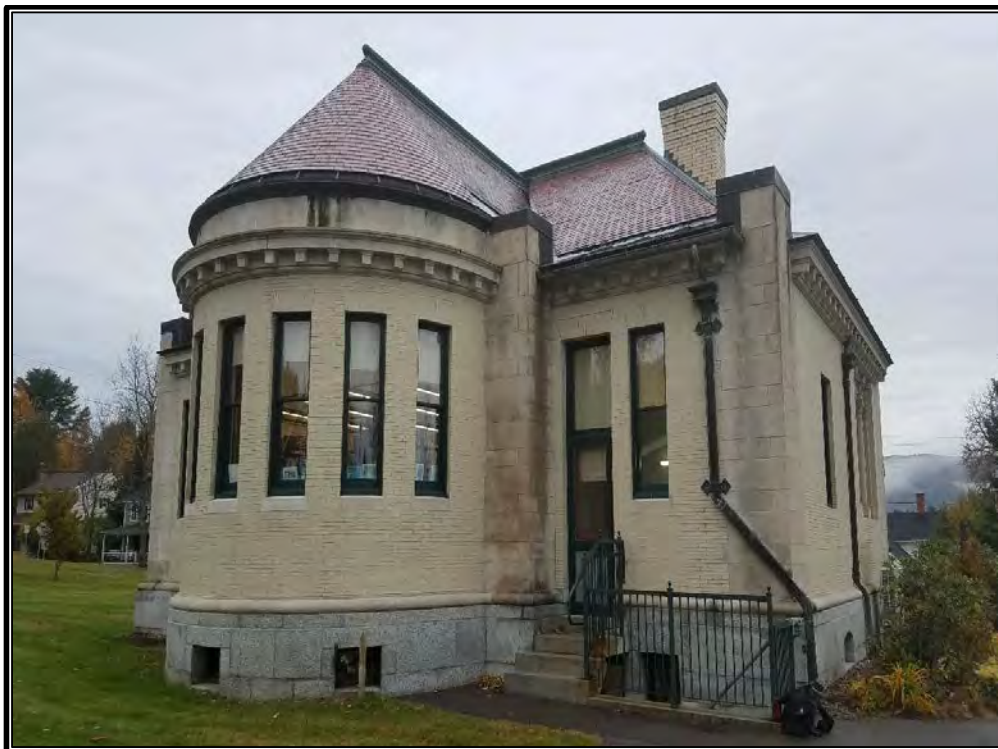
Photo 2: View of rear of building.

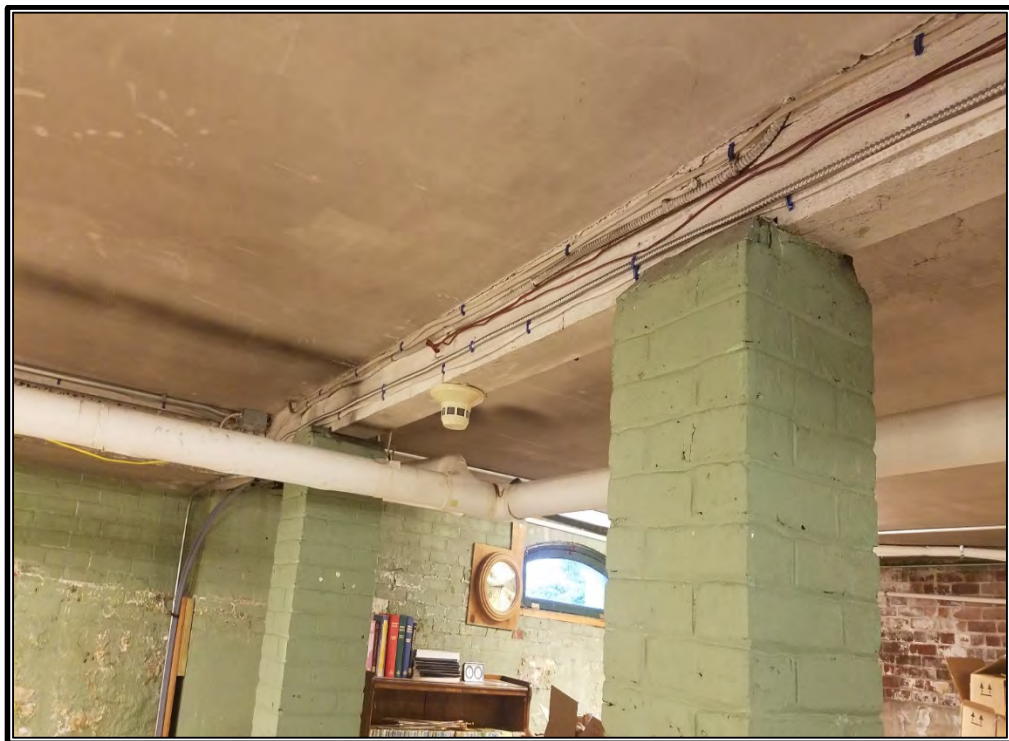
Photo 6: View of brick columns.

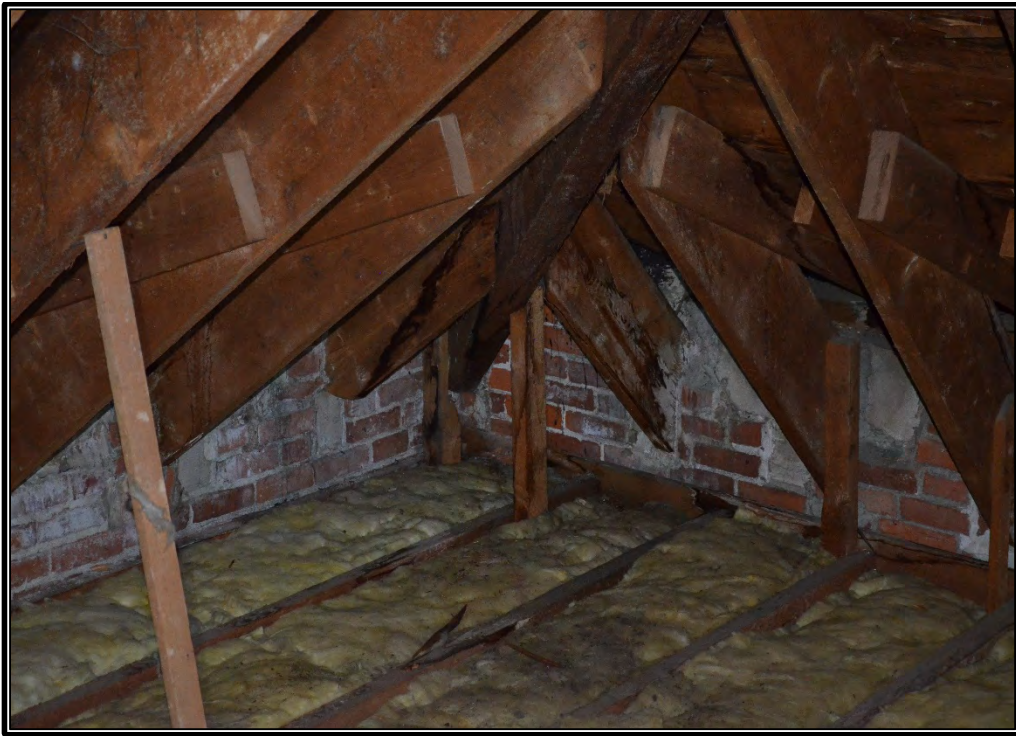
The hip roof framing is supported by the exterior brick walls that are approximately 2 feet thick (see Photo 7). The brick walls appear to be in good condition, with only a few areas of cracking observed. The roof has slate shingles with copper flashing and integral gutters at the bottom. The ridge beams are double 2-inch x 10-inch members (see Photo 8). The hip beams are 4-inch x 10-inch timbers. The valley rafters are 4-inch x 12-inch timbers. The 2-inch x 10-inch rafters in the main roof are spaced at 20 inches o.c. The 2-inch x 8-inch rafters in the front gable section and the rear rounded hip section are spaced at 20 inches o.c. In general, the roof framing appears to be in good condition with no obvious signs of overstress. There are several areas where water staining was observed, but no significant rot was observed. Some cracks were observed on the bricks in the western chimney.

Photo 7: Looking at bottom support of roof framing.

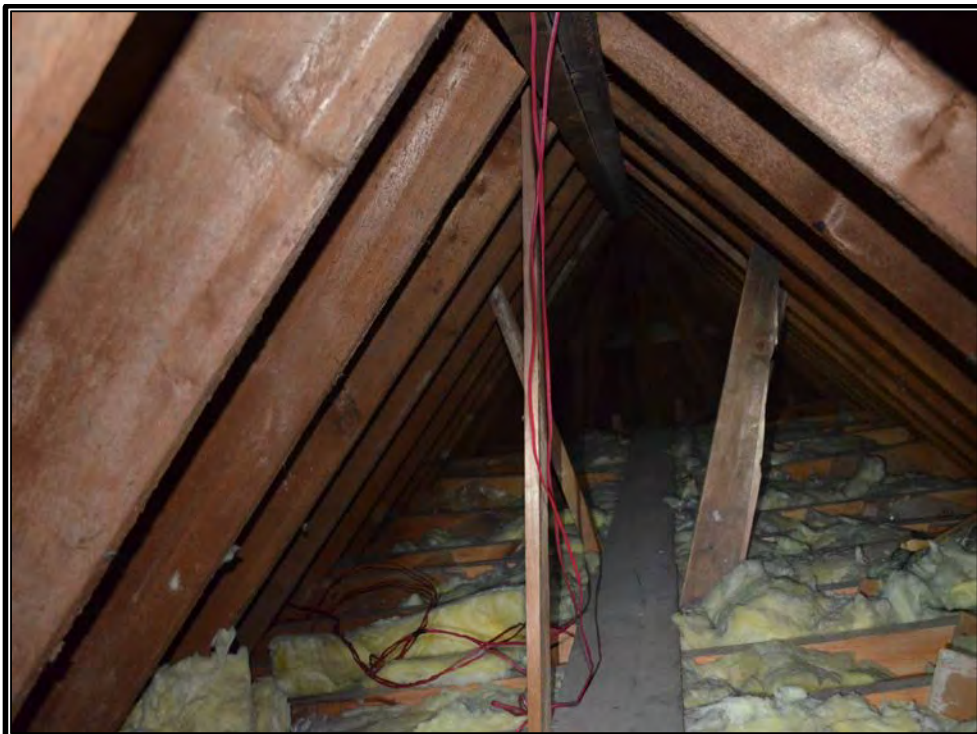
Photo 8: Looking at ridge beams.

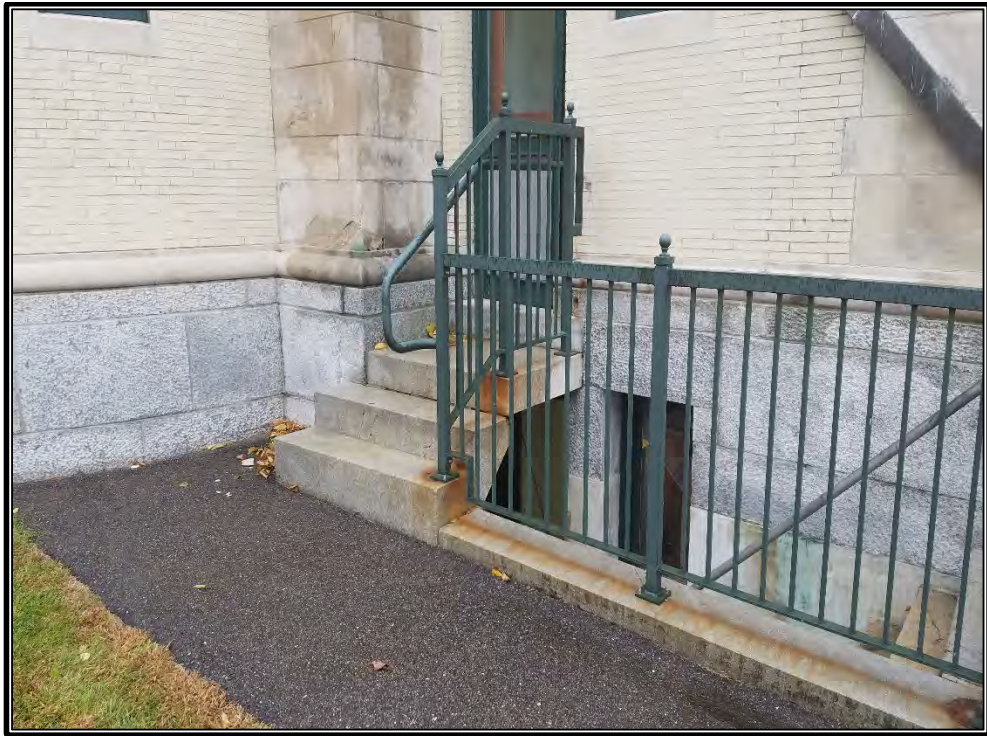
There is an exit stairway on the southern (rear) side of the building that spans over a lower-level exit stairway (see Photo 9). The upper stairs are constructed with cantilevered granite slabs. Although it is unclear as to how these slabs are being supported, no significant movement was observed in the stairs (see Photo 10).

Photo 9: View of granite staining at rear of building.

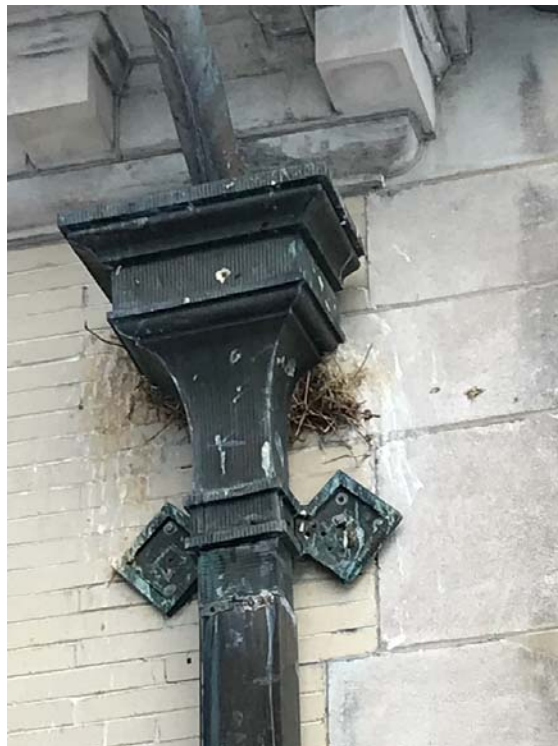
In the case of the Library, the condition of the basement is clearly symptomatic of long-term exterior drainage problems. Though the site is on a hillside sloping to the southeast, the immediate site is extremely flat. [Figure 14](#) The building is fitted with built-in eaves gutters leading to decorative copper downspouts. [Figure 15](#) The foundation features foundation splash stones on all sides. [Figure 16](#) However, the drainage system is currently designed only to concentrate runoff from the roof into isolated gutters that empty out onto the ground only inches from the foundation. While the gutters and downspouts appear to be sized adequately for the water load from the roof, the water does not drain away from the foundation, takes too long to dissipate into the ground, and is constantly being absorbed by the foundation masonry.

Figure 15: Detail of typical copper downspout and gutter leader

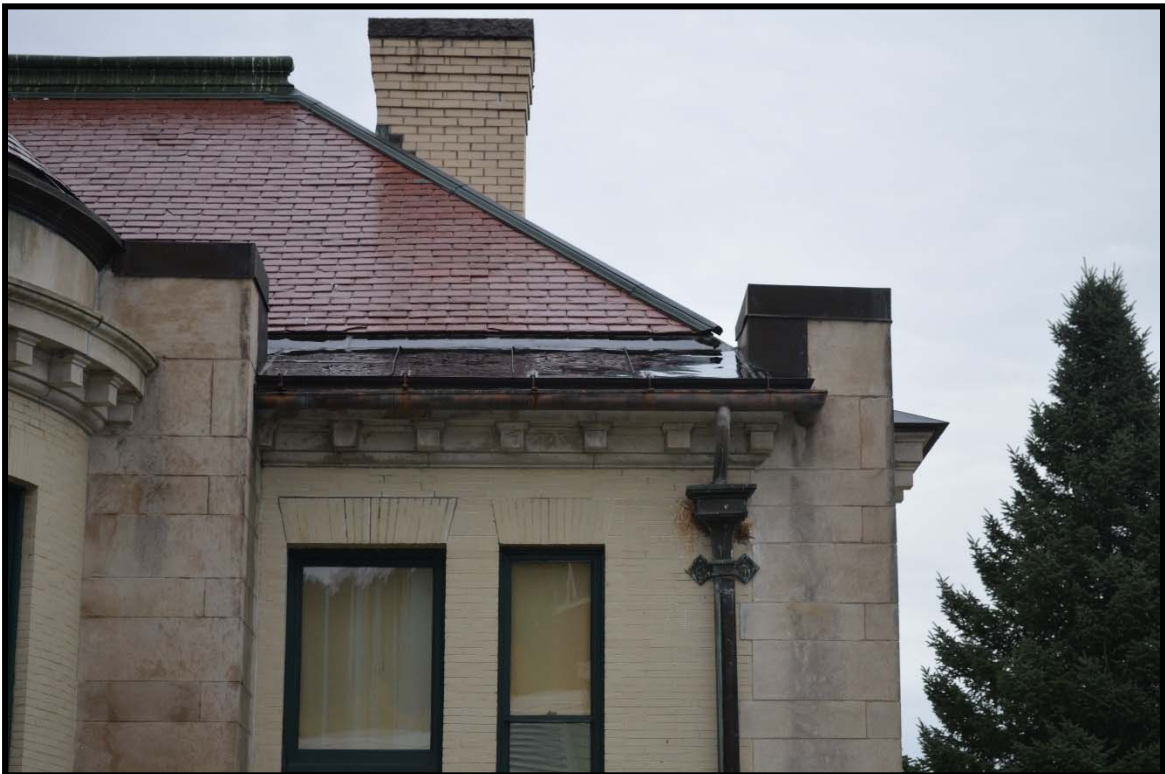
Image Exterior Detail 10 – Typical Eave Detail with Metal Infill over Original Drainage System.

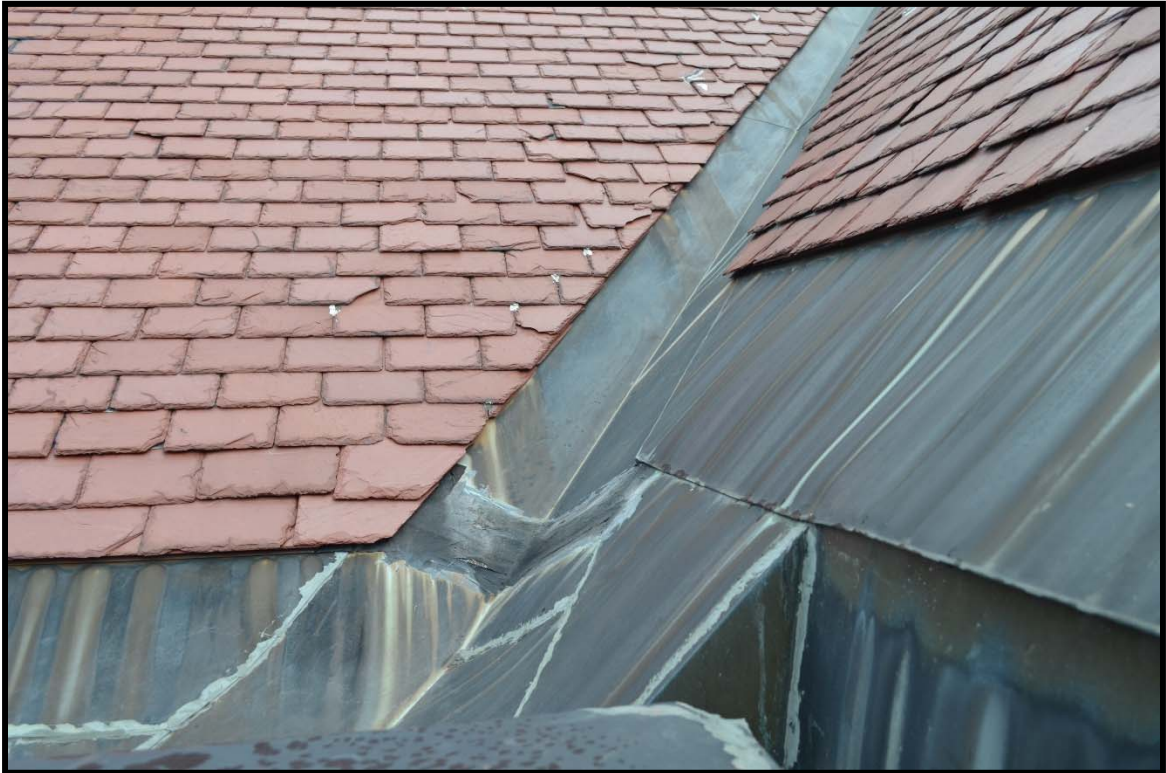
Image Exterior Detail 19 – Typical Condition at Open Valleys.

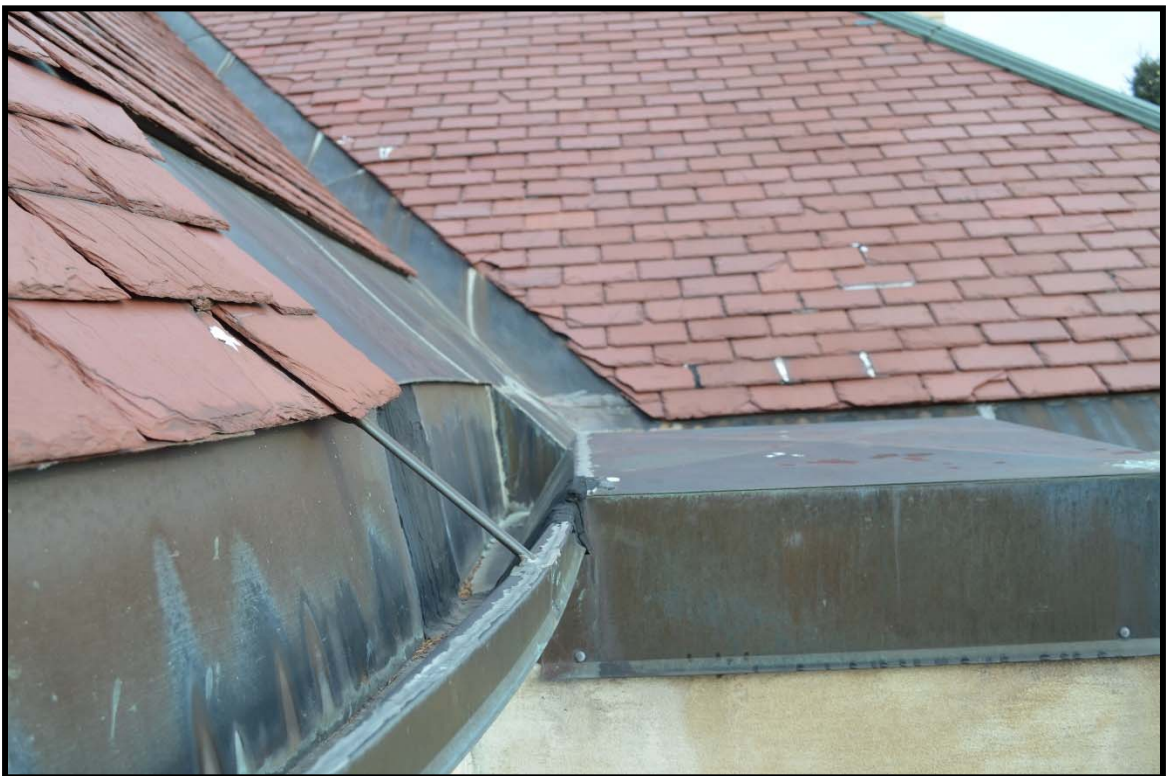
Image Exterior Detail 20 – Typical Gutter Condition at Semi-Circular Rear.

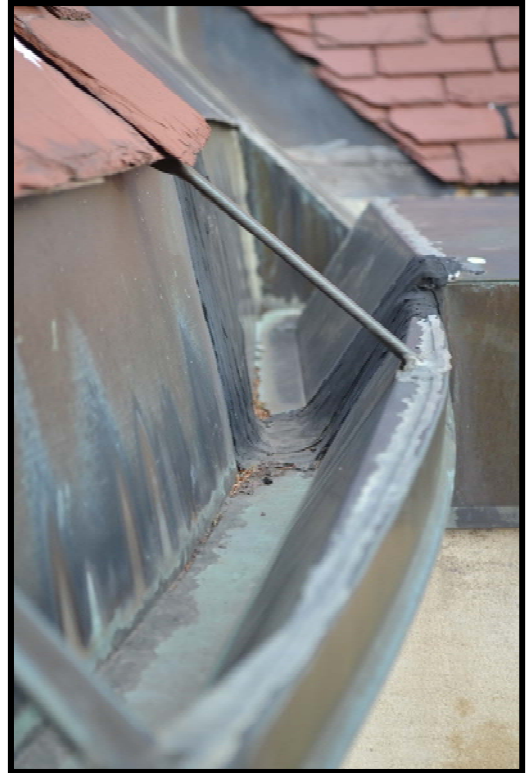
Image Exterior Detail 21 – Typical Gutter Condition at Semi-Circular Rear.

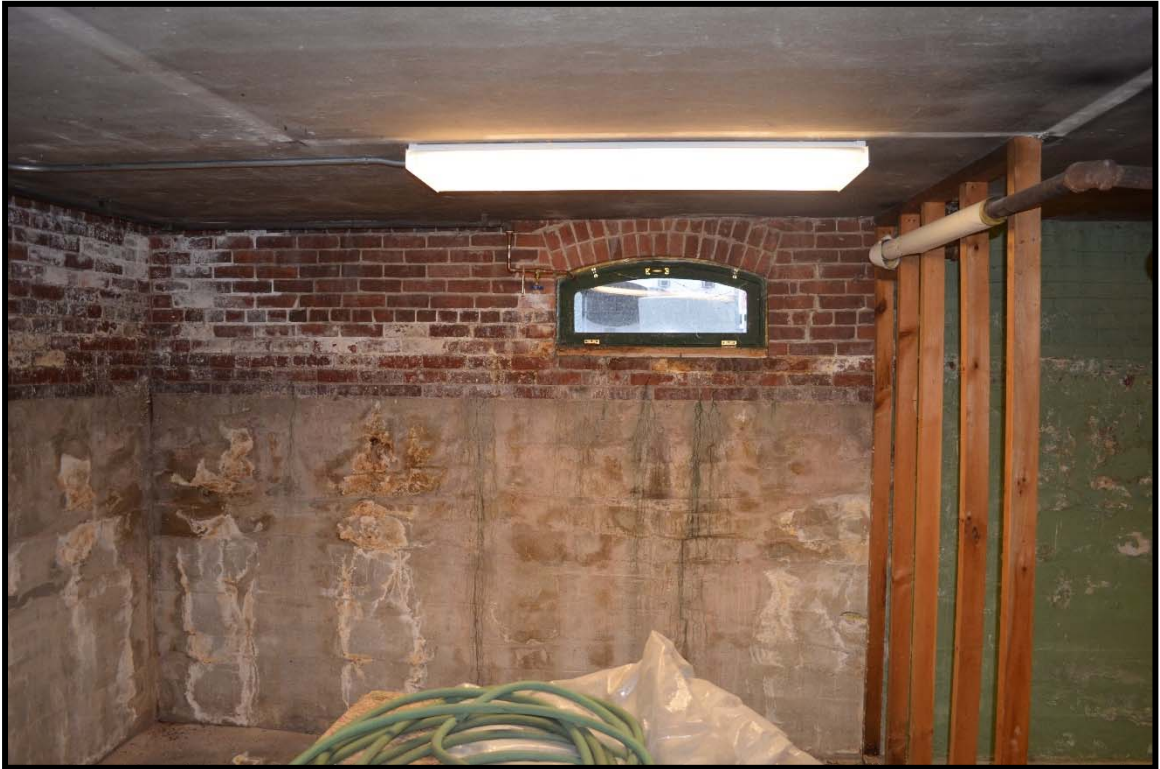
Image Interior 21 – Typical Basement with Efflorescence Visible on Masonry.
