**CENTER HARBOR VILLAGE SCHOOLHOUSE**

**94 DANE ROAD, CENTER HARBOR, NH**

**EXISTING CONDITIONS REPORT & ASSESSMENT**

**8 JANUARY, 2018**

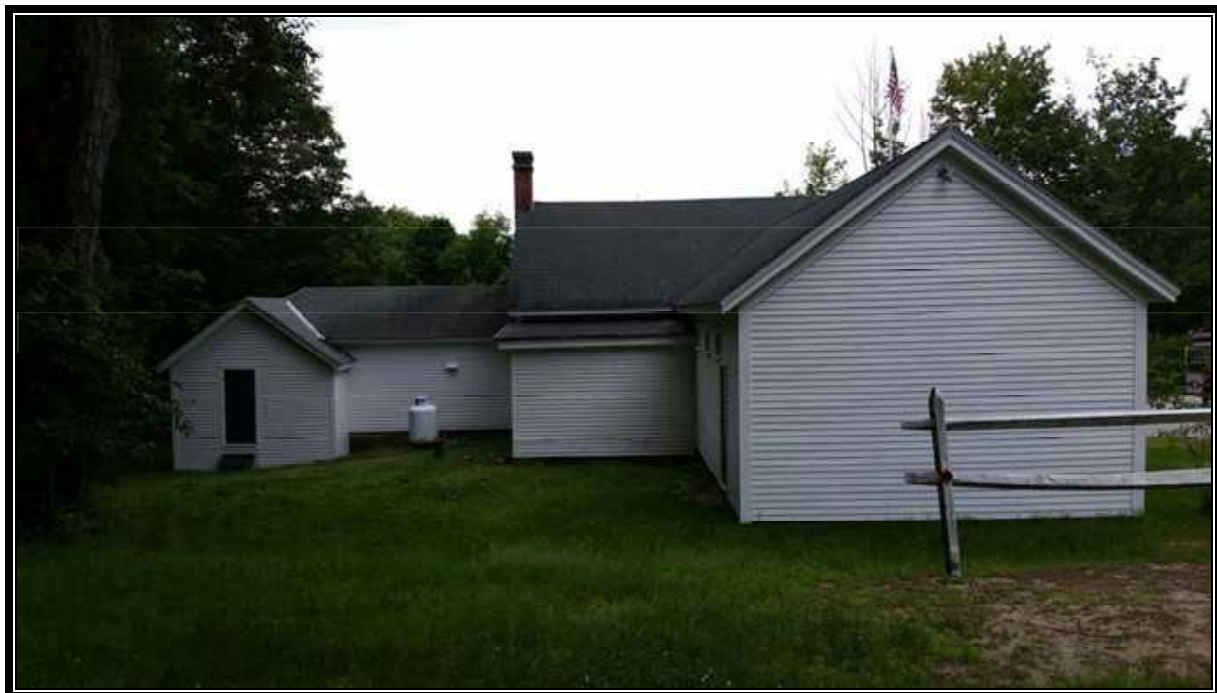
Photo 2: Looking south at the building.

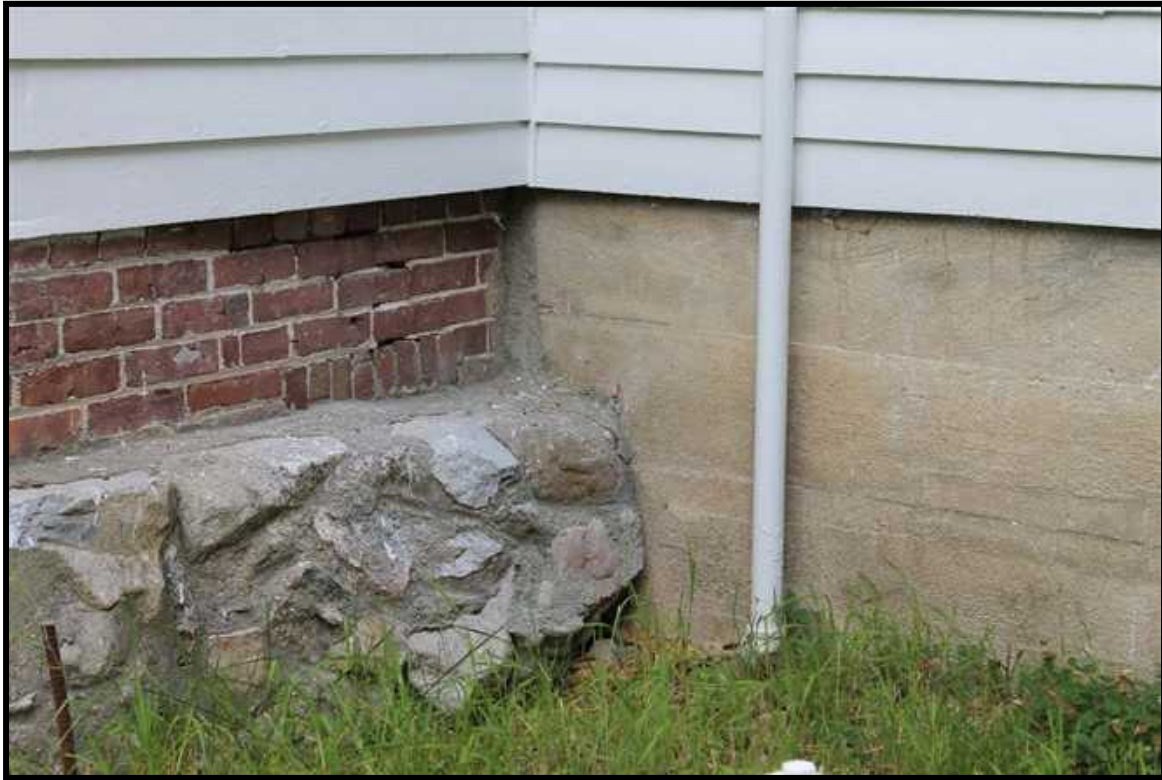
Image Exterior Detail 001 – Inside Corner of Foundation at 1886 Schoolhouse and 1919 Kitchen Addition

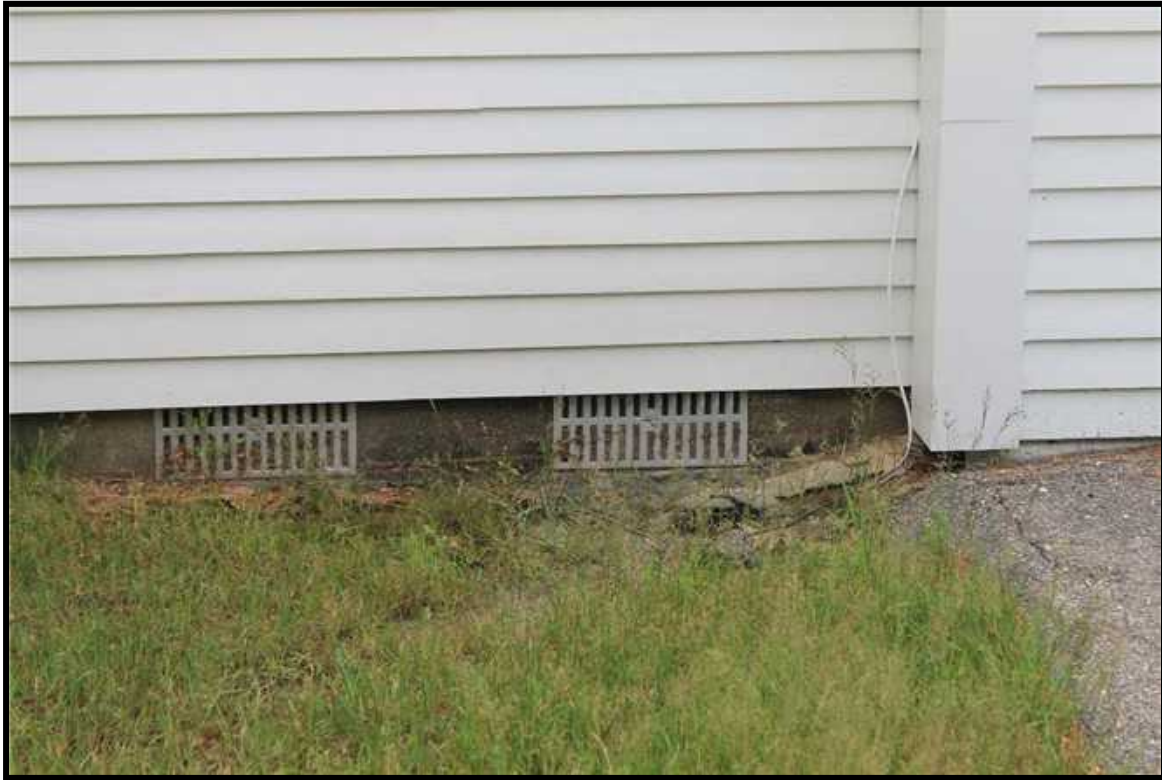
Image Exterior Detail 003 – Crawl Space Venting at 1902 / 29 Addition

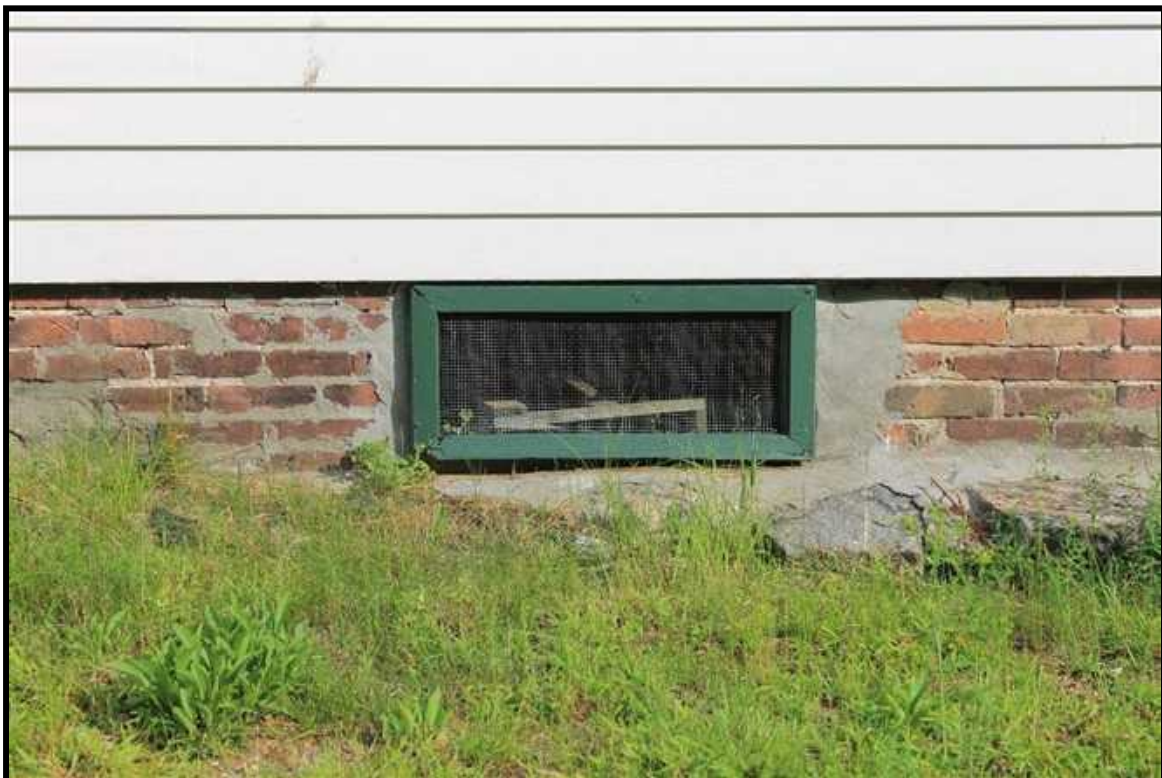
Image Exterior Detail 004 – Crawl Space Venting at 1886 Schoolhouse

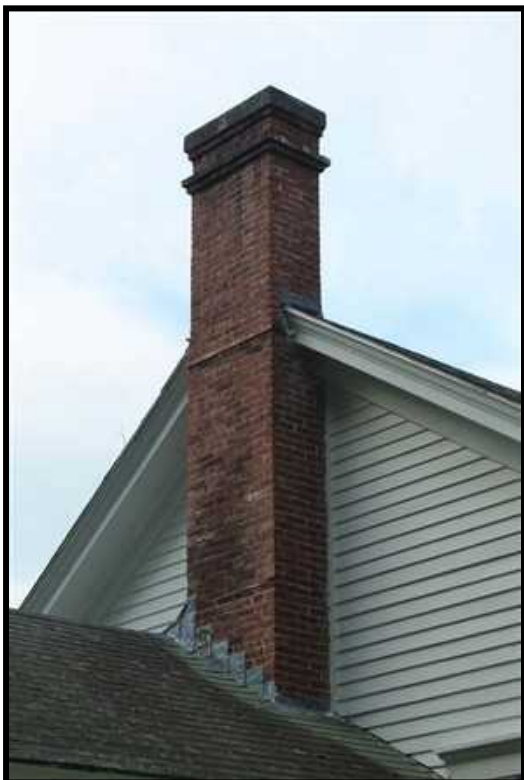
The brick chimney appears to be in stable condition. However, some loose brick has been observed, as well as at least one occurrence of dislodged brick, and further detailed inspection is recommended.

Image Exterior Detail 010 – Chimney at Rear of 1886 Schoolhouse

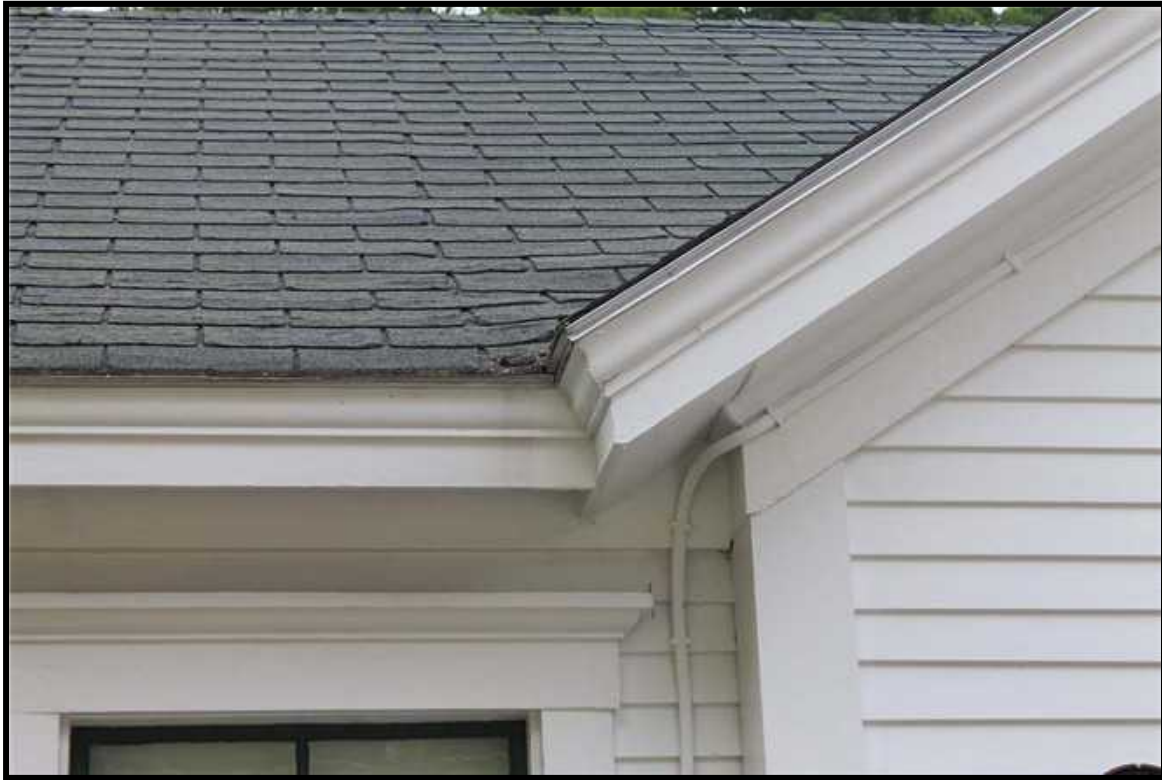
Image Exterior Detail 011 – Typical Eave Condition

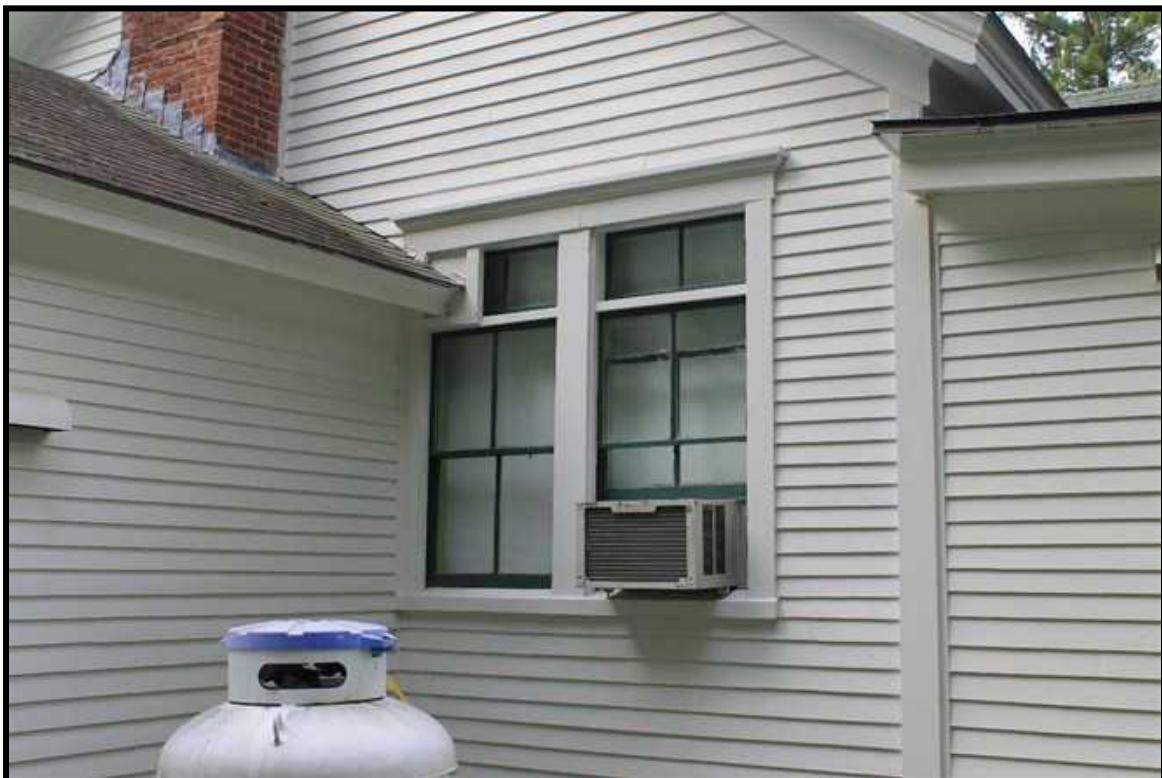
Image Exterior Detail 012 – North East 'Rear' of 1886 Schoolhouse

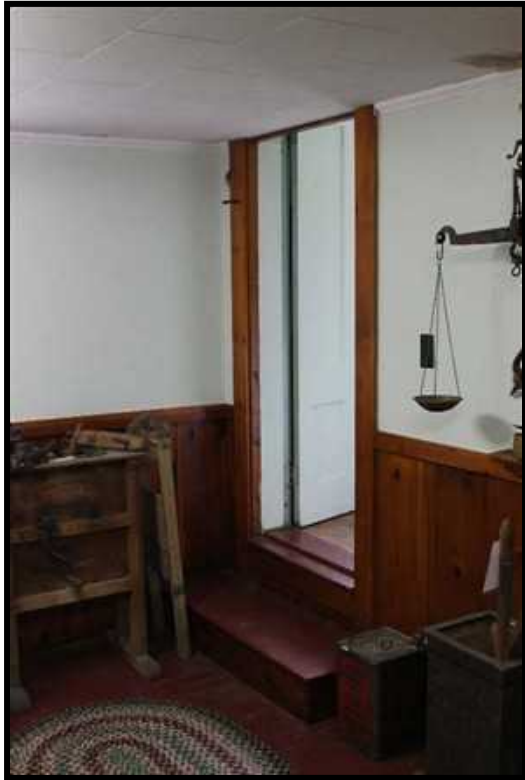
Image Interior Detail 005 – Floor Elevation Transition at Workshop Addition
